**Report: Okiato/Russell Walkway - Condition Assessment**

**From: Far North Holdings Limited**

**Date: 1 October 2018**

# FNHL Russell to Okiato Boardwalk Asset Inspection and Valuation – August 2018

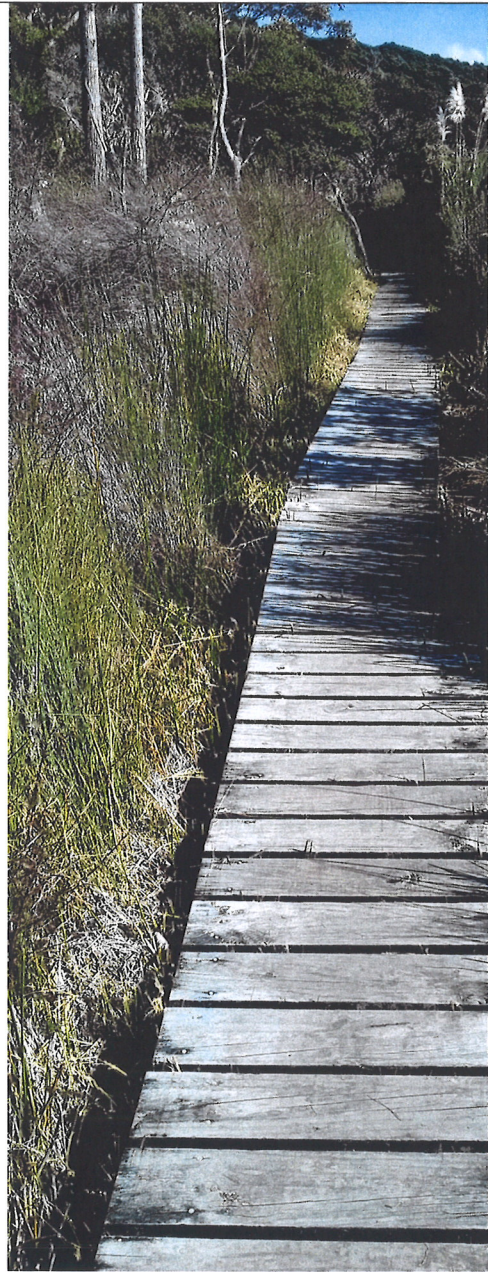
There are areas of the walkway where structures are partly covered by vegetation. Organic matter has rotted on top of the structures and become slippery and damp.

*Figure 15 Vegetation clearance required*

1. Vegetation removal	48 hours	\$2,200pa
2. Vegetation spraying	32 hours	\$2,500pa
3. Wet & Forget spray	32 hours	\$2,500pa
4. Materials		\$1,500pa
5. Metal	N/A	N/A
6. Labour (other)	40 hours	\$1,800pa
Total		\$10,500pa

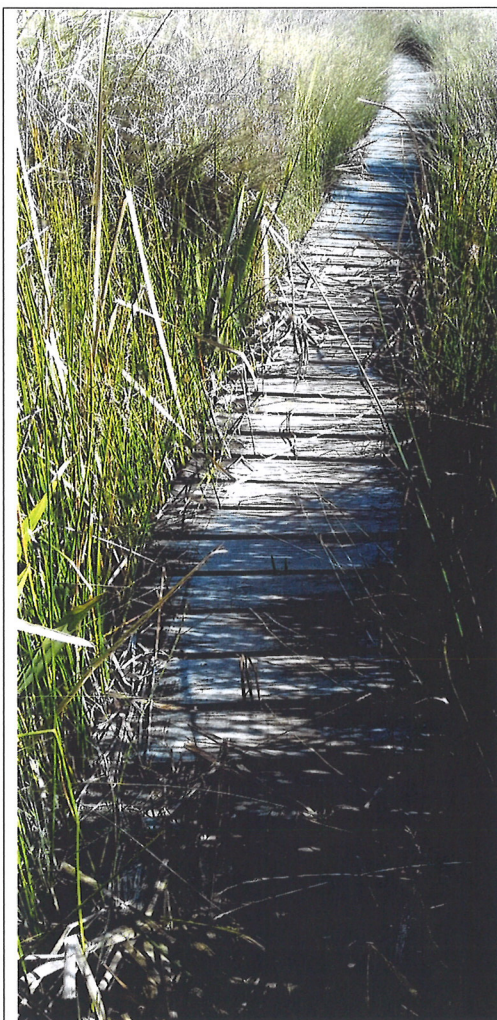
*Figure 17 Vegetation clearance required*

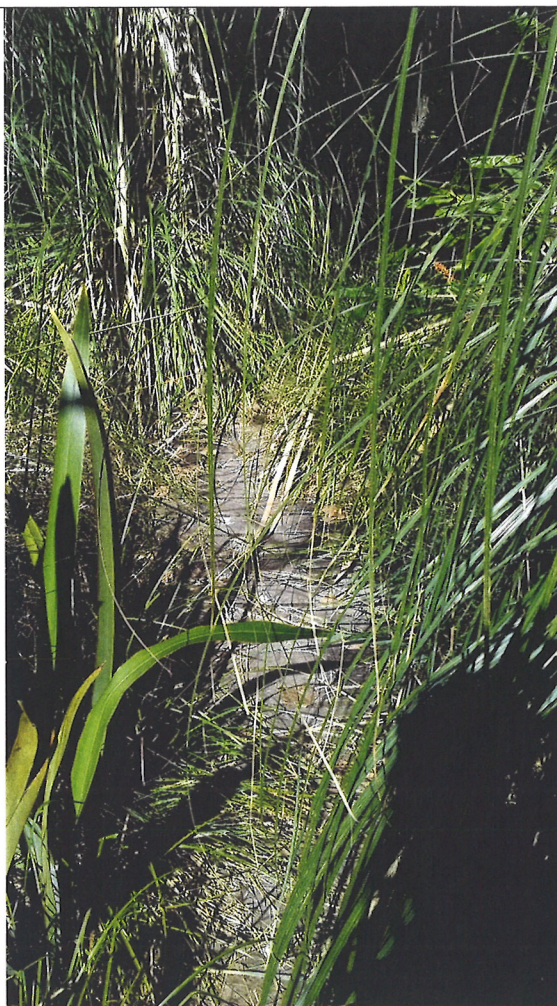
*Figure 18 Vegetation clearance required*
