Asset Condition Report

Project: Lake Ohia Hall

Location: 4906 SH 10, Lake Ohia 0483

Date: 20/07/2020

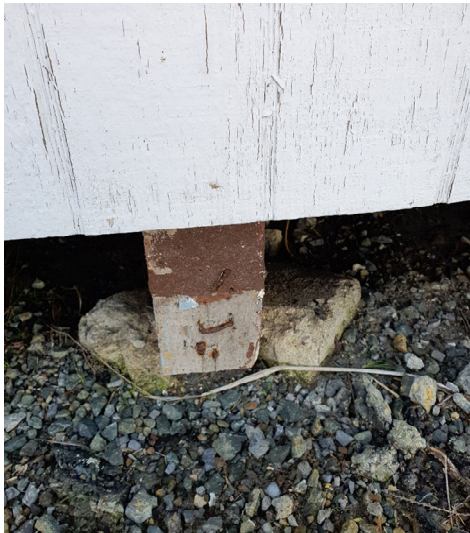
The foundations are preformed concrete pile pads sitting on existing grade. There does not appear to be any key into ground however no subsidence is evident. Some areas of ground are damp under the building with no damp proof membrane (DPM) barrier present. Clearance for ground to joist meets current code. Some of the perimeter piles and pile foundations have deteriorated and require replacing.

Figure 8 Degraded perimeter pile footing

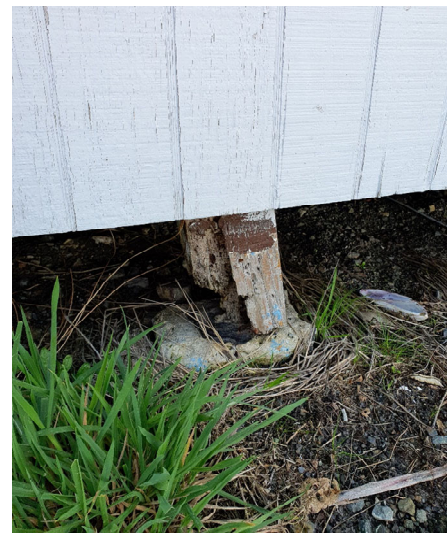
Figure 9 Rotten perimeter foundation pile

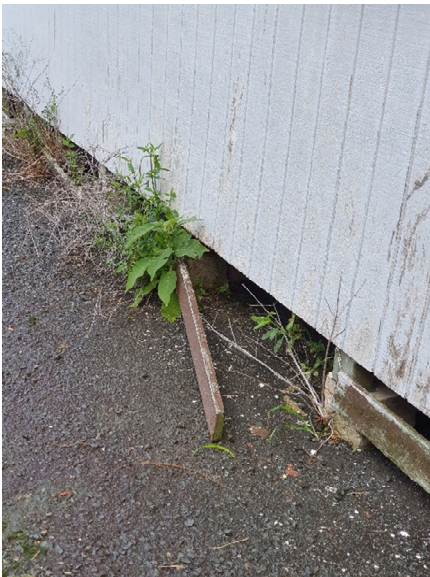
Subfloor framing is original native sawn timber joists over bearers on timber piles. Piles are wire fixed over DMP to precast pile pads. All subfloor framing is in a good dry condition and fixed with skew nails, no specific bracing elements or tie down fixings are used (i.e. wire dogs or timber connectors). This is fit for purpose and shows no signs of movement. Baseboards are damaged or missing and need repair.

Figure 12 Damaged baseboards

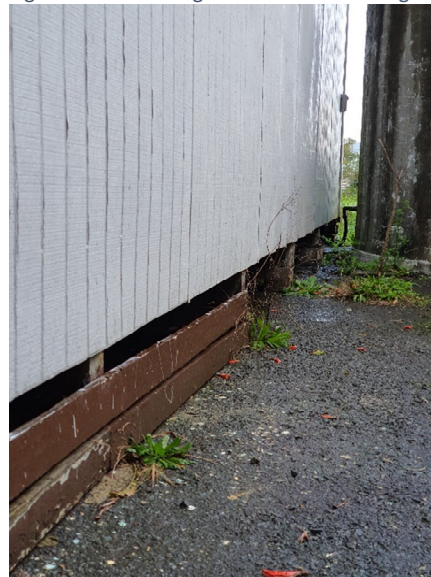
Figure 13 Missing baseboards

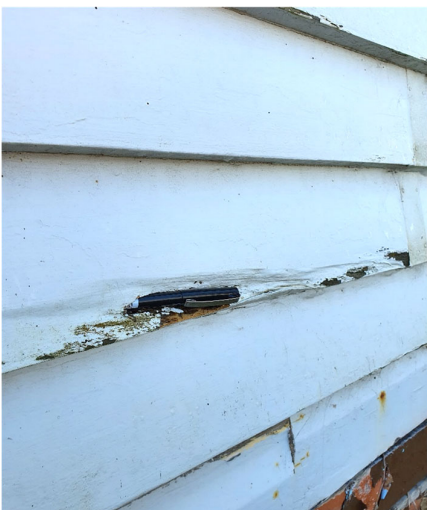
External claddings are a mix of painted mix of timber weather boards, rusticated weatherboards, and shadowclad plywood. All claddings, edge trims and joiners show signs of deterioration, distortion, and rot. The shadowclad ply has areas of delaminating paint and is deteriorating at the corners and lower edges of the building. These areas of rot and damaged claddings required cutting out, replacing, and repainting. It is public knowledge that shadowclad plywood has resulted in a class action lawsuit throughout New Zealand due to its weathertightness failings.

Figure 14 Rotten weather boards

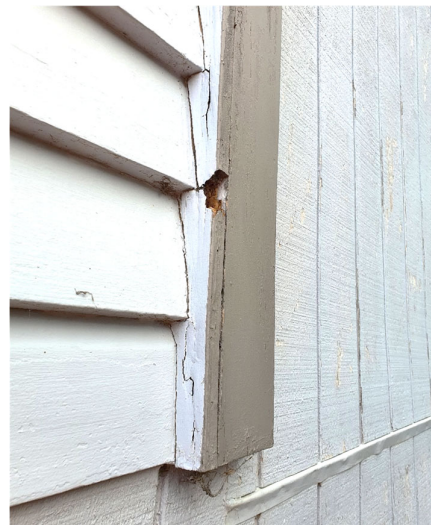
Figure 15 Rotten mouldings

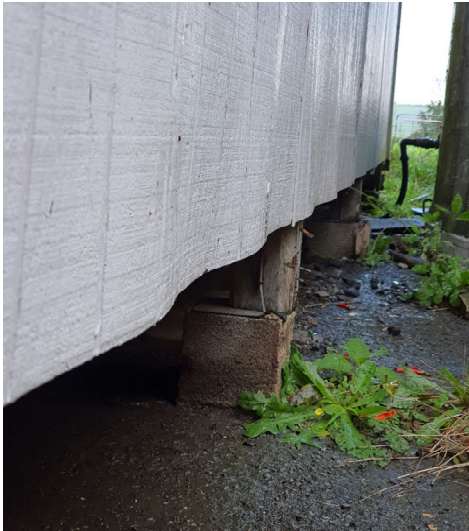
Figure 16 Deformed shadowclad ply cladding

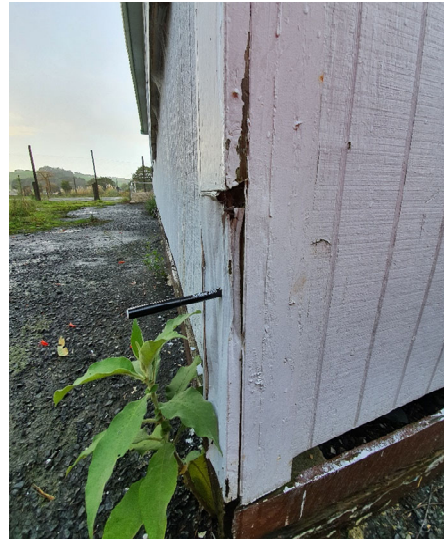
Figure 17 Rotten shadowclad at corner

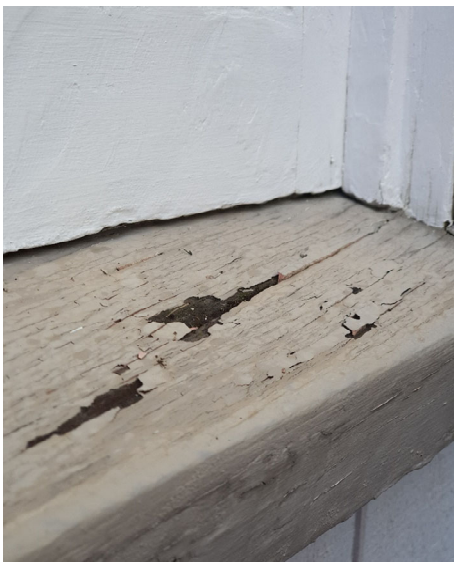
Windows are timber throughout and inoperable. Several windows, sills and surrounds show signs of rot and moisture ingress. Localised repairs should be affected to these damaged areas to arrest continued degradation. Where possible windows should be made operable. This will require easing and repainting of adjusted sashes and in some case new or reworked operators.

Figure 18 Typical rotten window sill

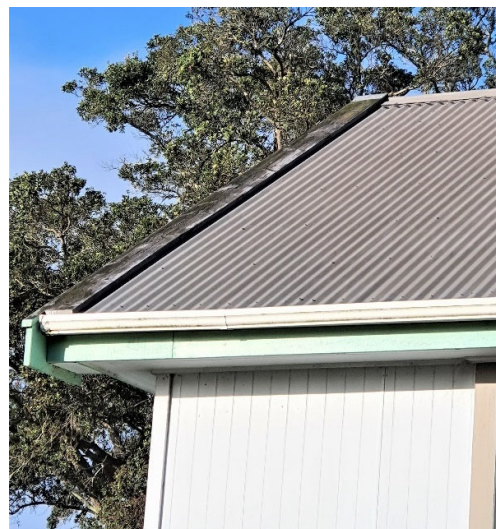
Roof cladding is of an undeterminable age. This is a replacement of the original and appears to be at least twenty years old due to its unfinished underside and having been installed directly onto the existing rafters without any underlay. The roof is in a serviceable condition however, requires a pressure wash and paint touch up at the next programmed maintenance period. There is an unused flue pipe with no evidence of leakage which can remain in place.

Figure 21 Roof showing algae build up

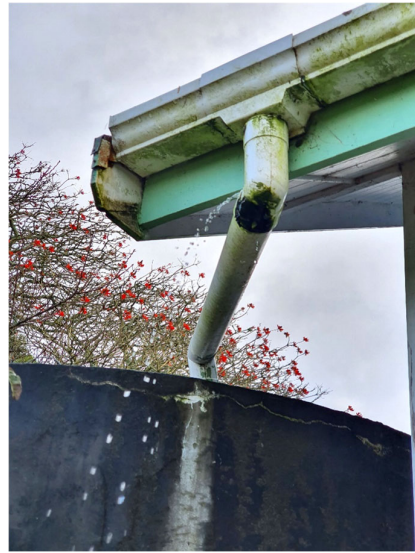
Gutters and downspouts are uPVC, are in good condition but need cleaning and re-joining in places (see fig 23).

Figure 23 Gutter showing leak

flashings to rear of the building at the water tank require cleaning and repainting in near future (fig 23). The roof space is not insulated.

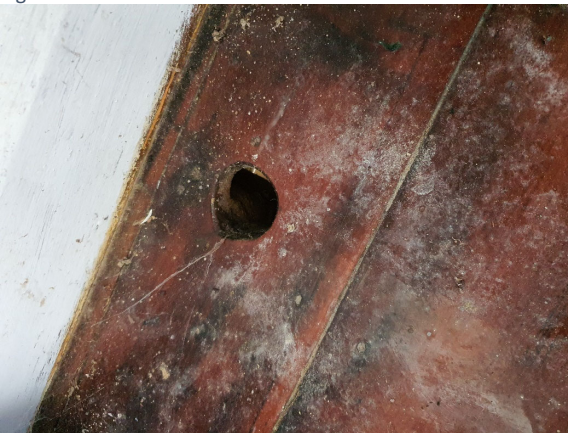
Floors appear to be a variety of varnished remu planking throughout in good condition. Some old plumbing holes require plugging (fig 24) to deter rodent ingress.

Figure 24 Holes in floor

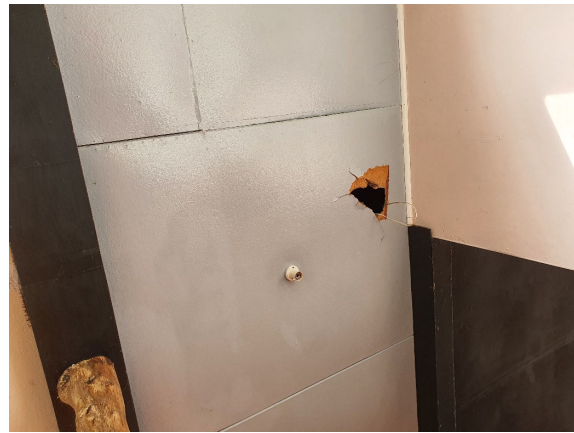
Ceilings are of low density sheet fibre board with battens. There are areas of minimal damage that will benefit from repair (see interior images and fig 25). Water damage is evident in the toilet ceiling but appears old (fig 26)

Figure 25 Ceilings

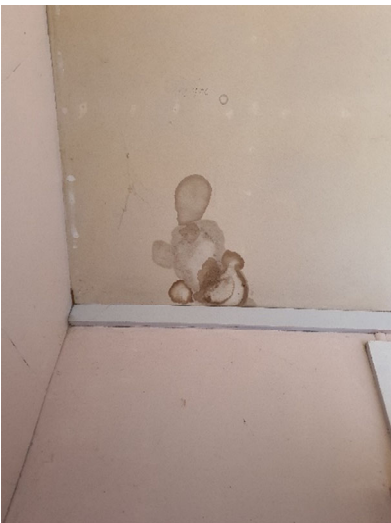
Figure 26 moisture on ceiling lining

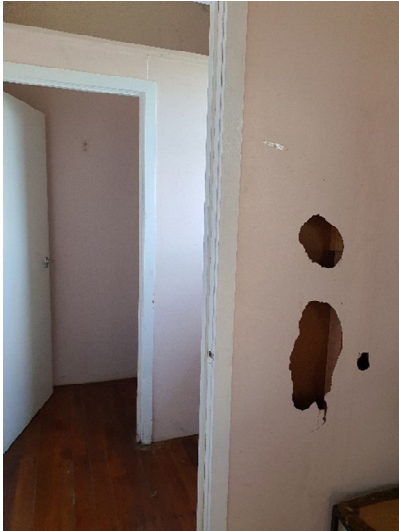
Interior linings are a mix of painted vertical timber shiplap, low density fibreboard and masonite, in a reasonable condition. There is some damage to masonite (fig 28) on the male toilet partition walls however this is just unsightly and not presenting a human or structural hazard.

Figure 28 Damaged wall linings

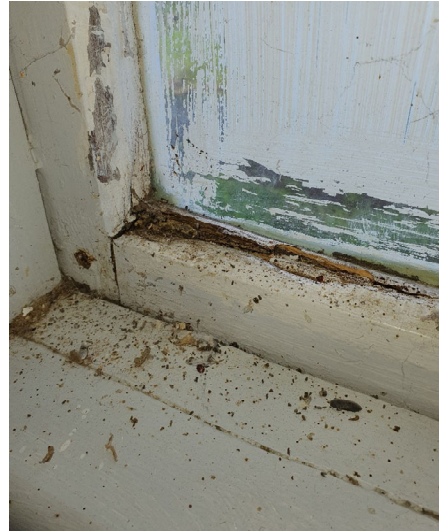
Windows to the south of the building, including bathrooms and kitchen are timber pivot windows with some showing signs of rot. Rotten timber needs to be cut out and replaced with new primed and painted timber infills. Sashes are inoperable, and it is recommended that at least one window in each of the toilets and the kitchen are made operable to permit ventilation and eliminate moisture build-up.

Figure 29 Rotten interior windows

Ensure that any exposed timber due to this process is suitably primed and painted and that any missing putty is replaced, and latches are secure and operable.

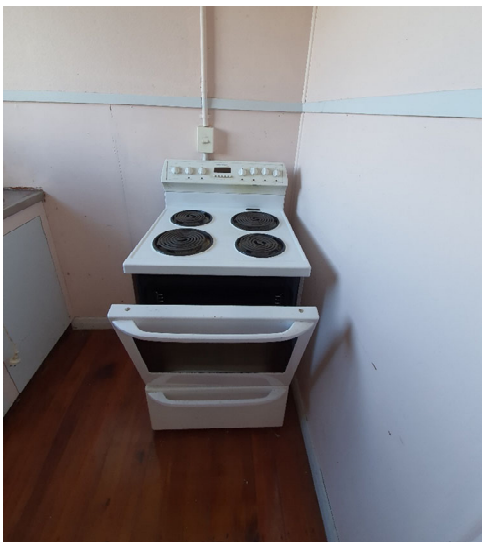
The free standing electric stove operates. There is no evidence of an electrical certificate. It is recommended that a certified electrician review this and all other electrical reticulation, fixtures and fittings at the next programmed maintenance period.

Figure 32 Kitchen stove

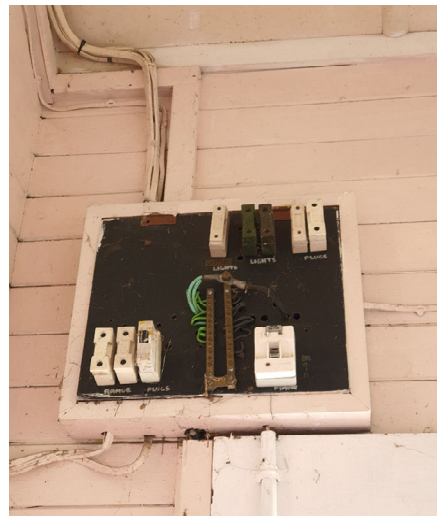
The sub panel is original (fig 37). It is recommended that the panel be reviewed and serviced by a certified electrician over the next programmed maintenance period.

Figure 37 Electrical subpanel

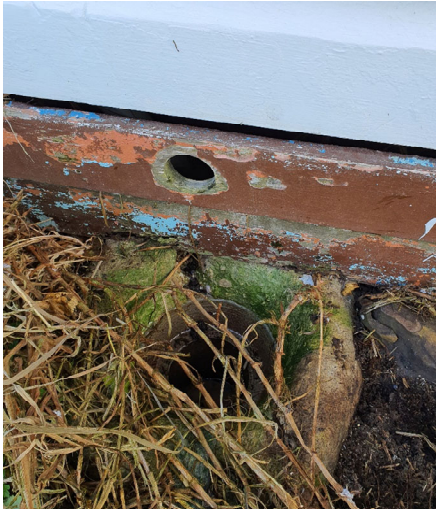
Waste is uPVC to an onsite effluent management system. The kitchen sink waste required reconnection through to the exterior gulley trap.

Figure 40 Sink waste not connected to outside

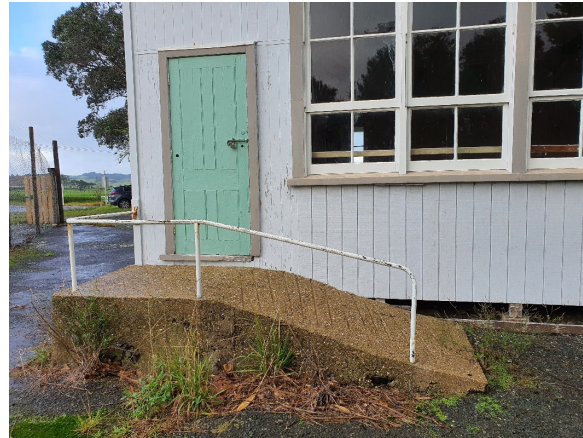
There are no complying accessible ramps to the building entry or exit doors. It is recommended that should the hall continue in use, that a complying accessible ramp be installed to the main entrance door and the door threshold interior be made to compliant.

Figure 41 Non-complying ramp to building

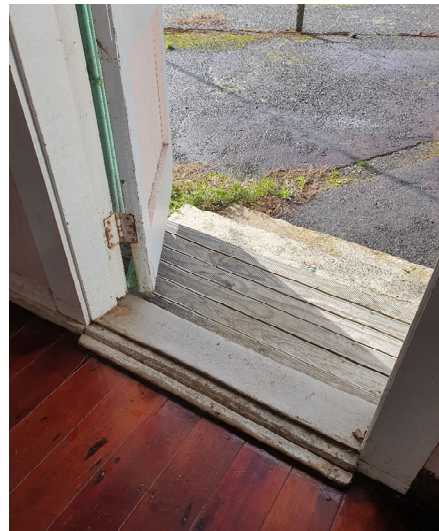
The external doors are wide enough for accessibility compliance however, thresholds will need to be modified to meet the requirements of NZS4121.

Figure 43 Entry door steps & threshold

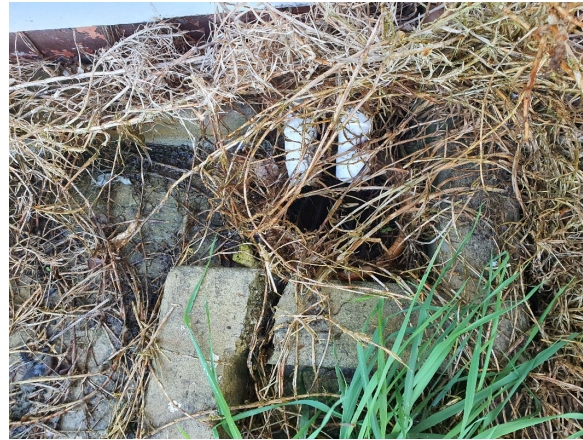
Gully traps at the building permit stormwater ingress. This needs to be resolved as soon as possible as stormwater ingress overcharges the effluent management system and can cause system failure.

Figure 47 Toilet gully trap overgrown & damaged

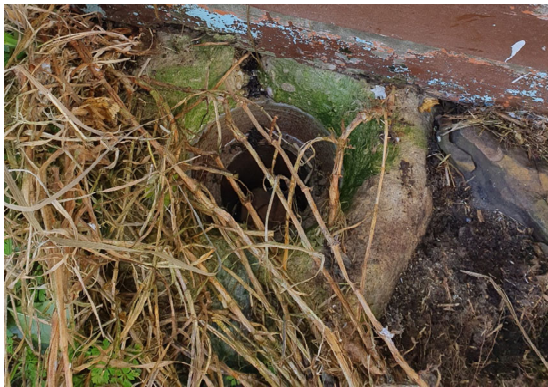
Figure 48 Kitchen gully trap overgrown

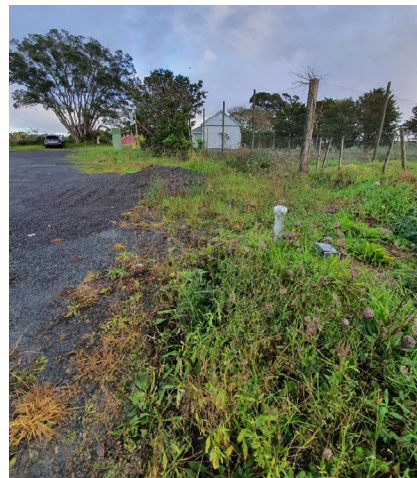
Effluent management is onsite disposal. It was not possible to detect type or location of any drain field, Council records may reveal this. A vent pipe indicates the location of the effluent tank which appears to be located in the road reserve. Function of the effluent disposal system will need to be verified by a plumber.

Figure 49 Location of effluent tank
