Project Number: 1-13191.00

Hihi WWTP Activated Sludge Reactor

25 November 2019

Structural Condition Assessment

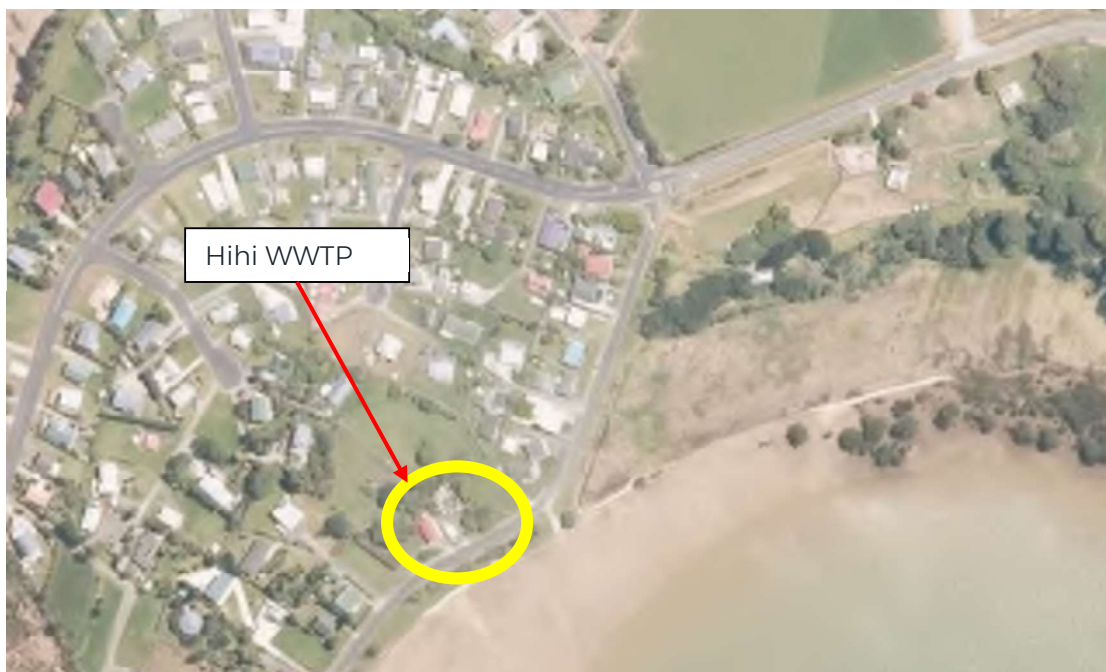
An inspection by Fraser Thomas in 2014 (attached in Appendix A) found significant damage to the large aeration tank at Hihi wastewater Hihi WWTP Activated Sludge Reactor located at Marchant Road, as shown below. This report included the following observations:

- The internal dividing wall had partially collapsed
- Flaking of the tank waterproofing and,
- Exterior cracking.

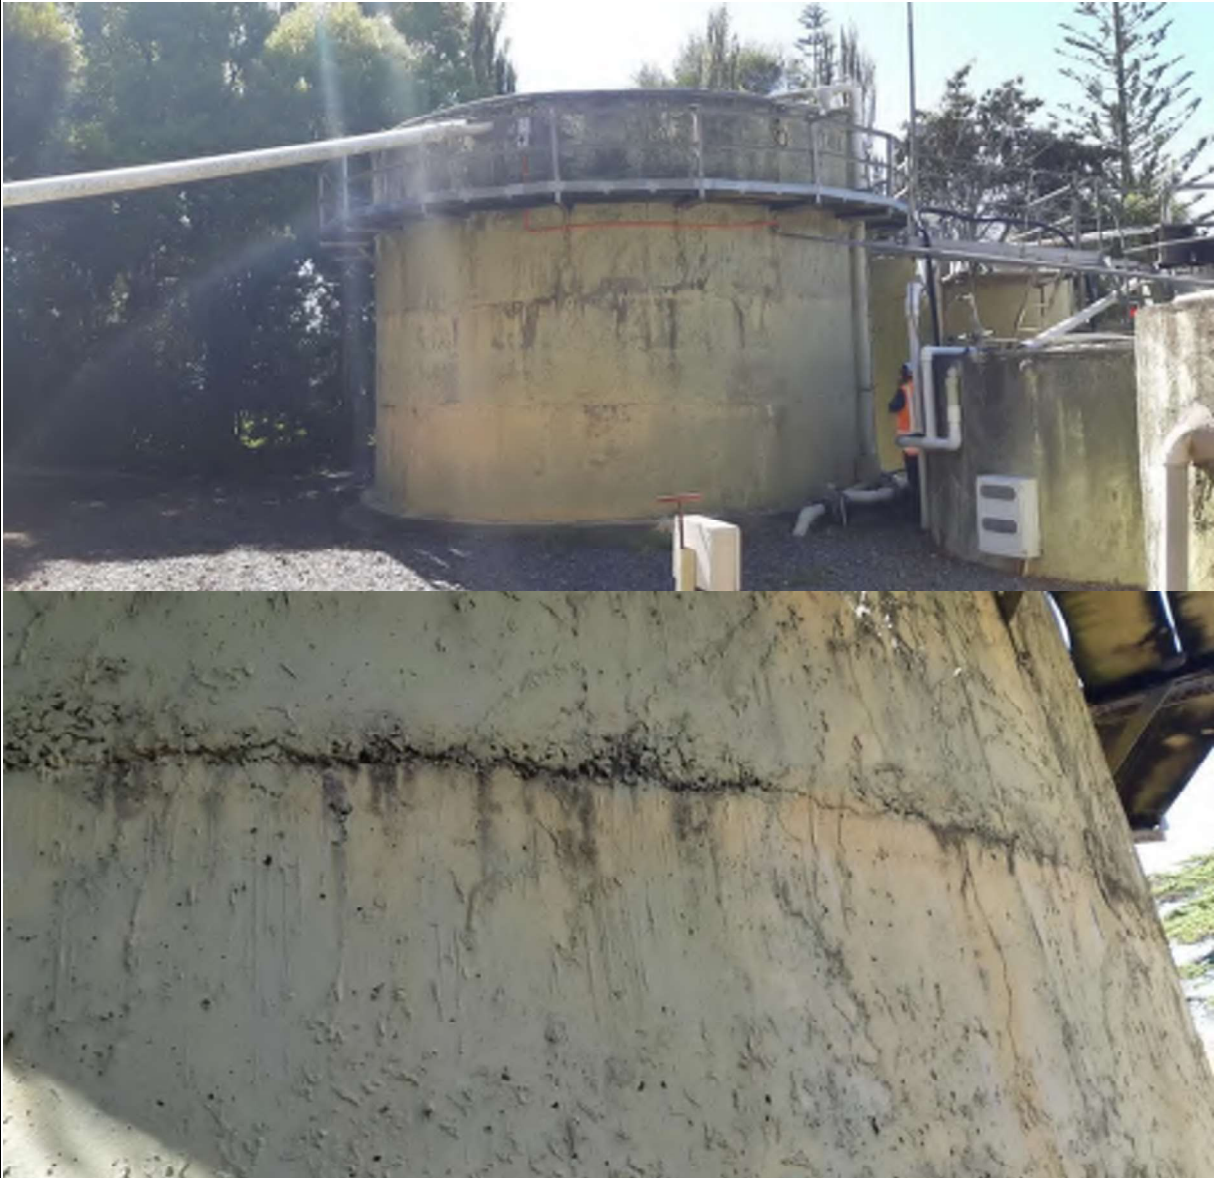
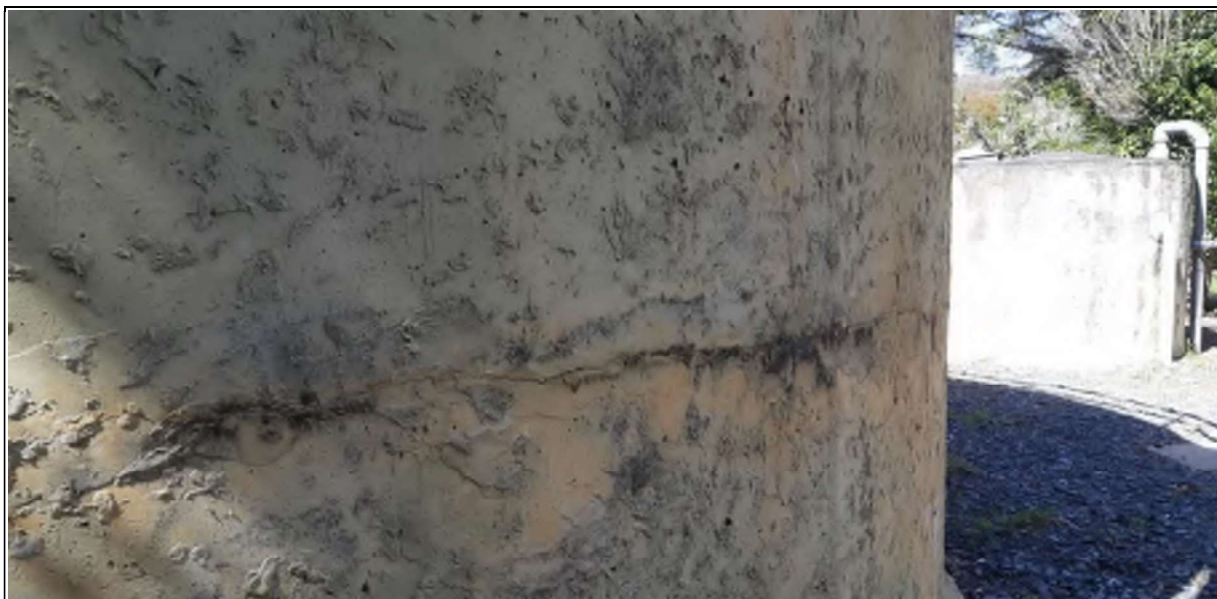
Several cracks along the construction joints were observed, and one section was noted as being wet. This section was approximately 50mm long and covered in mould. Some vertical cracking was also observed, in addition to calcification and mould growth around the cracks. Other than the section noted no wet patches were found. The wall should be water-blasted to clear mould so cracks can more easily be recorded.

Item	Defect or Issue	Recommended Action
External Structure		
1.1	Cracking around the two construction joints around 75% of tank	Sika approved contractor to seal the cracks with Sikadur 31

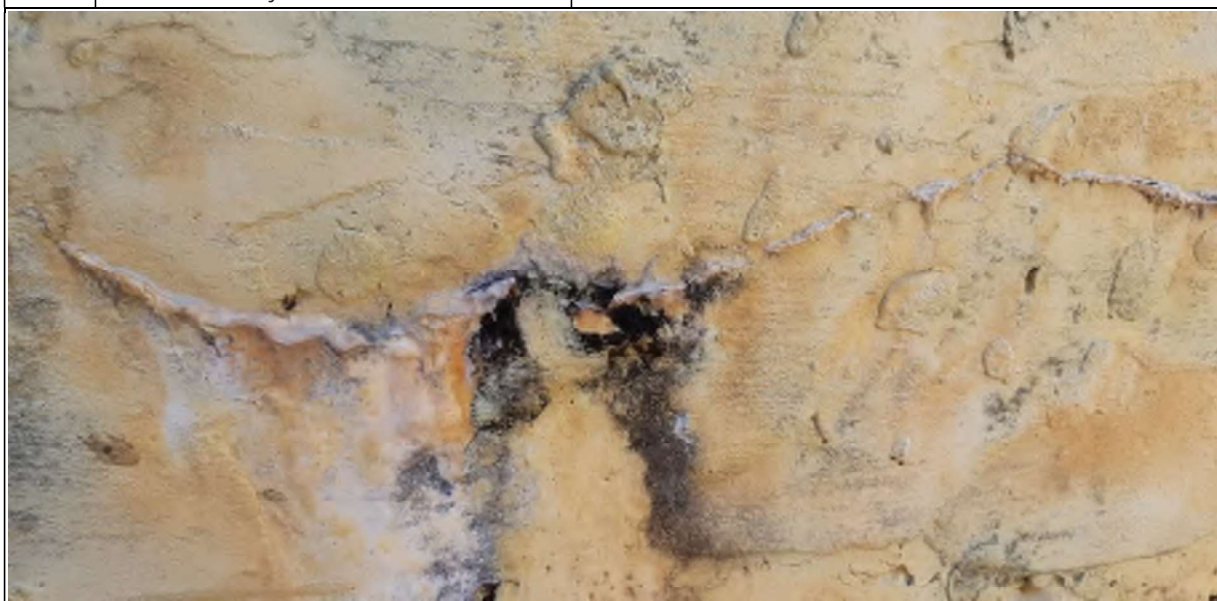
1.2	A 50mm moist crack covered in mould on the north side of the tank that runs along the lower construction joint	Clean out crack and repair with sika monotop

The perimeter wall is a critical structural element, and minor signs of cracking are already present. There is also a limited area of damp which indicates some water egress.

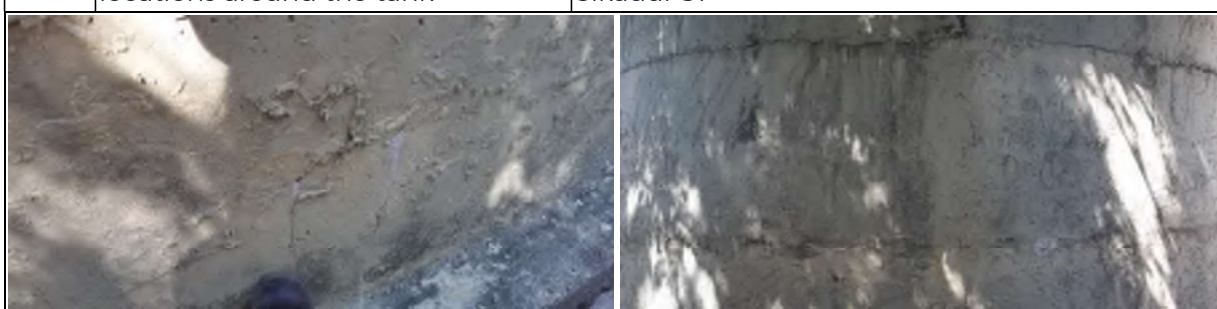
1.3	7 m of vertical cracks in various locations around the tank	Sika approved contractor to seal the cracks with Sikadur 31

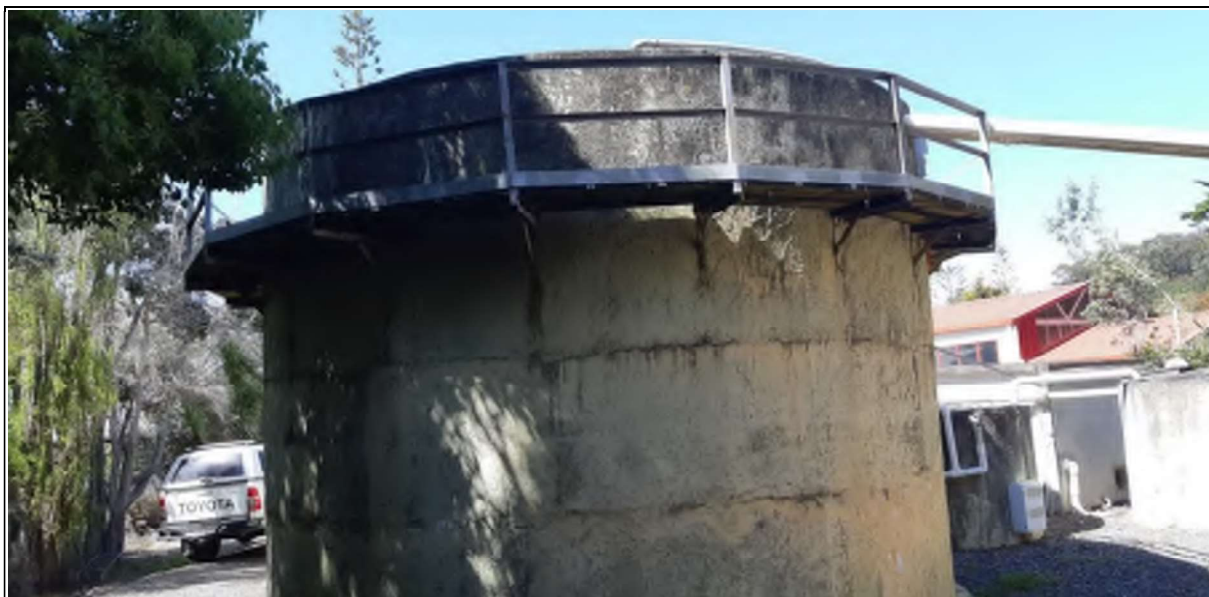
Minor spalling of concrete. Exposed reinforcement

1.4	Exposed reinforcing is visible inside the tank	Remove laitance and repair with sika monotop

1.5	Scour inside the tank and wear of tank waterproofing	Re-apply waterproofing with a product from an approved supplier

1.6	Moss and mould may be obscuring the extent of cracks	High pressure water blast walls of the reservoir to remove all vegetation, debris and laitance

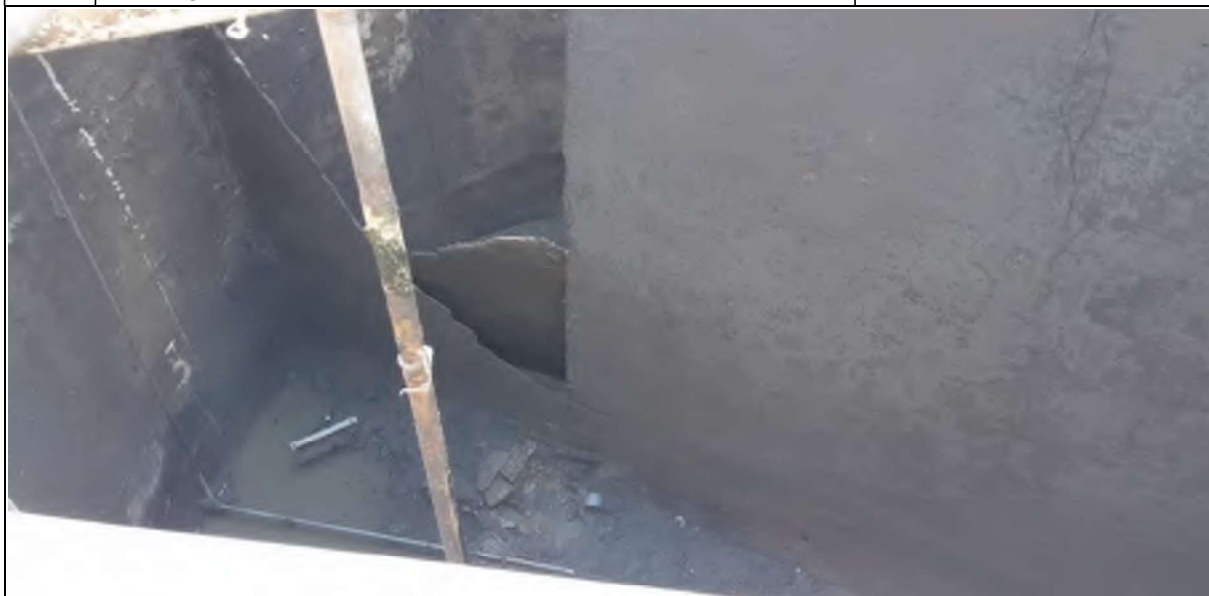
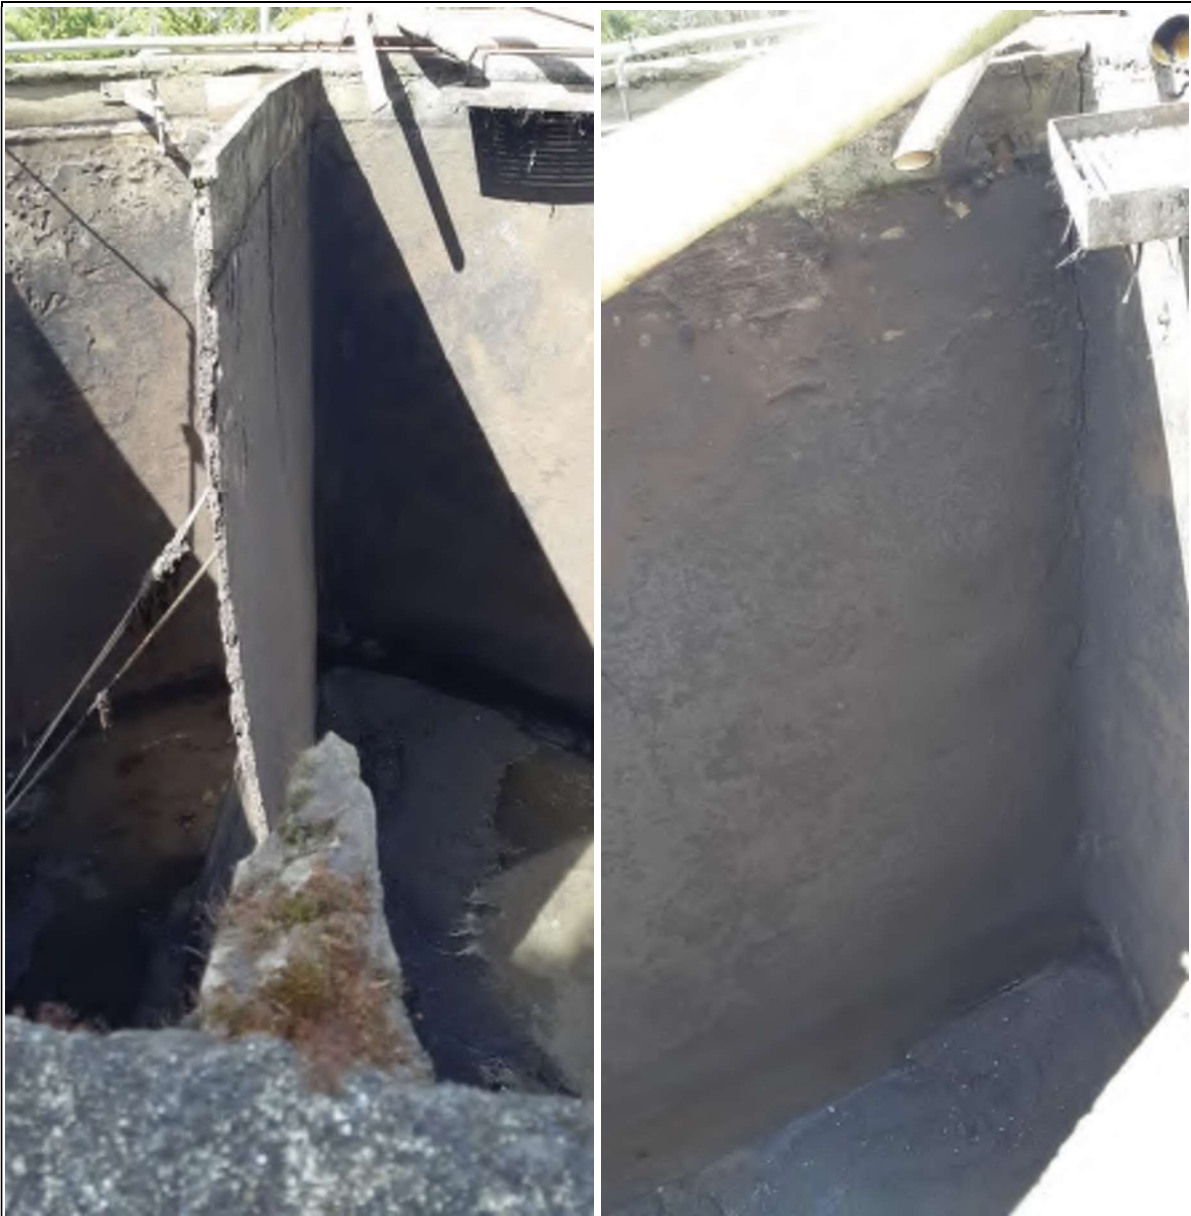
A section of the internal dividing wall was noted to have collapsed in the Fraser Thomas report. The internal assessment revealed this to still be true, in addition to further degradation of the wall. Cracking on the western side of the wall suggests this section will fail in a similar manner if left. Scour also affects this wall and the outline of steel reinforcing can be seen. Due to this lack of support the wall is bowing and has been observed to sway while the tank is running. The wall should be removed or replaced to avoid further damage.

2.1	<p>The wall is showing several signs of failure:</p> <ul style="list-style-type: none">The eastern segment has collapsedThe western segment is showing significant crackingThe wall has been eroded and the outline of reinforcing can be seenThe wall has been noted to sway when the tank is running	<p>Repair or replace the internal dividing wall.</p>
-----	---	--

The internal dividing wall has already experienced partial failure. It can be expected to fail completely as further deterioration occurs over time, or during a significant seismic event.

The internal wall is not considered to be a structural element; therefore, its failure will not result in loss of contents or progressive failure of the tank.

While not essential to the structural stability of the tank, a full replacement of the internal wall would be advisable to maintain full function. Advice from a process specialist should be sought before undertaking this.

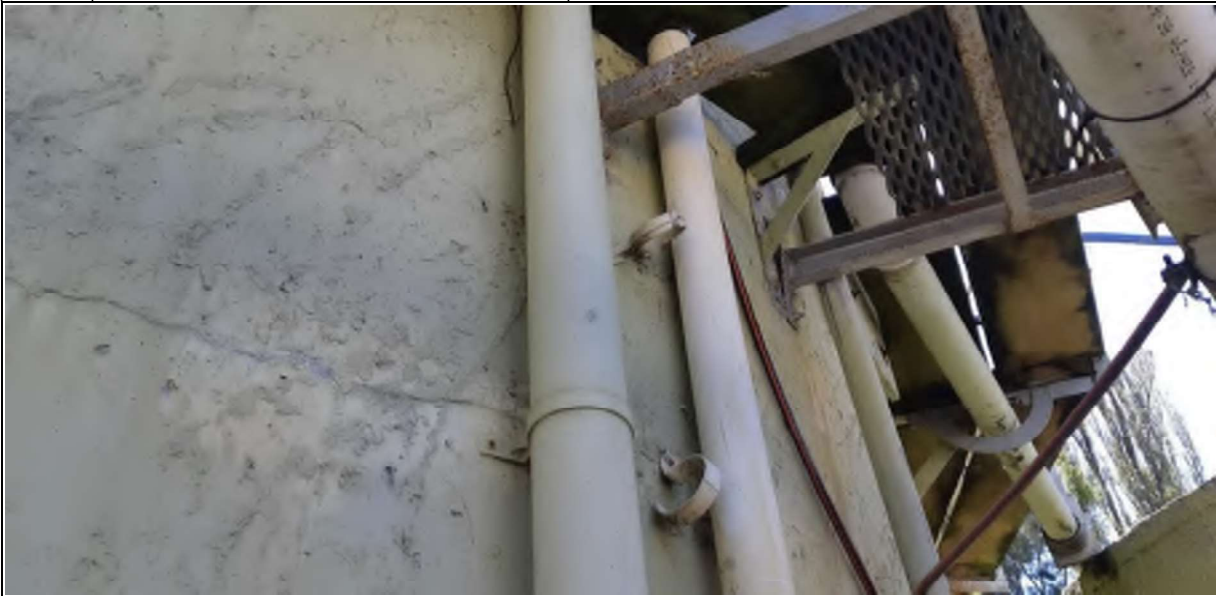
3.1	Obsolete Brackets	Remove and seal holes with appropriate mortar
-----	-------------------	---

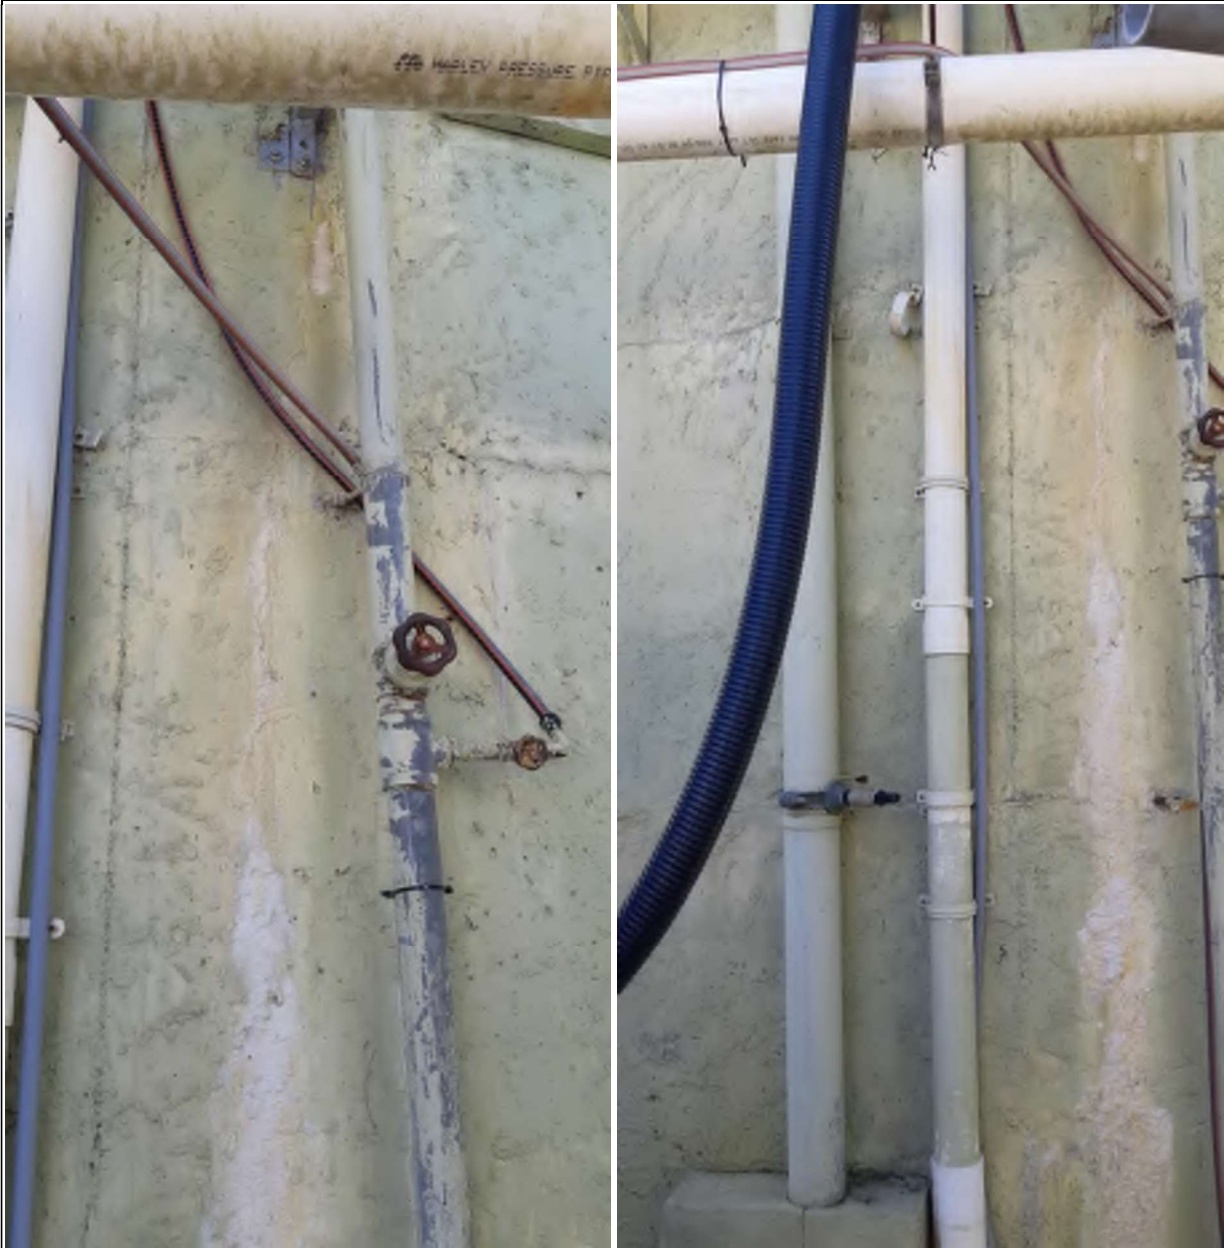
3.2	Rust on external brackets, valves and bolts	Replace with stainless steel fixtures

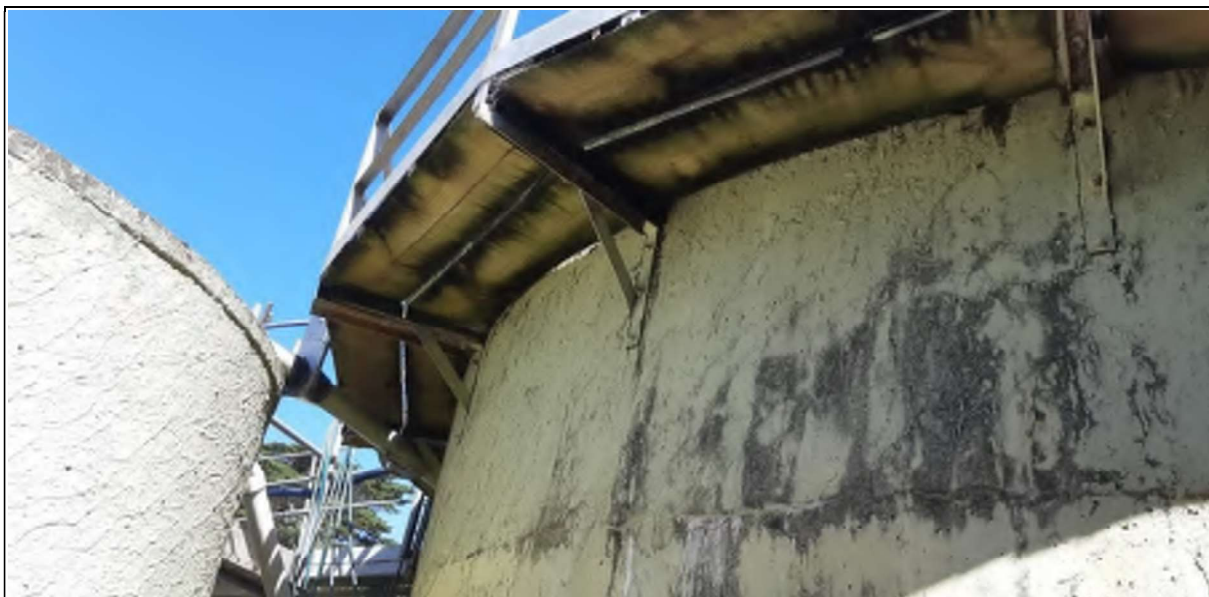
3.3	Rust and mould underneath external walkways	Clean element and record rate of corrosion

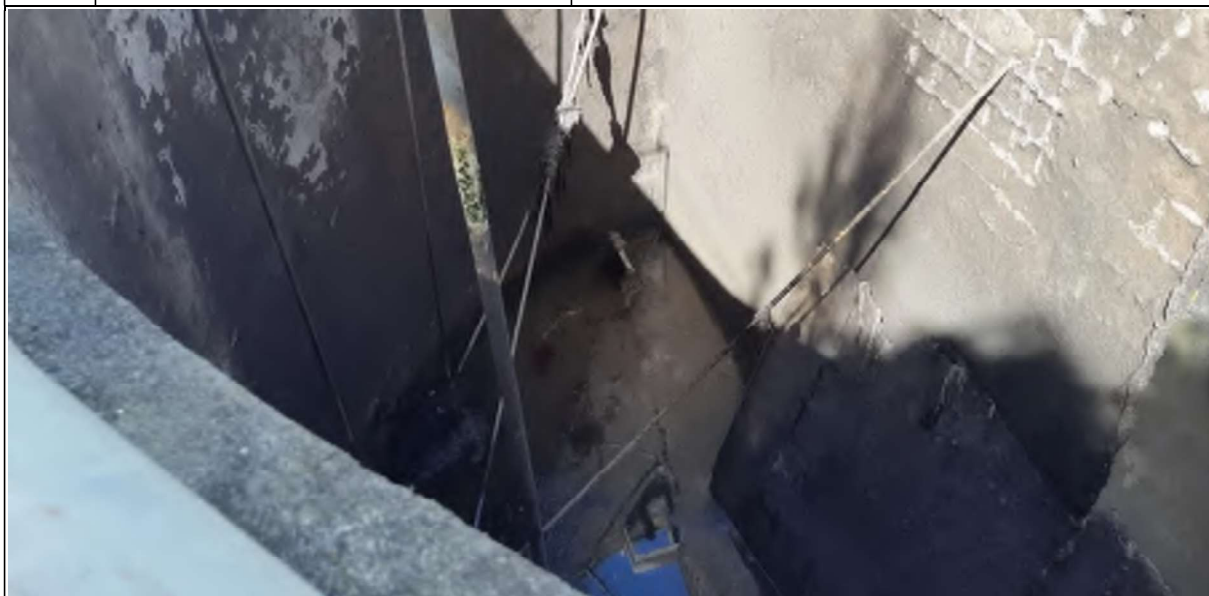
3.4	Several defunct pipes have fallen into the tank and remain there	Remove the defunct pipes and replace as needed
-----	--	--

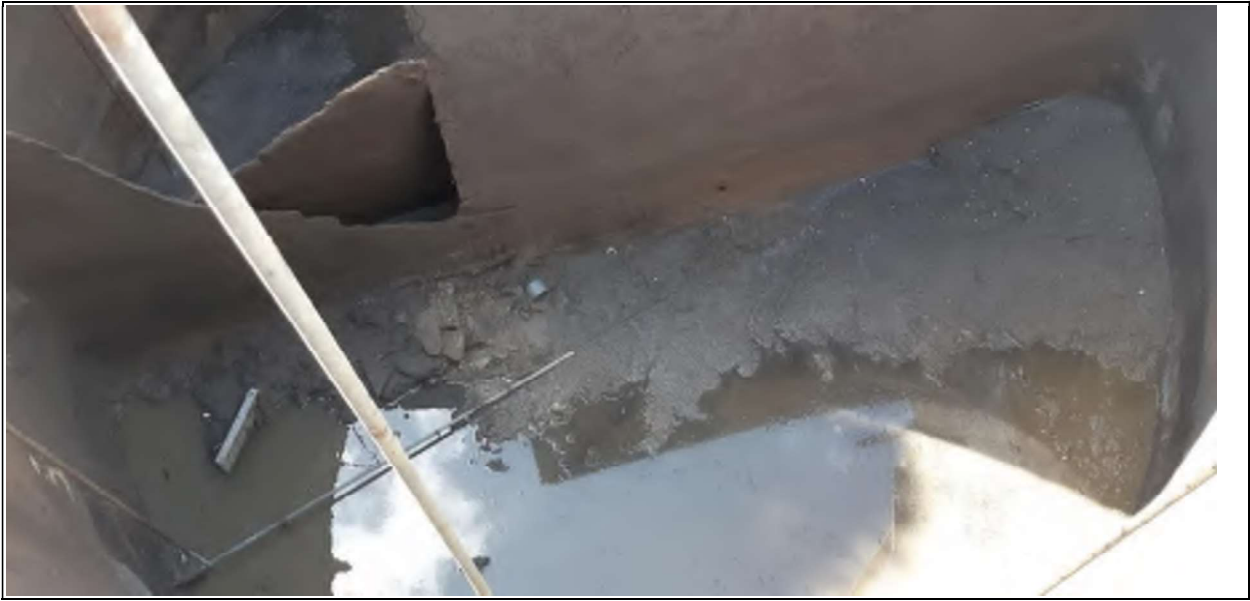
An internal assessment of the base could not be made as sediment within the tank covered the floor.

Other		
4.1	Sediment build-up inside the tank which limits the capacity of the tank and prevented a full inspection of the base	Remove sediment and drain tank to conduct a full inspection of the base; In the future perform regular maintenance to prevent build-up
