02 August 2023

Far North District Council  
C/o – Andy Finch

**RE: GEOTECHNICAL WALKOVER APPAISAL FOR COASTAL SLIPPAGE BELOW 7 RICHARDSON STREET, OPUA  
(TE ARAROA TRAIL)**

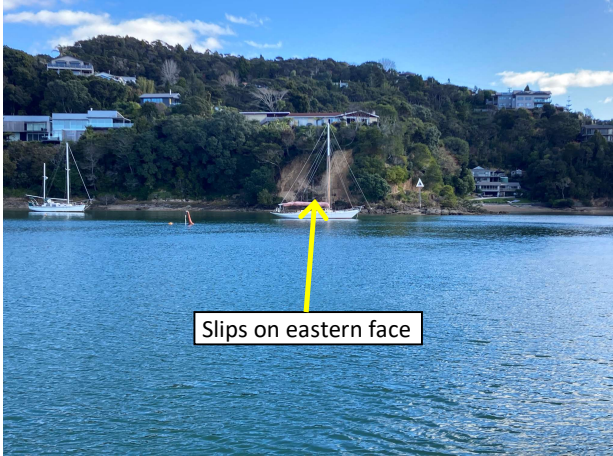
<p>Slips on eastern face</p>

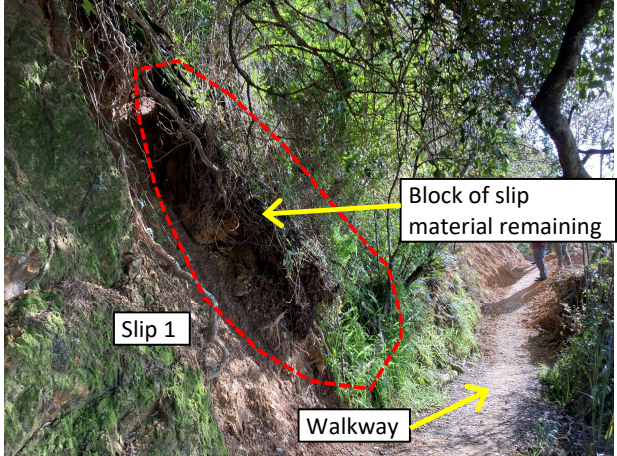
- There are 3 main slips along the eastern side and 1 minor slip along the northern side (refer to attached mark-up plan)
- The first slip (numbered slip 1 on the attached plan) is a small slump, approx. 2.0 m wide with the bulk of the slip material remaining in place, including large block of rock.

<p>Block of slip material remaining</p> <p>Slip 1</p> <p>Walkway</p>
<p>Photograph taken from vehicle ferry</p>	<p>Slip 1 along eastern face of cliff. Block of slip material remaining needs to be removed/descaled.</p>

- Removal of any trees that are overhanging the walkway, have been undermined by erosion, or are situated above the recent head scarps.
- Descaling / removal of any loose rocks and slip debris.
- Re-grading of the vertical and overhanging lips below the head scarps to the typical cliff slopes.
- Removal of the rock and Pohutukawa tree root wedging on the northern cliff face.
- Removal of the undermined Pohutukawa tree (and any loose soil/rock) on the northern cliff face.

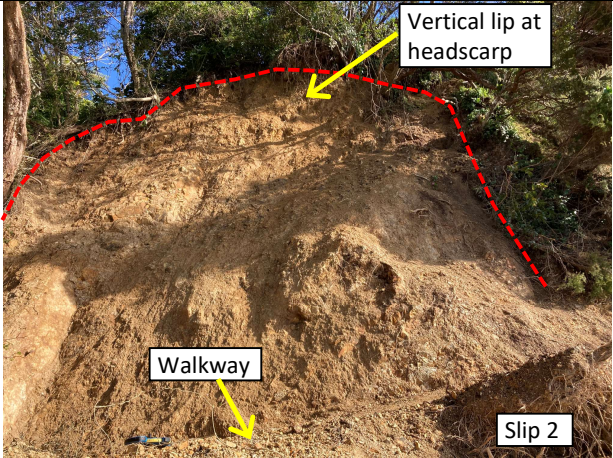
- The second slip (slip 2) is approx. 5.0 m wide. The slip material has completely evacuated and exposed the weathered rock surface. The slipped material appears to have comprised a 500 mm thick layer of soil and vegetation. This slip has left a near vertical lip at the headscarp with several trees overhanging.

<p>Vertical lip at headscarp</p> <p>Walkway</p> <p>Slip 2</p>

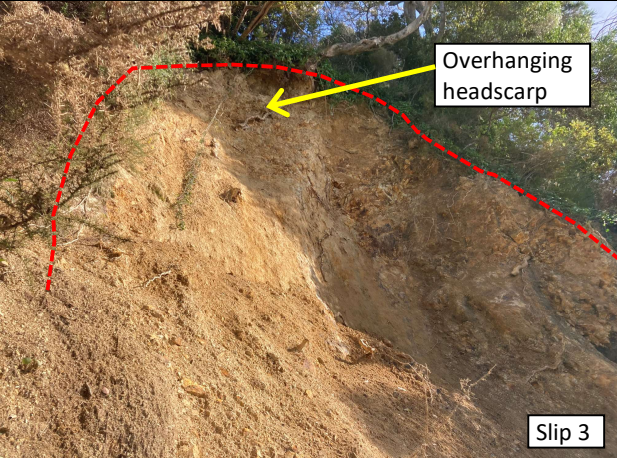
- The third slip (slip 3), approx. 3.0 to 4.0 m wide, has mostly evacuated with a small amount of debris at the toe. This slip has regressed further than Slip 1 (approx. 1.5 m into cliff) and the slipped material is mostly weathered rock. This slip has also left an overhanging lip at the headscarp with several trees above.

<p>Overhanging headscarp</p> <p>Slip 3</p>
<p>Slip 2 along eastern face of cliff.</p>	<p>Slip 3 along eastern face of cliff. Headscarp has overhanging lip.</p>

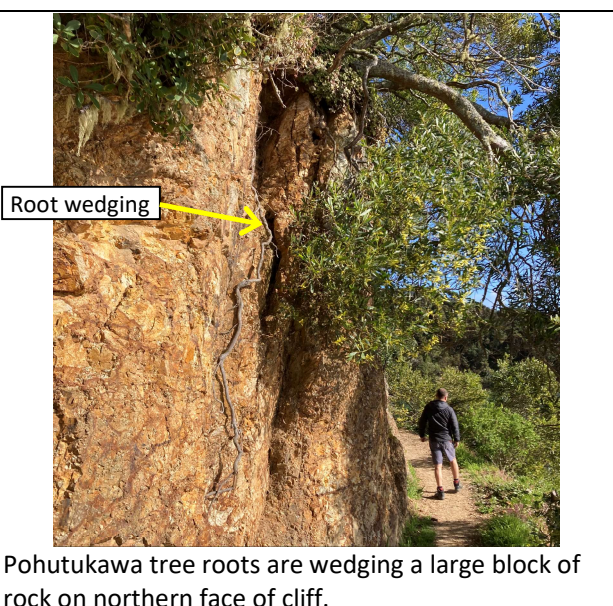
- The minor slip on the northern face (slip 4) has left an overhanging lip at the headscarp with vegetation above.
- On the northern face there is an area where Pohutukawa tree roots are wedging a large block of rock and the tree is overhanging the walkway. The cliff is vertical in this area.

<p>Root wedging</p> <p>Pohutukawa tree roots are wedging a large block of rock on northern face of cliff.</p>

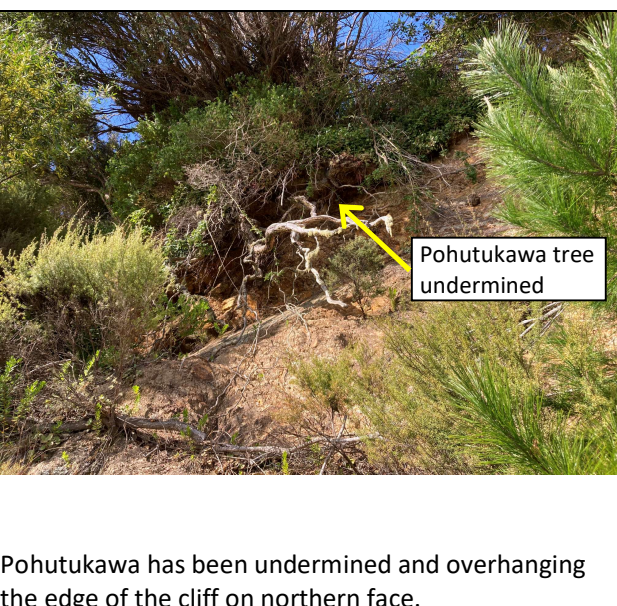
- Another mature Pohutukawa tree on the northern cliff has been undermined (by cliff erosion) and is overhanging the edge of the cliff.
- There are numerous visual signs of historic shallow seated soil movement within the landscaped area on the eastern side of 7 Richardson Street, above the coastal cliff (i.e. terracing, cracks, over-turned landscape walls) however, these are older features and unrelated to the recent slippage along the cliffs.

<p>Pohutukawa tree undermined</p> <p>Pohutukawa has been undermined and overhanging the edge of the cliff on northern face.</p>
