Tree Report

Prepared for Far North District Council

by Roger Gale, Treeskills

Subject: Assess the options for clearing repeatedly blocked sewer pipes.

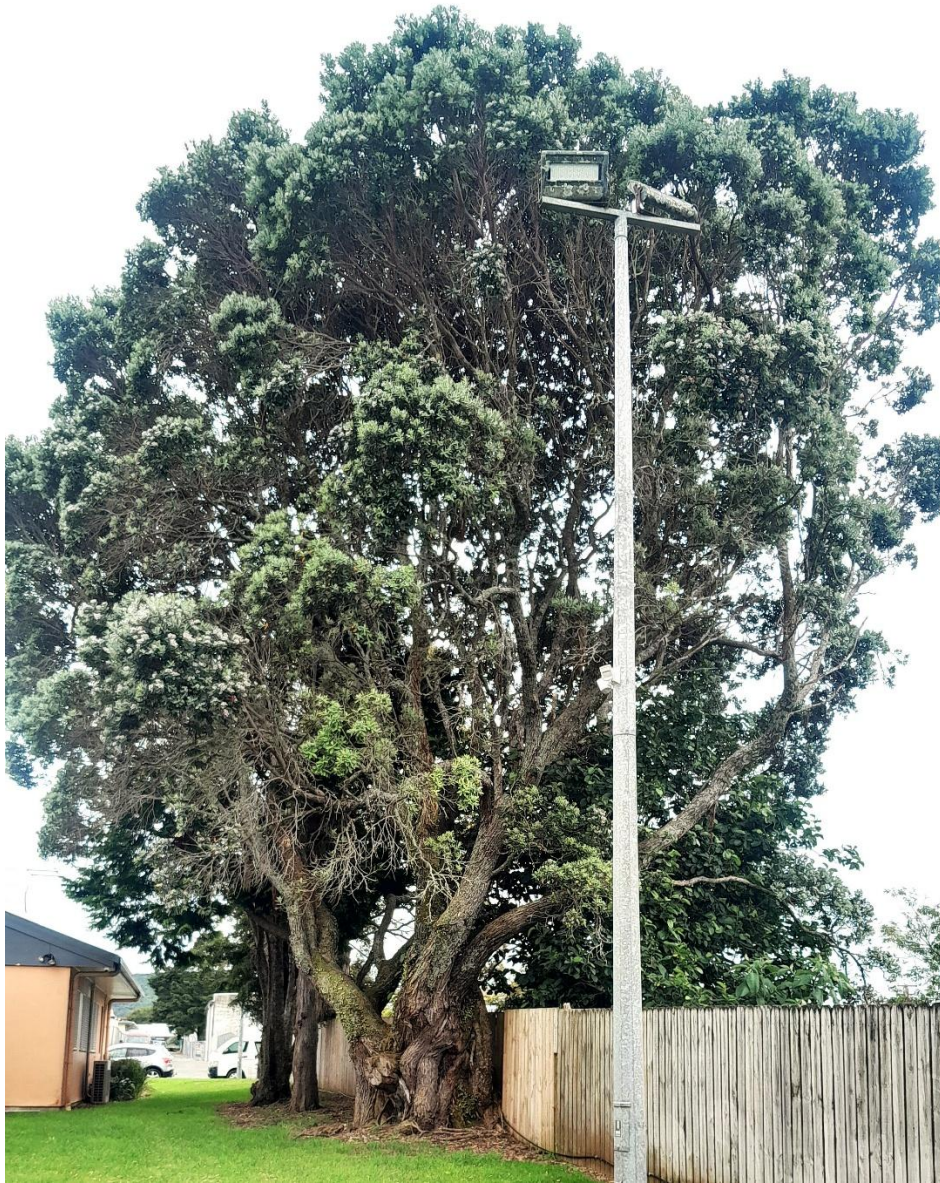
Figure 1: showing the *Metrosideros excelsa*.

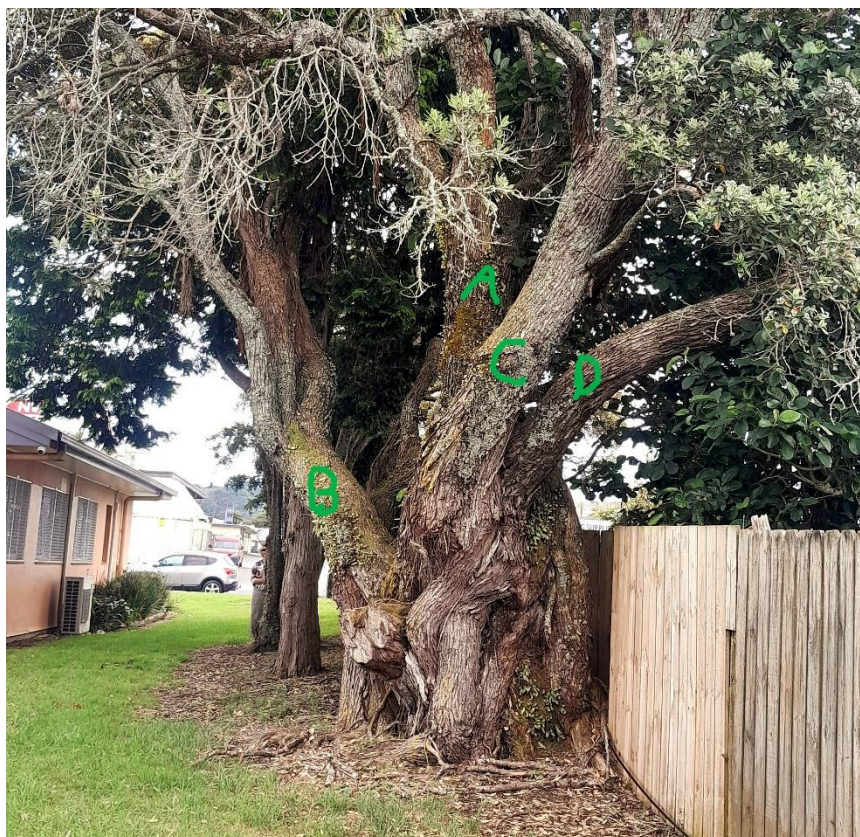
Figure 2: Showing the multiple stems.

- A. The original stem, whose growth has been constrained by the growth of other stems around it, has decay intruding into its centre from a severed branch stump.
- B. The stem with a heavy lean towards the Council building has had to grow two 1metre aerial roots down into the lawn in order to achieve some degree of stability.
- C. The stem that extends for more than half its length out over the fence and into 35 Rahara St has already lost a large branch and has some evidence of branchlet dieback. Its area of union with the original stem is minimal, as Stem D has outcompeted it for space around the original Stem A.
- D. The stem that extends over the fence boundary with 35 and 37 Rahara St has evidence of branchlet dieback.

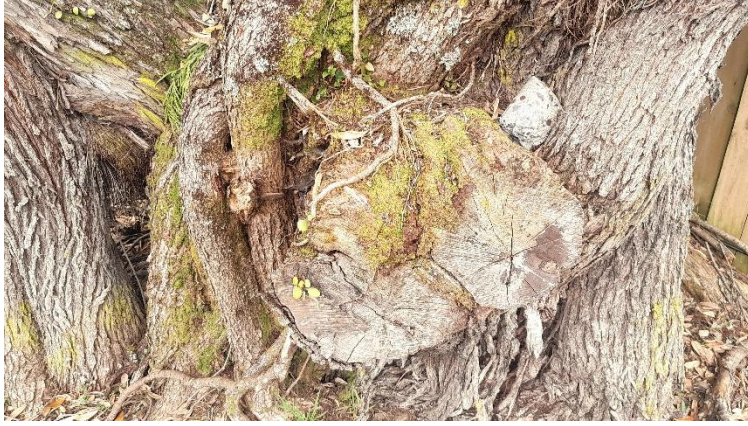
Figure 3: Showing a large rotting wood.

This pair of 2 limbs were attached to stem A and are channeling decay back down into the center of the root plate. This decay will also spread into the adjoining stems.

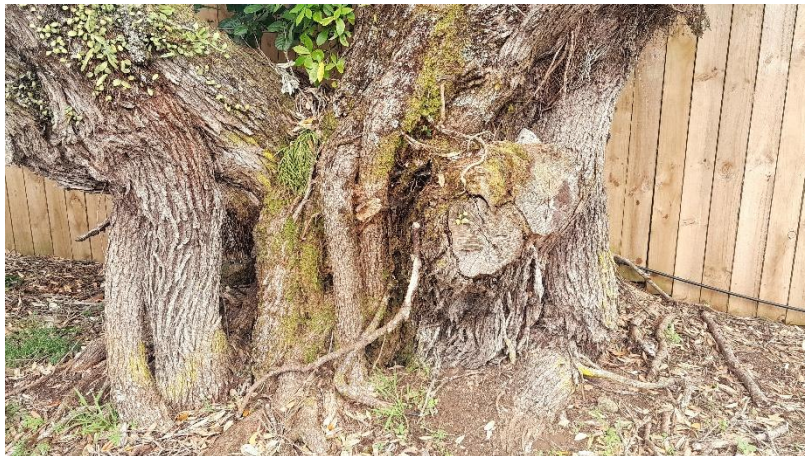
Figure 5: Showing the size of this large decay ingress.

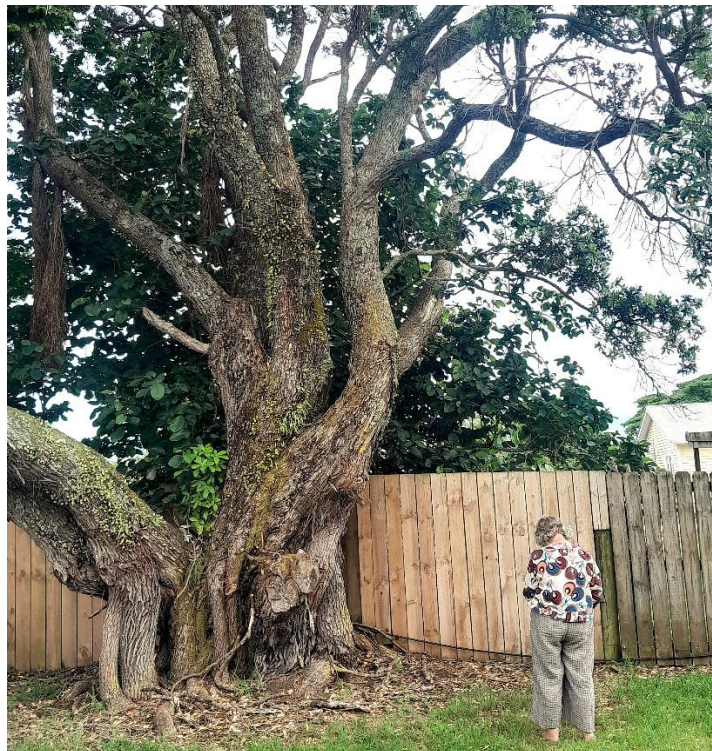
Figure 6: Showing stem B over the council building.

This large stem is an outlier in that it will catch any South Easterly blow.

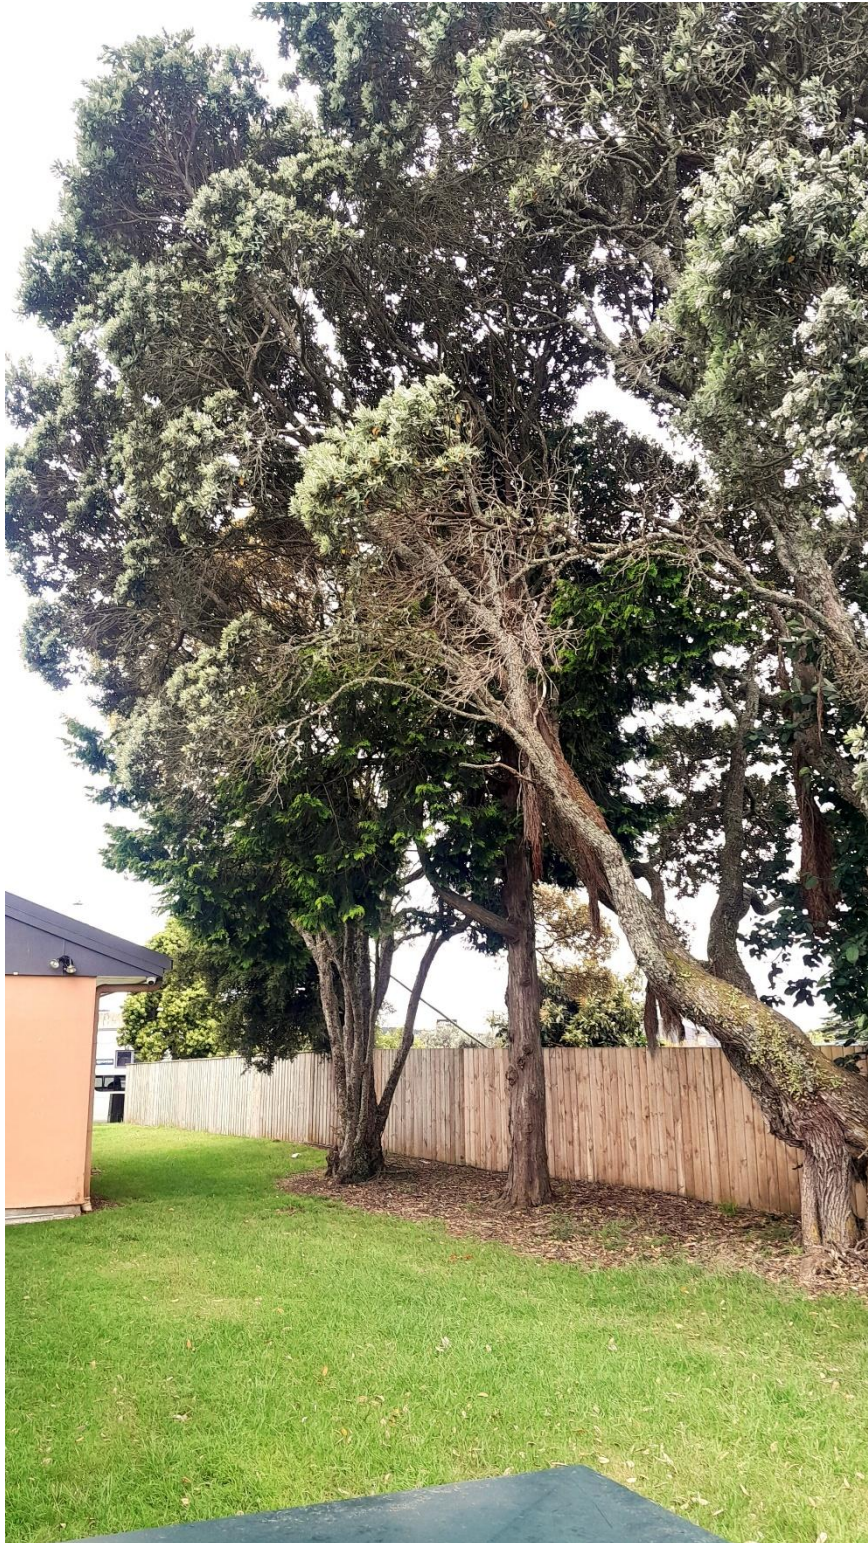
Figure 7: Showing stem B.

When this branch falls it can only fall on the building.

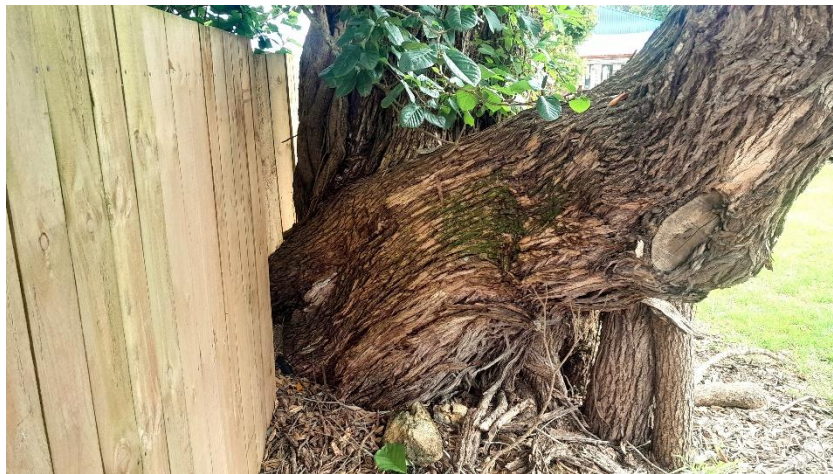
Figure 8: Showing the way stem B wraps around stem A.

The propping root will not hold it up but act as a hinge due to its placement,

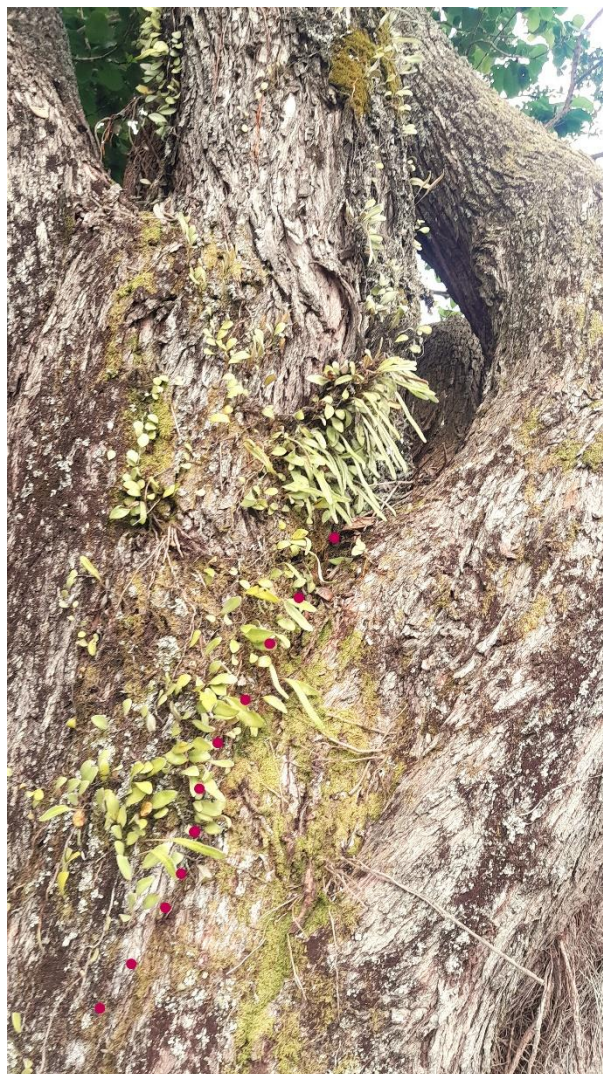
Figure 9: Showing the compressed union between A and B.

This tree has mostly formed tight unions. As stem diameters increase, the parallel stems inevitably begin to run out of space, their sides connect and then build up pressure which can increase until the xylem flow especially is reduced and then cut off causing dead tissue and decay. Also, the connecting grain between stems is compromised allowing stems to drop out of the tree more easily.

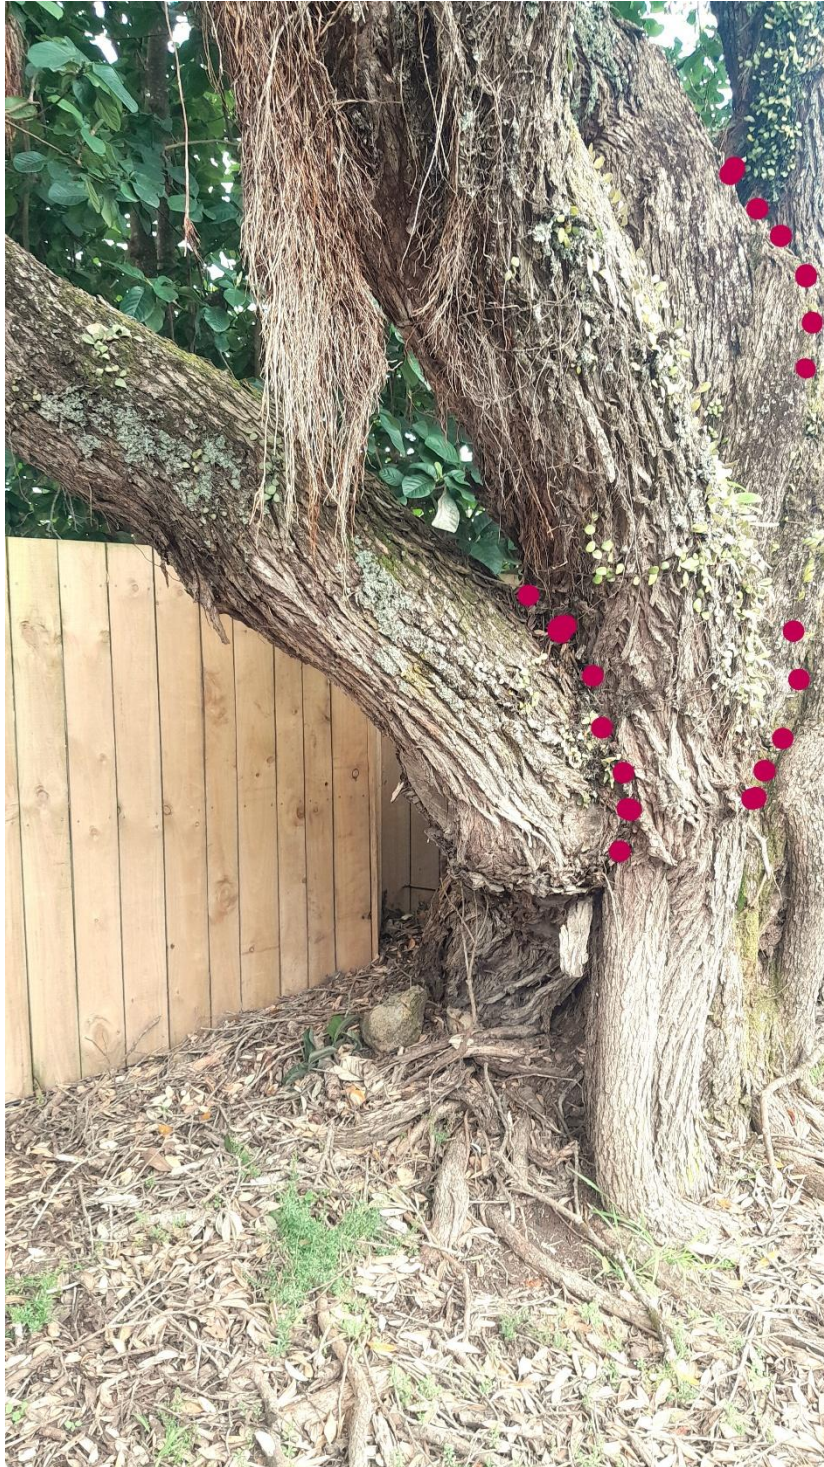
Figure 10: Showing more poor unions.

This problem is exacerbated when the stem is rotated around the other stem.

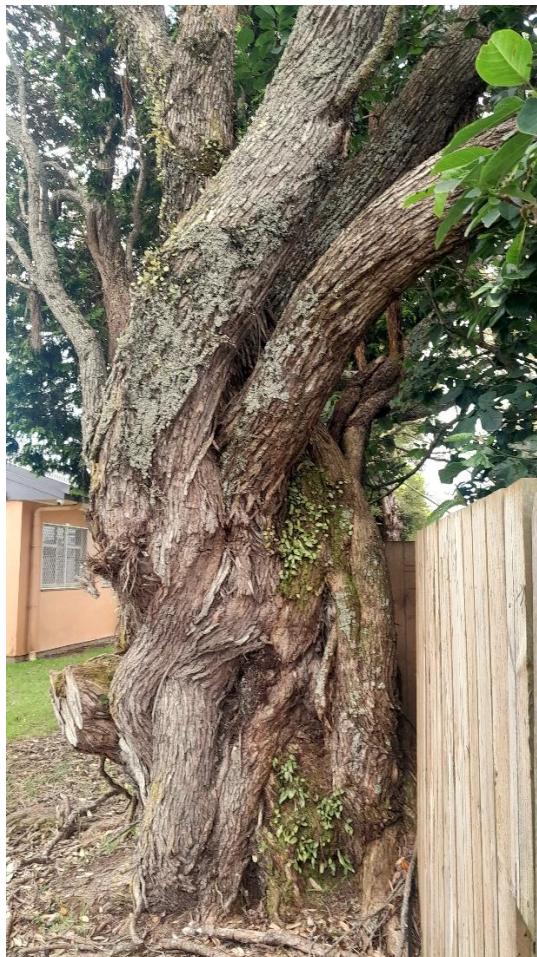
Figure 11: Showing stems C and D.

Stem C has already lost a significant limb creating a weak point, if it fell it would impact a building on Raihara street. Stem D would also fall into a neighbors' property.

1. Remove this tree.
