Northland Treeworks Group Ltd

18 February 2026

Arboricultural Assessment- 1 Taheke Road Reserve, Kaikohe

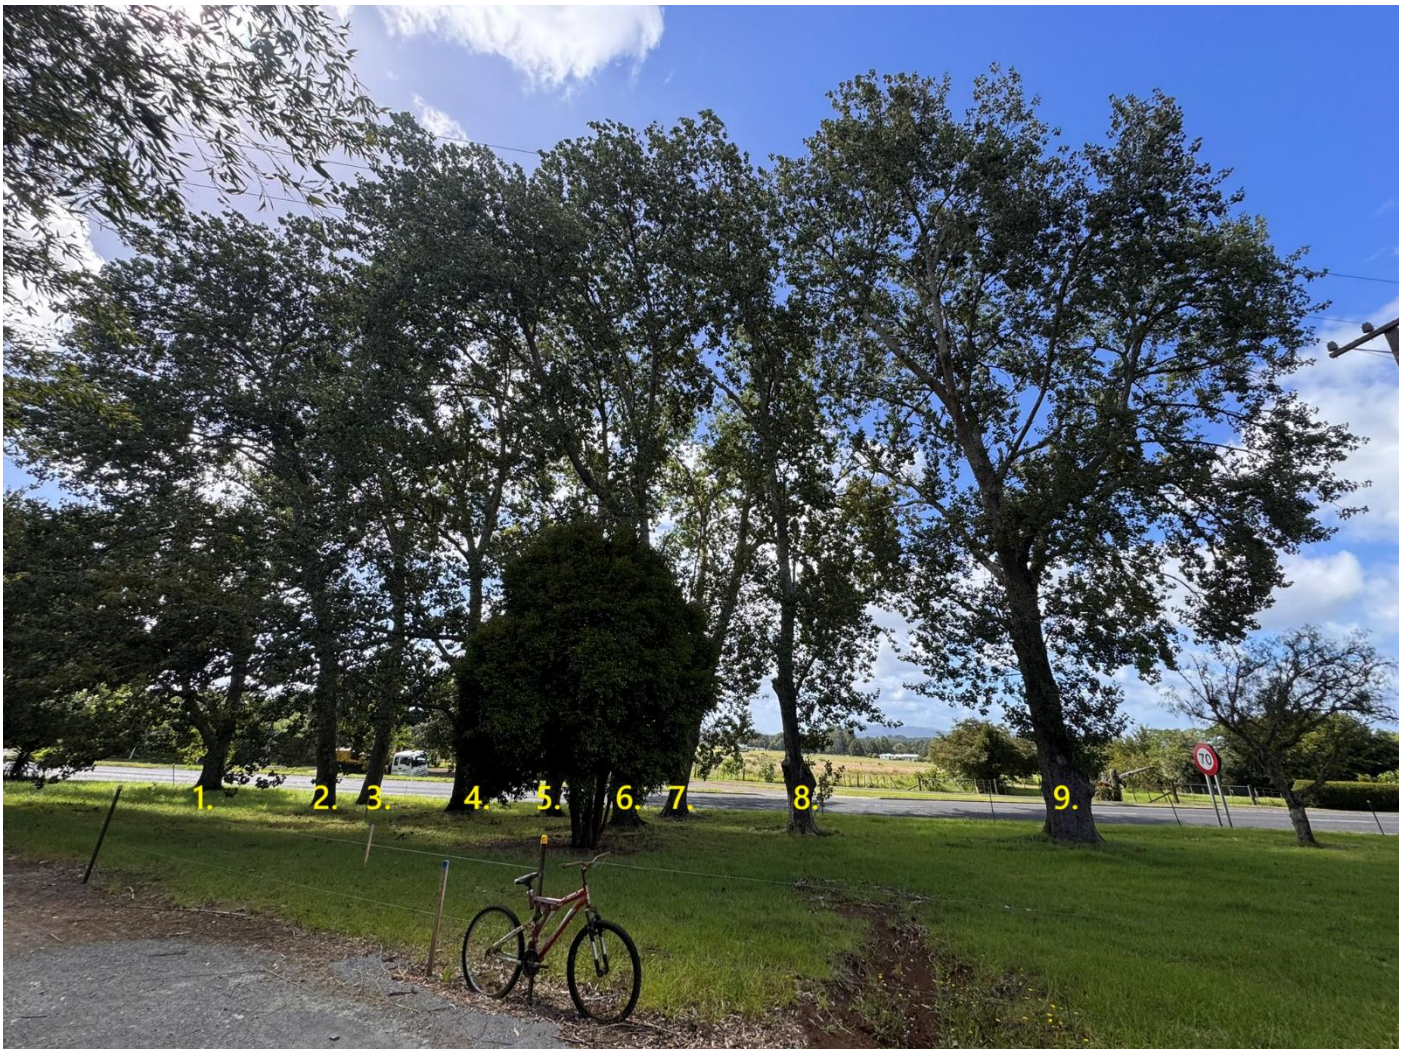
Fig 1. Trees numbered 1 to 9 with one being the Easternmost tree in the stand.

The 9 subject Poplar trees are situated parallel to SH 12. The close density of the planting has led to these trees growing together in a mutual continuous canopy.

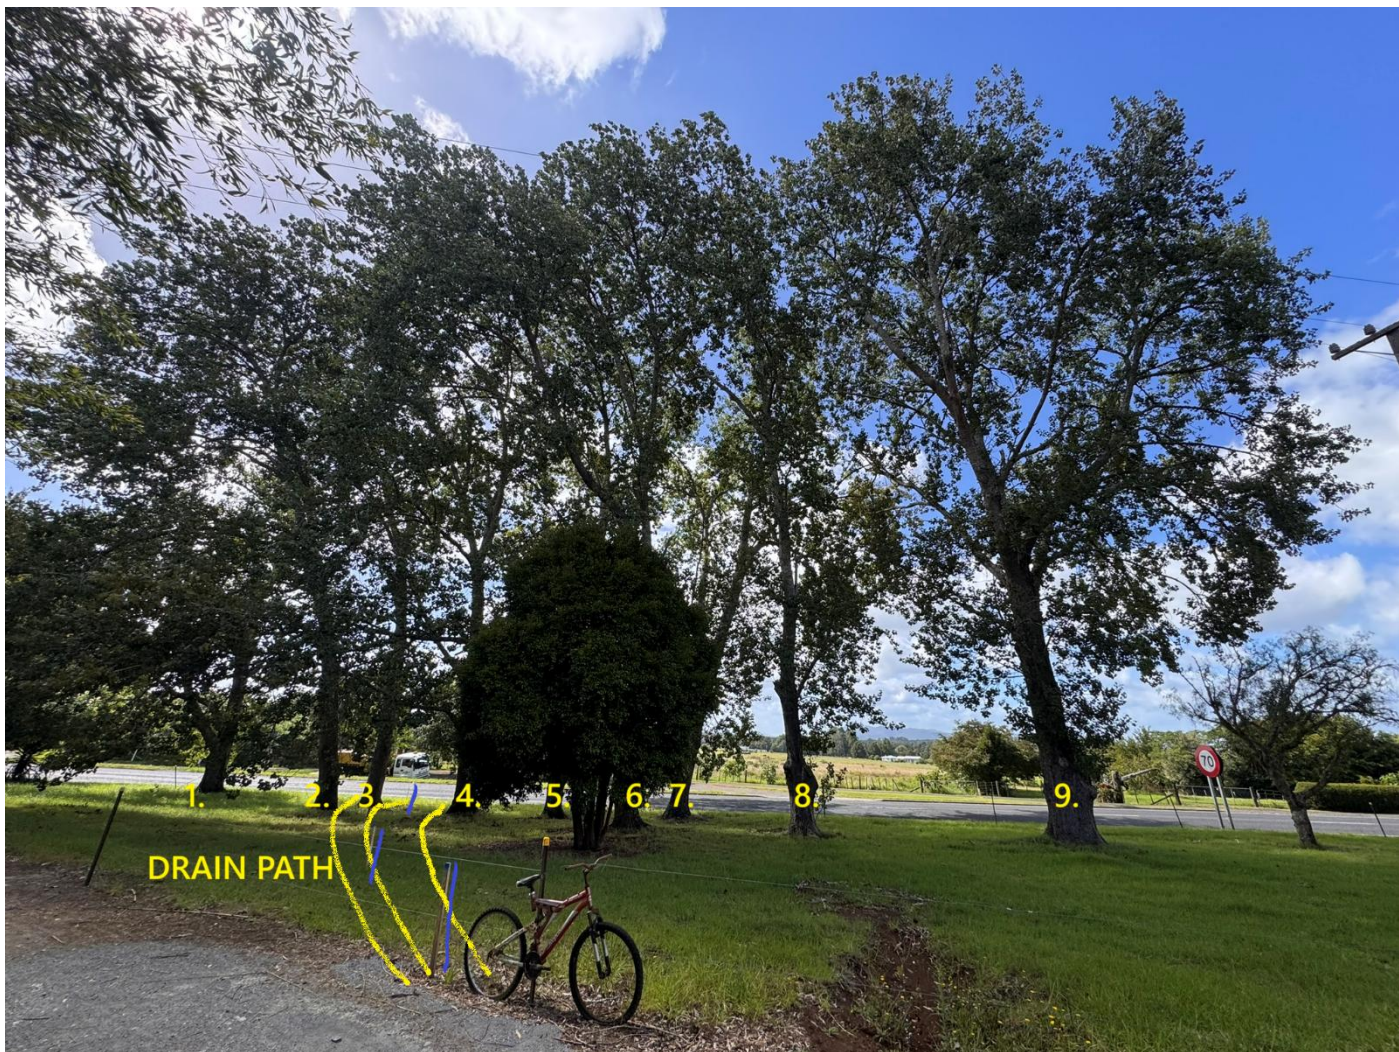
Fig 2. Illustrates the path of the stormwater drain to be installed.

The proposed stormwater drain excavation will be up to 2.5 meters wide and up to 1.5 meters deep. This would require the complete removal of trees 2,3, and 4, along with their root systems.

The proposed stormwater drain installation will require the removal of trees 2,3 and 4.

The root systems of trees 2, 3, and 4 will need to be removed to allow excavation.

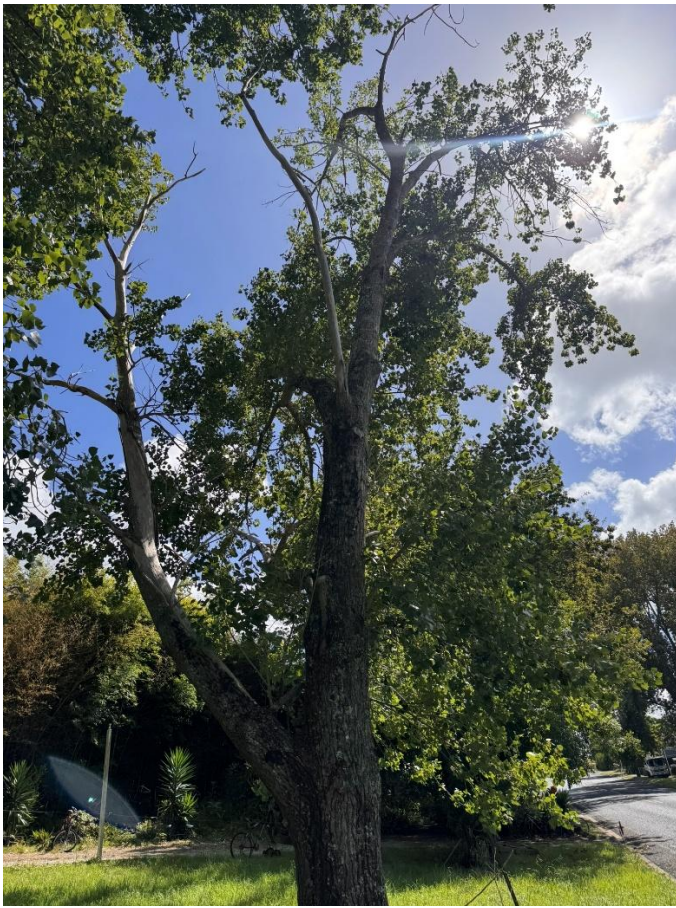
Tree 1. contains extensive deadwood and is in poor condition.

Tree 1 has already been identified as a hazard and is scheduled to be removed.

Fig 3. Tree 1. Is largely dead

Tree 1. Is largely dead and is scheduled to be removed.

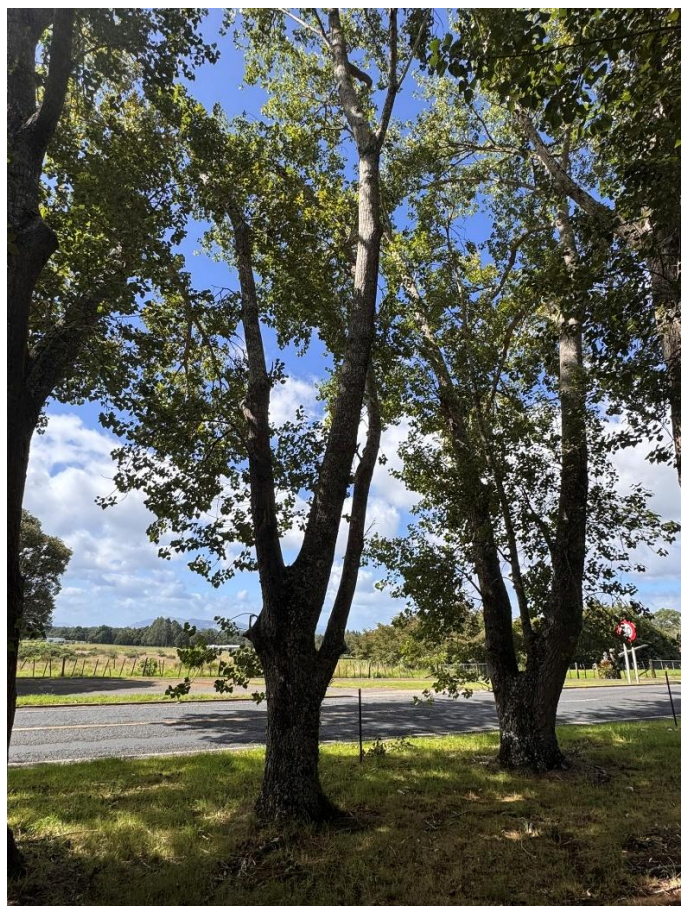
Tree's 5 and 7 have poor structure with multiple leaders and suppressed canopies with taper towards the Highway. These trees are the closest to the highway of any in the stand, and their canopies have significant encroachment over SH12. Removal is recommended.

Fig 4. Tree's 5 & 7 have poor structure

Due to poor health, structure, conflict with infrastructure, and increased exposure to wind, removal of Trees 5,6,7 and 8 is recommended.

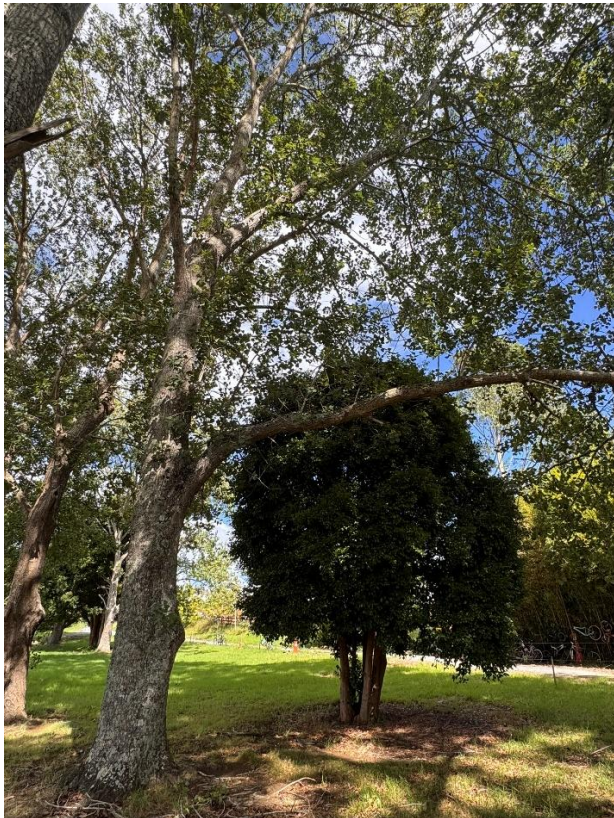
Fig 5. Tree 6.

Tree 6 is a reasonably healthy tree but has grown with a taper to the north as it has reached out from the stand for light availability. It has a large lower branch which would need to be removed to allow the stormwater drain to be excavated. Given the likely conflict of the root system with the stormwater drain, the trees taper, and vulnerability to unaccustomed winds forces once the surrounding trees are removed, it is also recommended that this tree be removed.

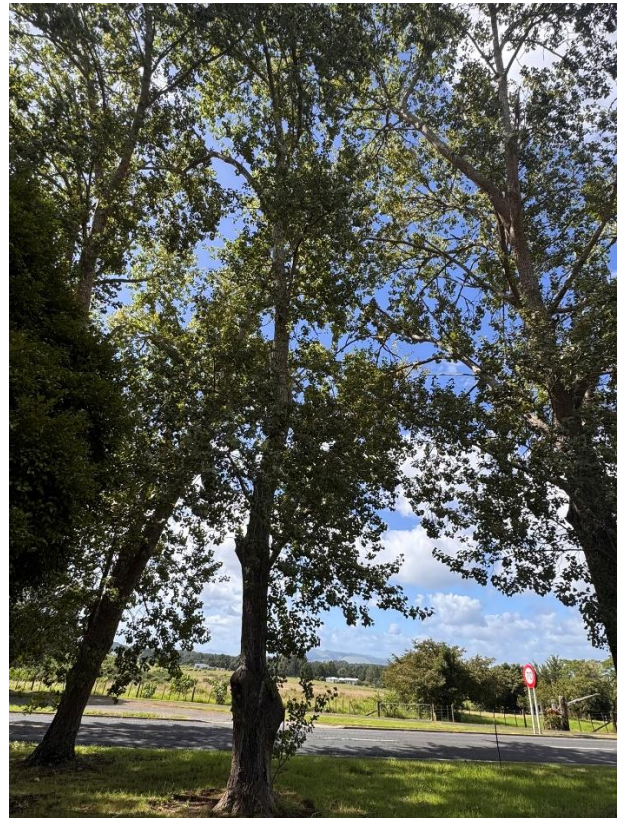
Fig 6. Tree 8

Tree 8 is a narrow-suppressed tree that exhibits signs of multiple historic limb failures. The failed and pruned limbs have left this as a tree of poor health and structure that has no viable future as a park tree.

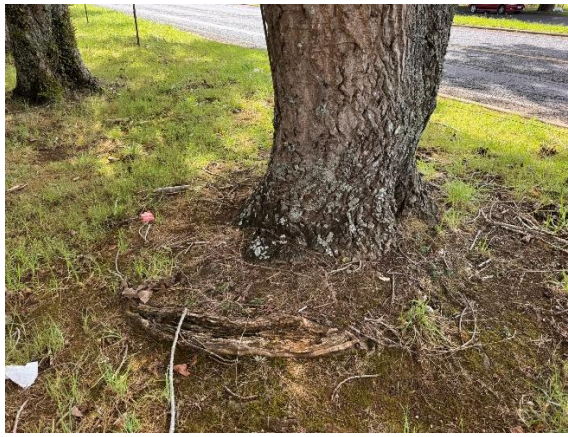
The remaining trees in the stand all have structural defects including stem inclusions, poor taper, root girdling and co-dominant leaders.

Fig 7. Root Girdling

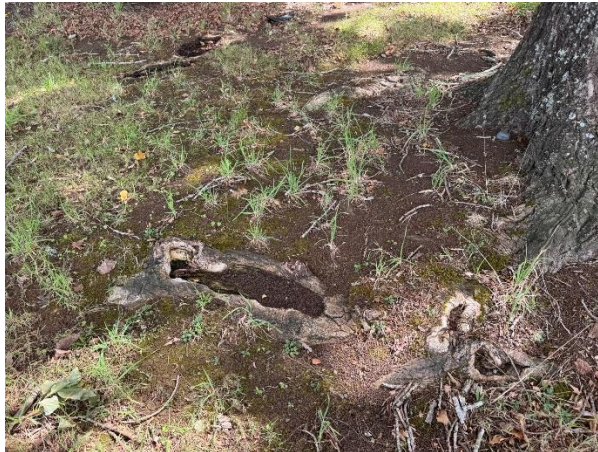
Most of the trees in the stand have obvious root damage from mowers which has led to the introduction of rot and pathogens to the root structure. Poplars are a shallow rooted tree and prone to failure in high winds.

Fig 8. Root Damage and Rot

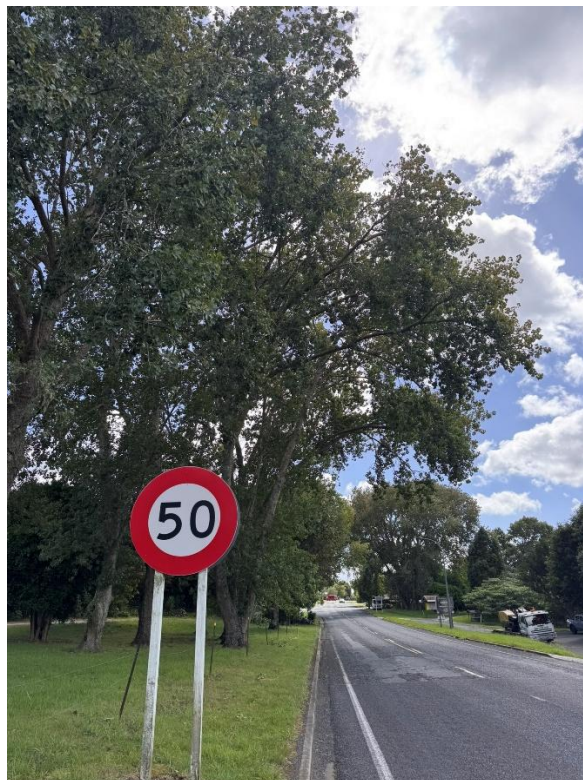
Fig 9. Canopy Encroachment over SH12

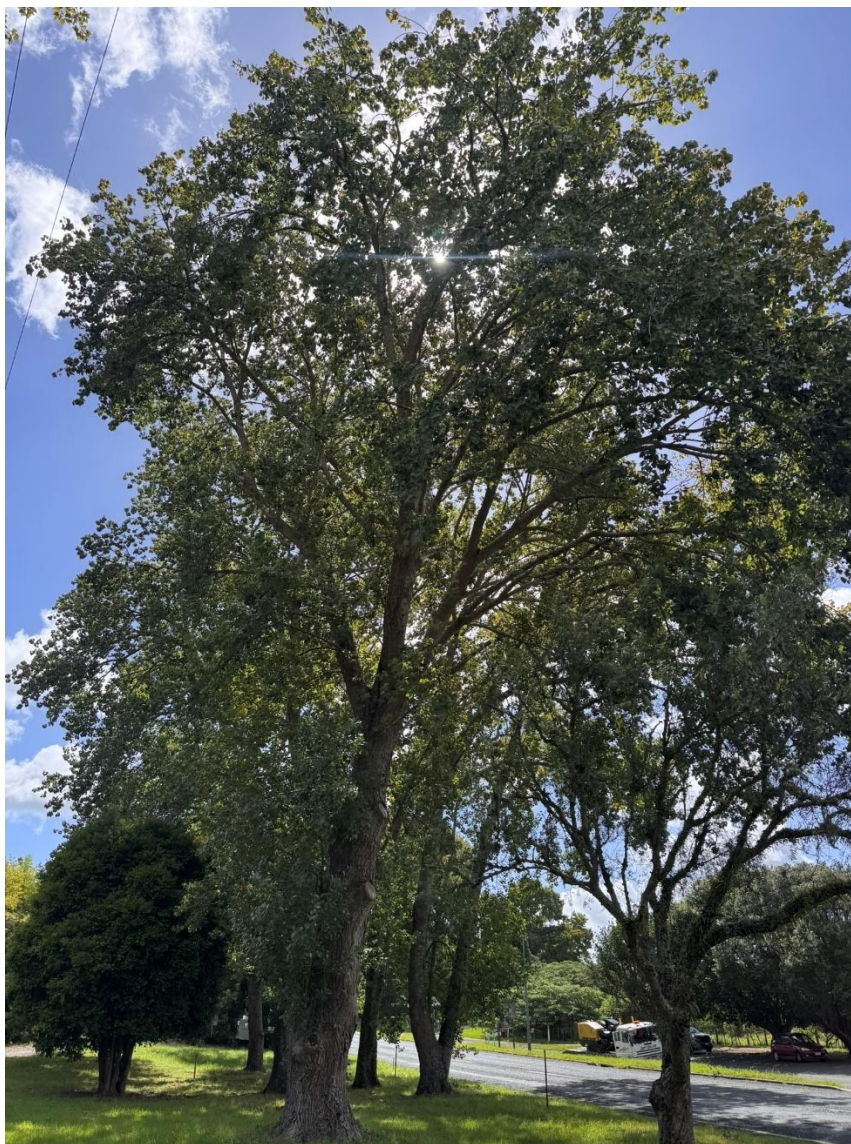
Fig 10. Tree 9.

Tree 9 appears to be the healthiest tree in the stand, likely due to having a greater spacing from the stand than the rest of the trees, subsequently enjoying less competition for space and nutrient.

Tree 9. Is the only tree in the stand that possess a decent structure, due to the space to grow a more balanced and less defective canopy.

Tree 9 possesses the best health and structure in the stand. It is on the Western end of the stand and enjoys the most physical separation from the stand. This is a candidate for being retained as a stand-alone tree to provide presence and shade in the park. We recommend some tidying and resilience pruning in the canopy to promote its health, structure and longevity. Its proximity to the overhead power lines means there will always be maintenance required to manage that conflict. This tree is set back furthest from SH12 of any tree in the stand.

Tree 9 could be retained, and resilience and maintenance pruning is recommended.
