Treeskills Tree Report

The Far North District Council

Site Visit to Hawkins Street, Kerikeri
Conducted 21/03/2019

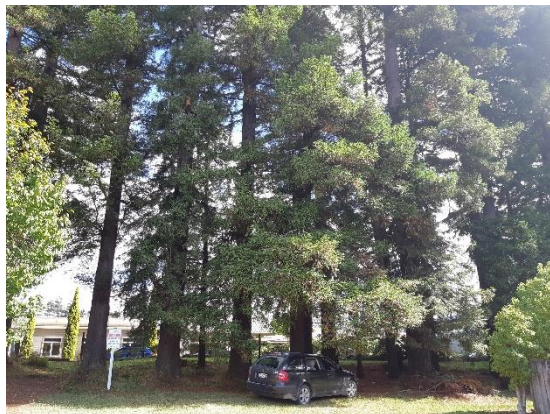
The form of the crowns have minor asymmetry, with large dominant limbs in their lower canopies where their site allows.

Figure 1: Showing heavy limbs over crescent.

The Redwood trees at the above address are generally of good health and sound form. There were no evident signs of disease or structural defects within the crowns which would be a cause of concern during a storm. The ongoing monitoring of these large trees on an annual basis is recommended. If the retirement village wanted more light a crown lift in that area would help.

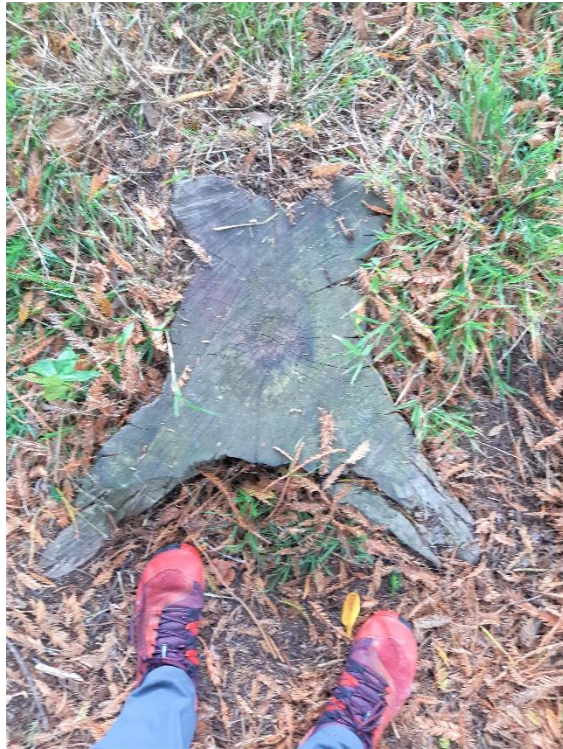
A common cause of concern with redwoods in the north of New Zealand is internal borer and decay at ground level. This is not a significant concern here as the weaker trees have been removed and their stumps show no sign of decay.

Figure 2: Showing a typical healthy.

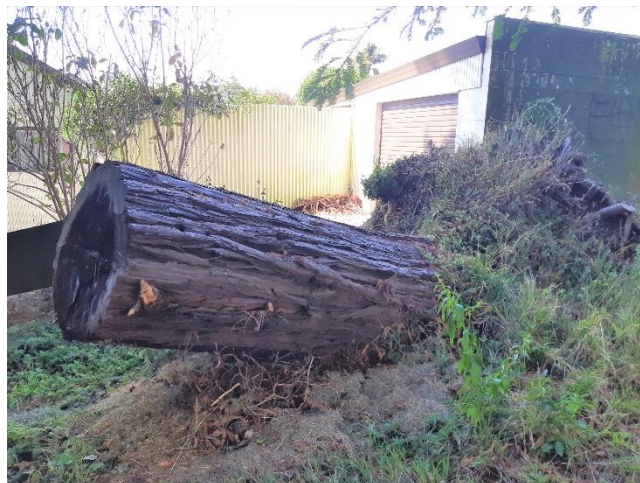
In this particular situation, one large Redwood has fallen into the stand. This is likely due to root damage caused by earthworks associated with the construction of the immediately adjacent driveway and concrete-floored garage

Figure 3: Showing the failed root plate.

Hazards: The most likely cause of damage or hazard from these trees root plate failure as happened in this stand especially if the tree fell out of the stand instead of within it. I did not see any other compromised root plates that could lead to this occurrence.

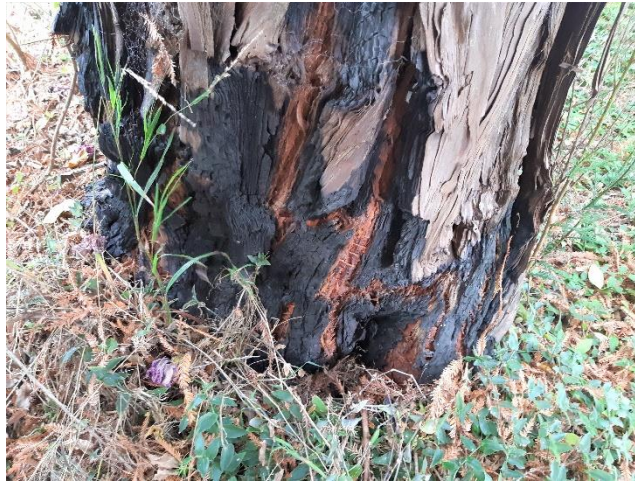
Figure 4: Showing the charred bark.

People have been setting small fires in this stand. This is an aesthetic problem as well as a small risk of fire spreading to adjacent houses. This is not a problem for the redwoods as they are fire resistant.
