**Treeskills Tree Report**

**The Far North District Council**

**Site Visit to Hawkings Crescent, Kerikeri**  
**Conducted 01/09/2020**

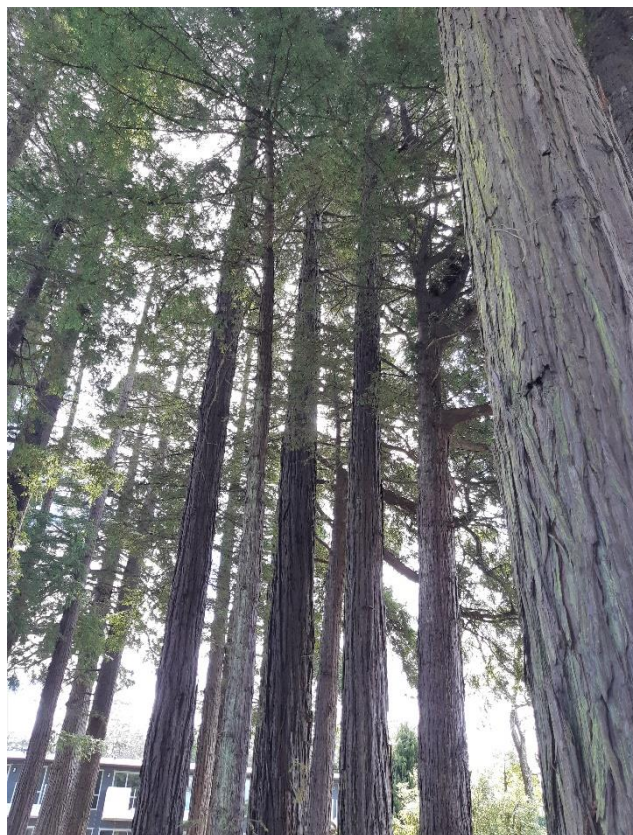
The form of the crowns have minor asymmetry, with large dominant limbs in their lower canopies where their site allows.

Figure 1: Showing heavy limbs over crescent.

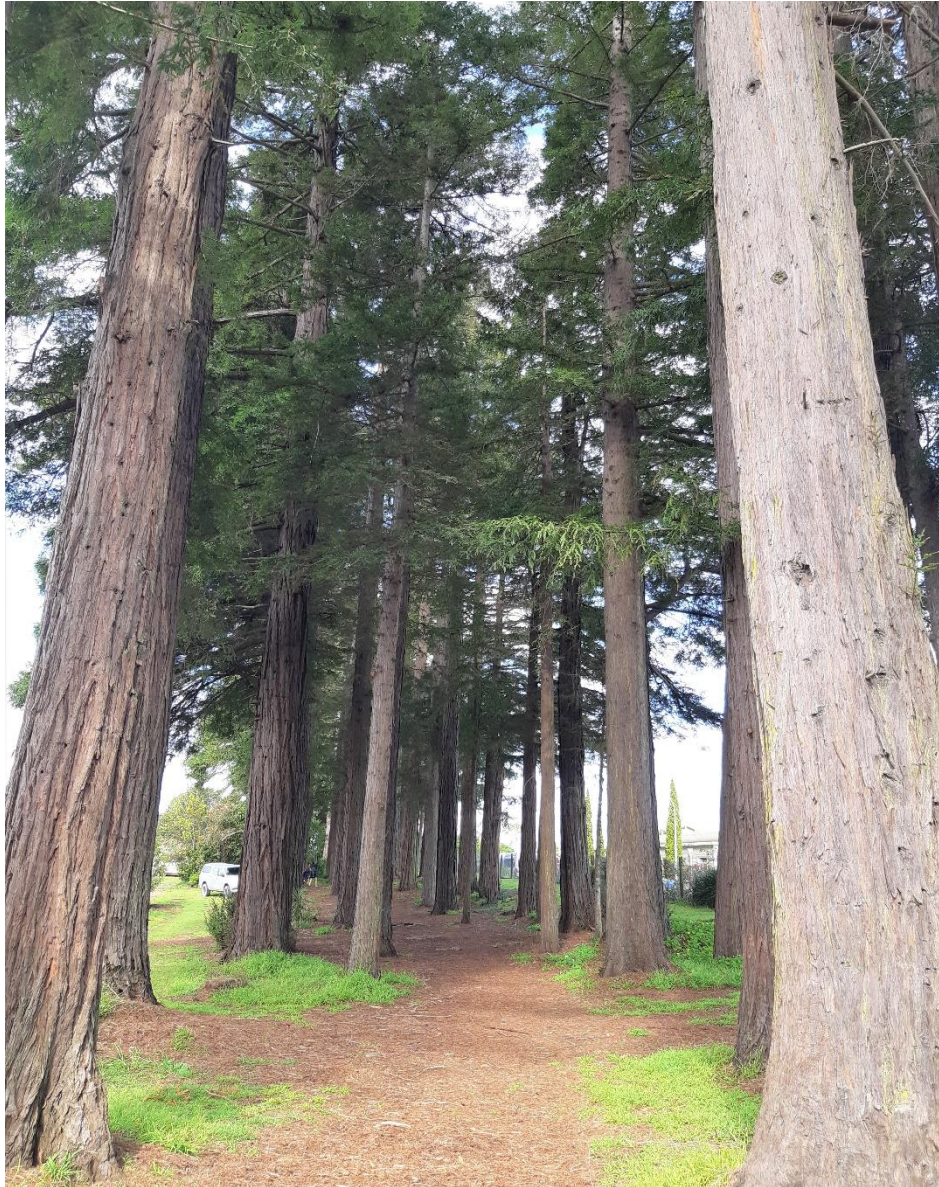
Wound wood development is fair to average. These trees have recently had a crown lift which has let more light into the copse and onto neighbouring properties

Figure 2: Showing the effects of the crown lift.

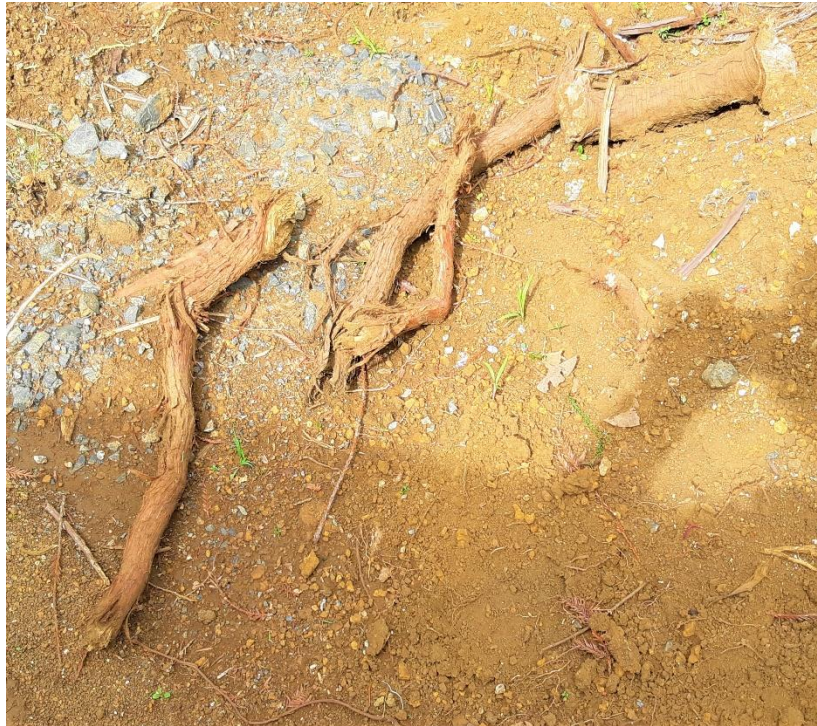
A new fence has been built at the north end of the copse. Significant damage has been done to the roots of the largest tree which needs further examination (already scheduled). Two Tarata and a pohutukawa have been severely pruned and will need remedial care next year.

Figure 3: Showing damaged roots.

**Hazards:** The damage to the roots of the largest tree in this copse could severely compromise the health and stability of this tree and lead to death or catastrophic failure of this tree. It is important that the agreed works to assess and mitigate any damage proceed as planned.

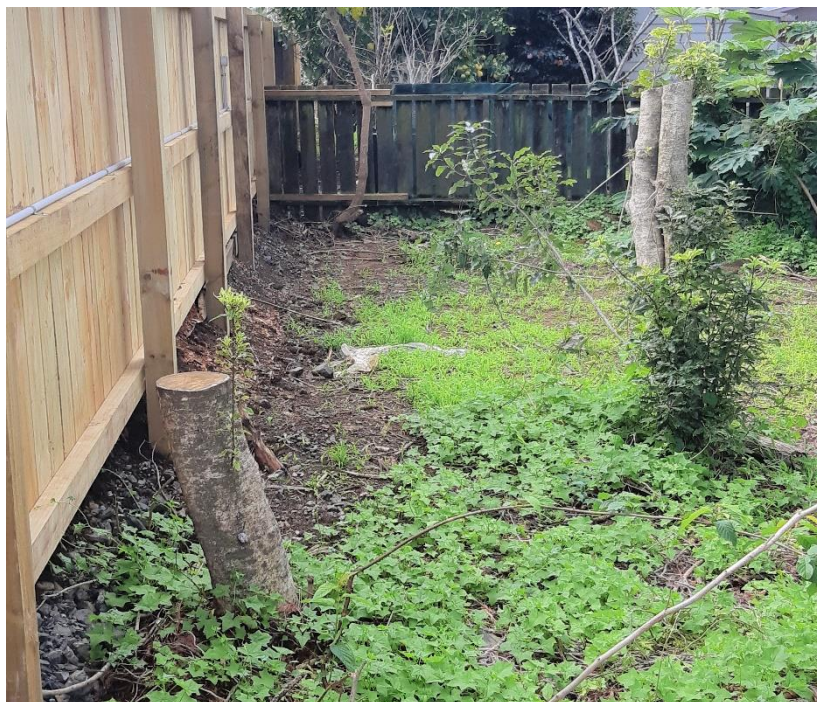
Figure 4: Showing damaged Tarata.

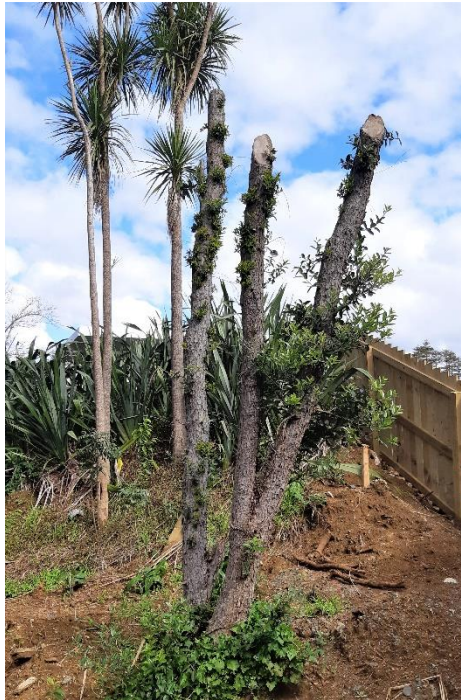
Figure 4: Showing damaged Pohutukawa
