Treeskills Tree Report

The Far North District Council

Site Visit to Wendywood Lane, Kerikeri
Conducted 01/09/2020

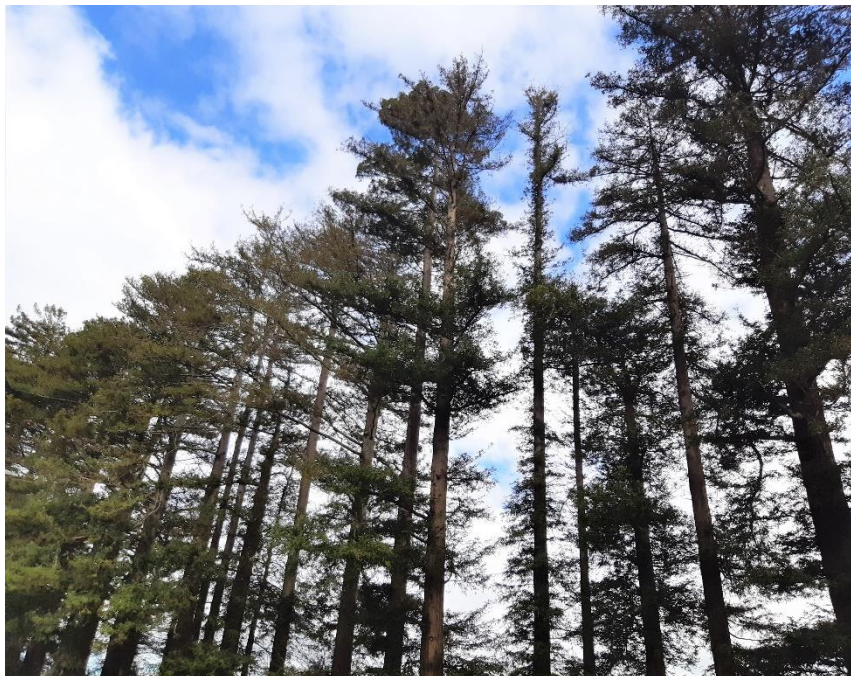
Figure 1: Showing necrotic foliage.

Health is variable; with 65% live crown ratio, poor foliage density and needle size. Foliage colour appeared to be poor with signs of necrotic trees. Annual shoot growth is limited and vigour poor. There are a few trees with extensive epicormic growth alongside the sealed area of new World and some have died.

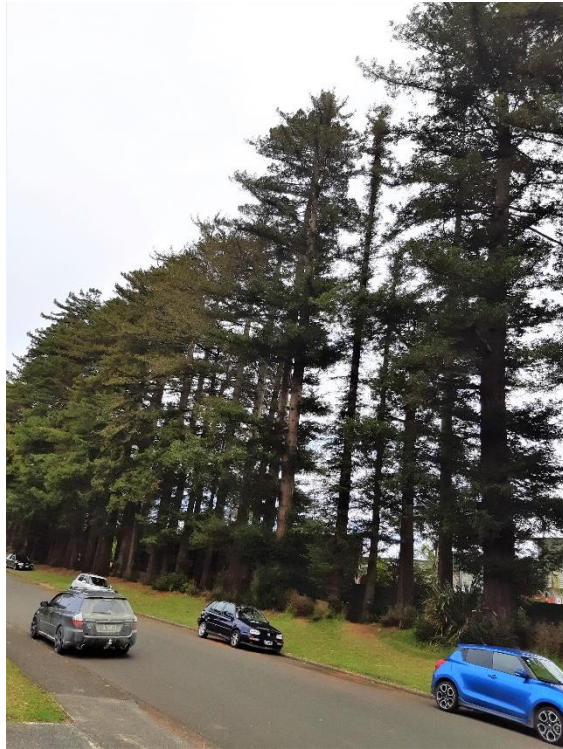
Figure 2: Showing a similar view a year ago.

The decline has been slow but steady. The causes appear to be a mixture of:

- The loss of permeable root run due to the car park being inserted
- Lack of mulch
- Lack of summer rain
- Foot traffic compaction

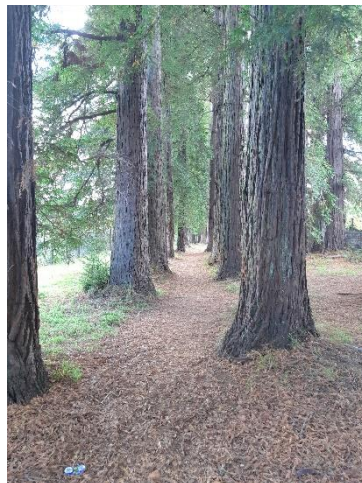
Figure 3: Showing a popular path.

The stand of trees is a useful and popular accessway through from a playing field and residential area to the shops. To reduce soil compaction a layer of mulch around 10cm minimum depth would help.

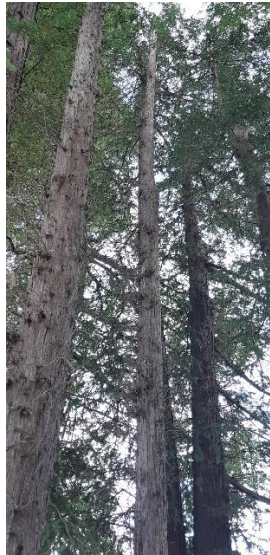
Figure 4: Showing one of two dead trees

These two trees should be felled before the top falls. They are both the second from the left in figures 4 and 5. They are side by side and roughly where the New world fence ends, and the soccer field begins. They will fall out onto Wendywood lane.

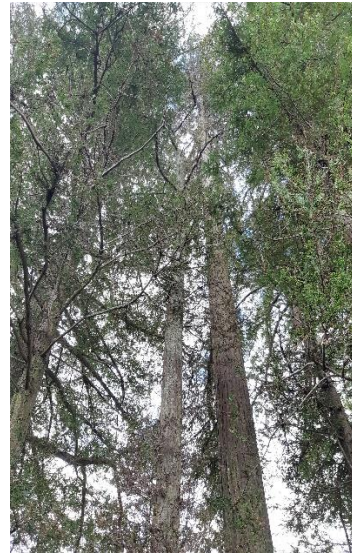
Figure 5: Showing the other dead tree

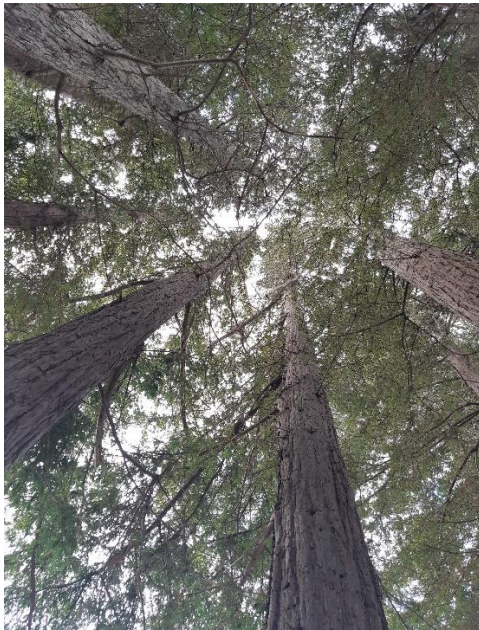
Figure 6: Showing trees where foliage density is poor.

These trees are very variable with patches of trees showing reasonable health and others showing severe decline. There are perhaps 13 trees in acceptable health, 4 of which are suppressed. There are 14 in poor health, two of which are dead.

- Air spade to remove compaction problem
- Application of mulch

The root zone has mostly been maintained by natural needle fall, however a generous layer of mulch on bare areas would significantly increase root health and vigour.

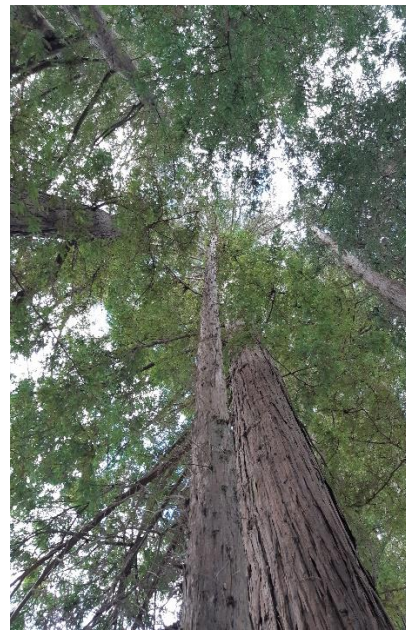
Figure 7: Showing good density and colour.
