Arboricultural Report

Moreton Bay Fig

The Strand, Russell

Date: 8 April 2021

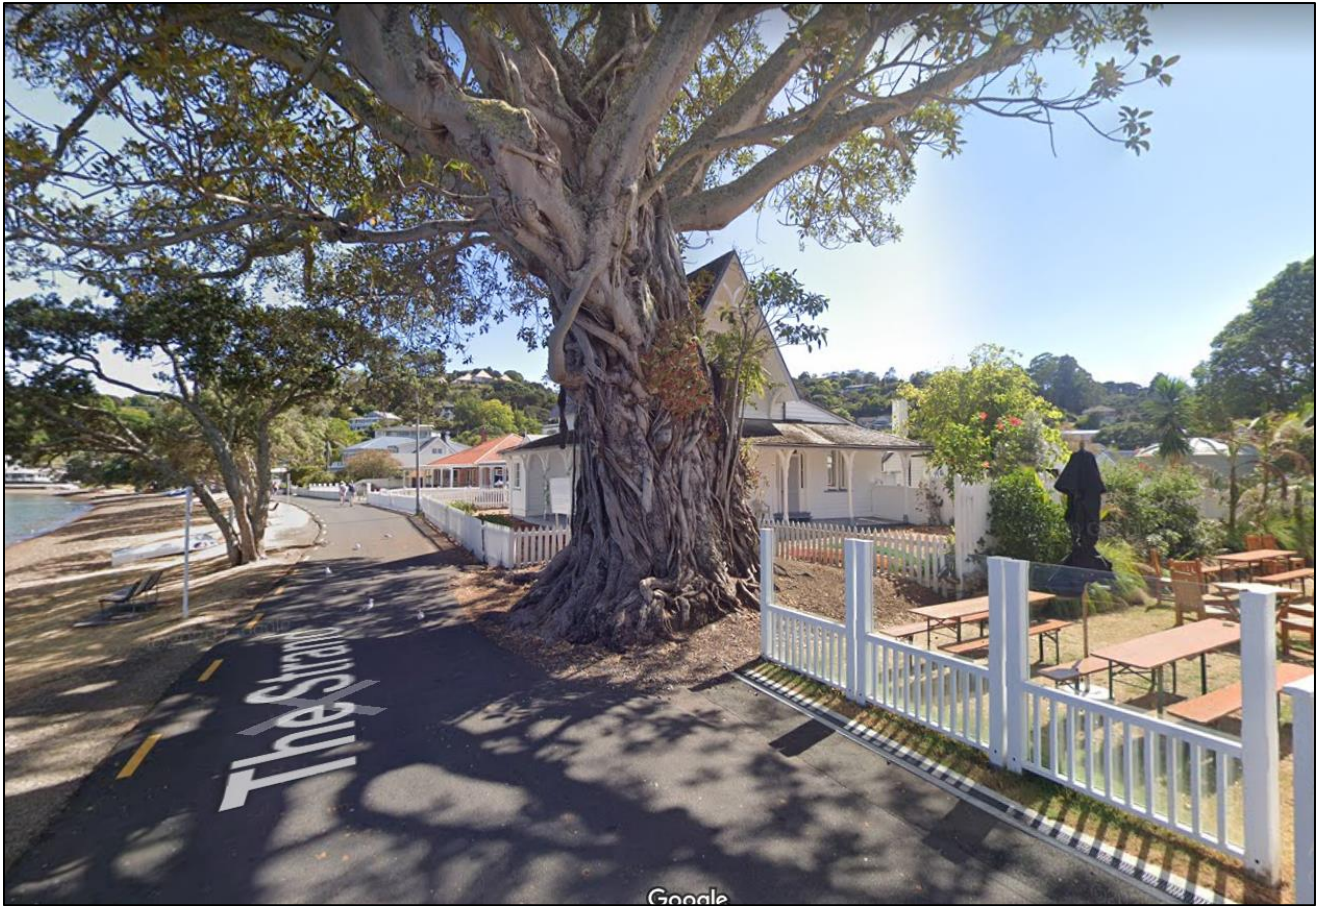
Figure 1: The lower trunk of the subject Moreton Bay fig tree viewed from the south. Channel drain visible in foreground. (Google Streetview image)

5. Bark damage is present on a large percentage of buttress roots, with cambial necrosis evident at many locations where the roots interface with ground level. This is likely through contact damage from foot traffic and vehicle tyres.

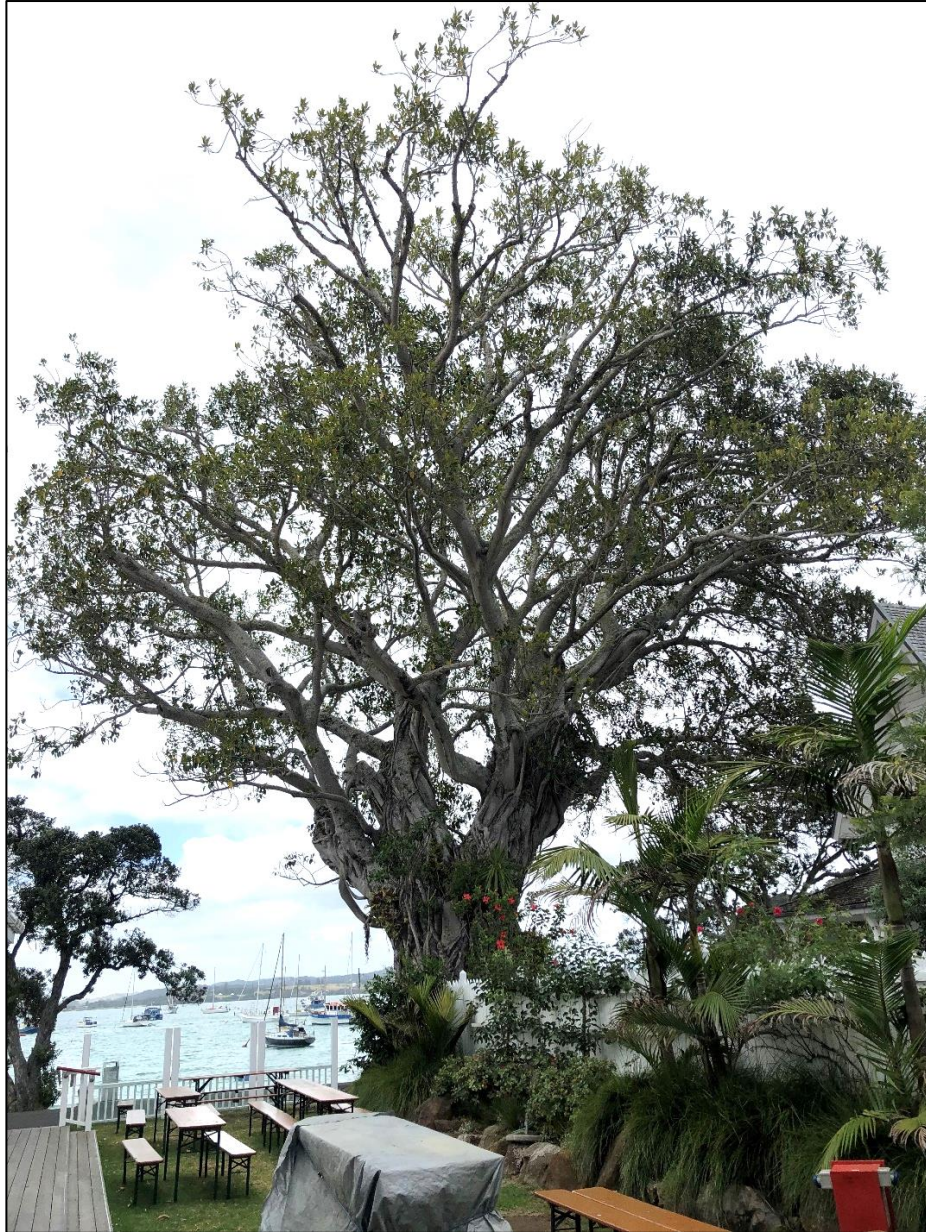
6. There is an area of decay on the eastern aspect of the trunk, which extends approximately 2m horizontally from the tree's base and approximately 2 metres circumferentially. In front of the decayed area are a number of live aerial roots, with the area immediately above covered by a 'stag-horn' epiphyte.

7. The area of decay covers approximately 20% of the trunk circumference, at the level of the decay. Selected areas of the decay were probed with a thin steel rod in an attempt to determine a depth of the decay. As a result, the decay did not appear to extend beyond the surface area of the trunk. Given the ratio unaffected wood to decayed wood, it is considered that it is unlikely that the tree will be structurally compromised by the identify decayed area.

8. The tree exhibits low vitality, as indicated by its sparse and irregular foliar cover. The low vitality could be the result of a number of factors including, such as; pests such as fig psyllid (a small number of which were noted on fallen leaves), long-term changes to rooting environment and recurring droughts over recent years or a combination of factors. The low vitality reduces the tree's ability to lay down additional wood in locations of stress due to reduced resources. However, the sparse foliar cover subsequently results in reduced loading on lateral branches and branch unions. It is considered that the most typical mode of failure for this type of species and age bracket is to be a lateral branch during adverse weather.

Figure 4 – Subject tree viewed from the east. LS – October 2020.

17. The tree is reassessed annually by a suitably qualified arborist.
18. Monitor for infestations of Fig psyllid. If infestations become severe, consider the use of injected systemic insecticide.
19. Monitor for deadwood and remove as required.
20. Continue to discourage the use of chemical sprays within the vicinity of the tree.
21. Continue to improve soil health within the root zone of the tree by; adding high fungal content compost, humates and aged tree mulch to as much of the root zone areas as possible.
