# Pa Road - Kerikeri Footpath

Road Safety Audit  
Design Stage  
October 2020

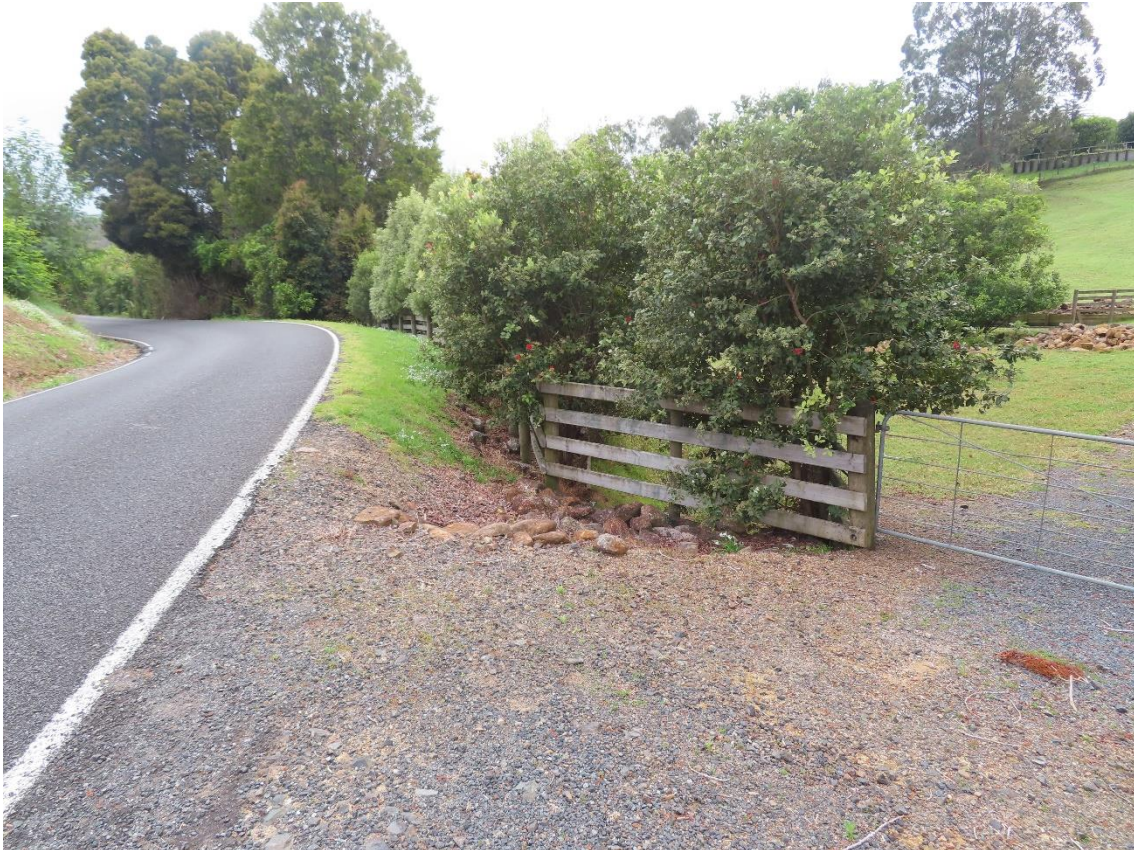
**Figure 4: Curve at Ch 400.**

At this location the footpath is located on the outside of the curve and at a lower level than the road. The drawings indicate that a timber pole wall is proposed to support the slope above the footpath. Should a vehicle lose control and leave the road at this location it is possible that the errant vehicle could fall onto the footpath and should there be a pedestrian at this location when it occurs this could result in death or serious injury. **Figure 4** shows this curve.

1. Consider providing a guardrail at this location to prevent errant vehicles from landing on the footpath located below the road level.

**Overall Rating: Moderate**

Designer Response: Not accepted – the probability of an errant vehicle occurring is infrequent, this combined with the very unlikely chance of a pedestrian being on the path at the same point gives a minor risk rating using the Table 1 assessment matrix.

Safety Engineer: Agree with Designer, value for money we would put guardrail on other higher risk curves ahead of this.

Action Taken: No action required

2. Remove fence and relocate to road boundary to enable a suitable setback (berm) to be placed between back of guardrail and proposed footpath.

Action Taken: Changes effected as per client decision.

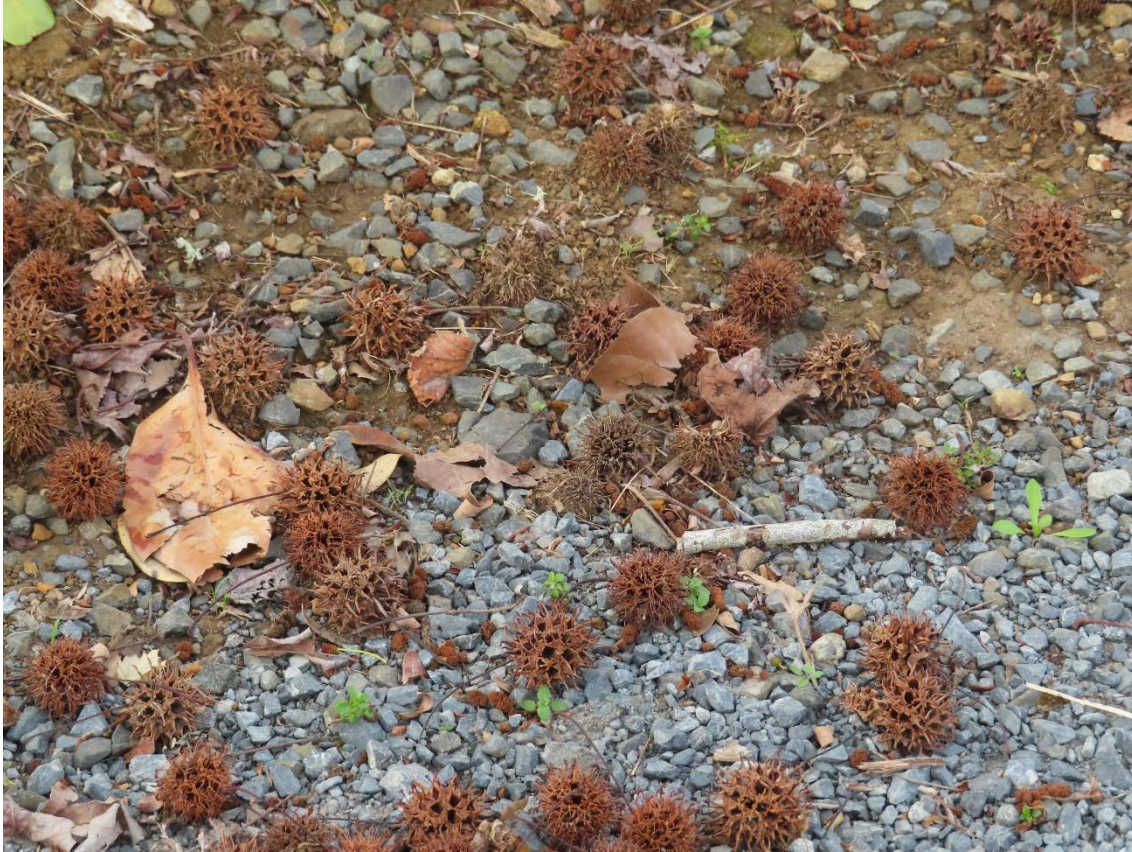
**Figure 5 : Seedheads off trees, Driveway Ch 290.**

The driveway at Ch290 is lined with trees that drop very hard round seed heads. These seed heads are such that they may cause users to either slide on them or roll their ankles resulting in possible injury. They have very sharp pointy spikes that can penetrate into bare skin. **Figure 5** shows these seed heads.

In consultation with the landowner consider removing the end tree nearest the footpath to minimise the number of these seed heads landing on the footpath.

**Overall Rating: Minor**

Designer Response: Not accepted – Engineer notes that these same trees line Queen Street in Auckland and outside the Kerikeri Police Station.

Action Taken: No action required.

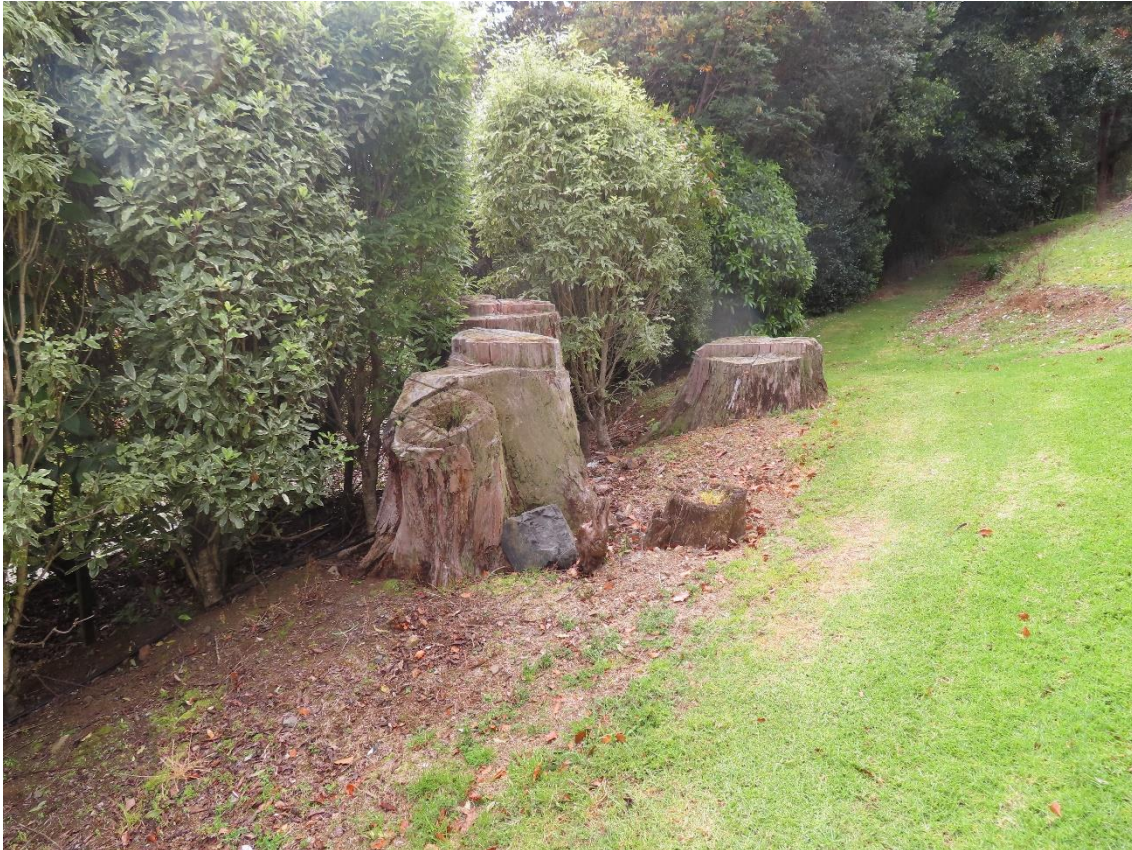
**Figure 6 : Tree stumps Ch 550.**

The design drawings indicate that these stumps are to remain and that the footpath is to be deviated around them. These stumps are a roadside hazard and should be removed, **Figure 6** shows these stumps.

Remove stumps. Straighten the footpath alignment to avoid bringing it closer to the sealed carriageway.

**Overall Rating: Minor**

Designer Response: Accepted – however stump removal may require heavy or specialist plant. Decision to remove to be based on affordability of contractor rates for doing the work.

Action Taken: Revised drawings to show stump removal as provisional item to be confirmed by engineer.

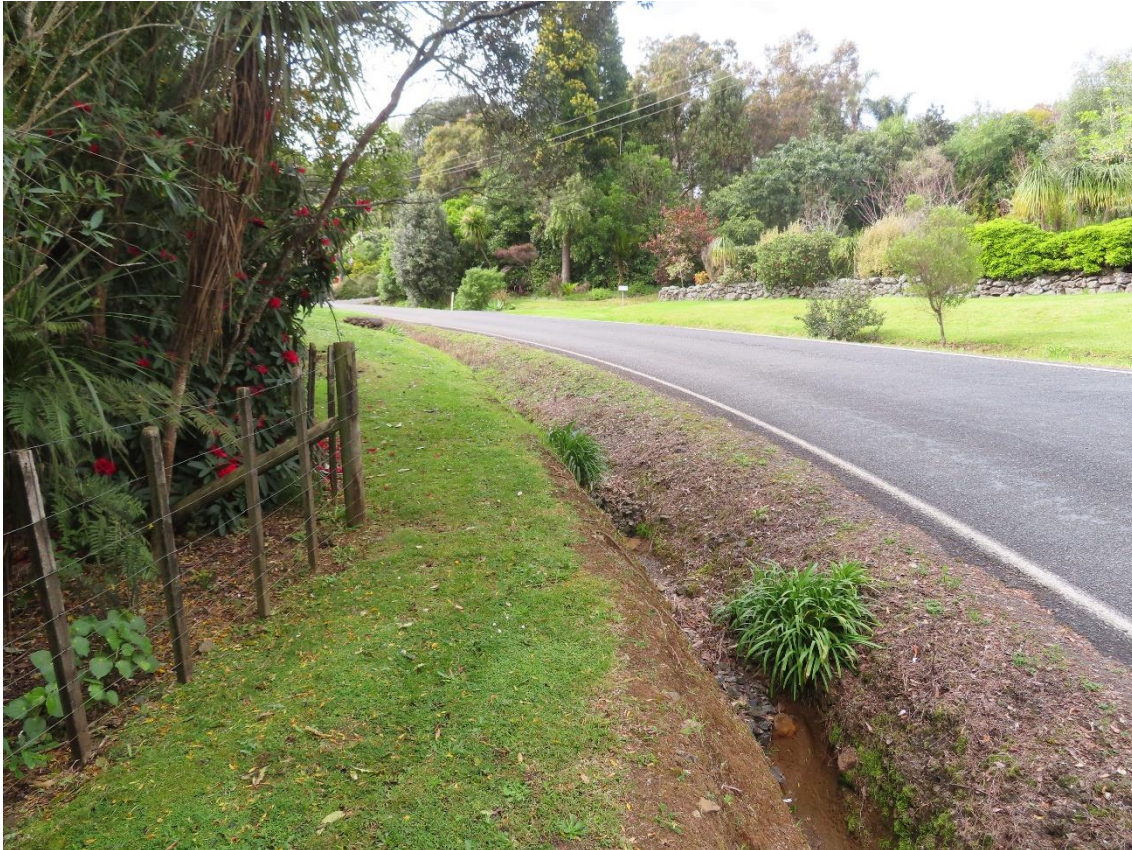
**Figure 7 : Curve Ch 650- 700.**

In order to gain space to fit the footpath past the pinch point caused by the boundary corner it is proposed to culvert two 10m section of the roadside water table and provide a handrail on the footpath at the pinch point. This leaves approximately 20m of water table between this culverting and the cross culvert under Pa Road. The short remaining lengths of open drain and the handrail are roadside hazards that could be eliminated by culverting the roadside water table for about 50m from the cross culvert. **Figure 7** shows the existing situation and **Figure 8** shows the features described above.

Consider pipe culverting approximately 50m of roadside water table to remove short lengths of steep open roadside drain and remove the necessity for a handrail.

**Overall Rating: Minor**

**Designer Response:** Not accepted – the proposed culvert arrangement avoids the need for manholes at change in direction and provides the most cost-effective solution. The road is un-kerbed and open roadside drainage is a common feature. The open drain hazard is an existing feature which is not exacerbated by the proposed footpath. It could be argued that the open drain provides protection to pedestrians from an errant vehicle. Further infilling of the drain would reduce this protection. The depth of the drain is not considered sufficiently deep to present more than a minor hazard, an errant vehicle would not come to a dead stop and is unlikely to roll. The depth of the ditch could be moderated by placing anti scour rock armour in the invert but even this is not considered necessary.

Action Taken: Revised drawings will show the over-deep section of water table lined with rockspall to mitigate further scouring

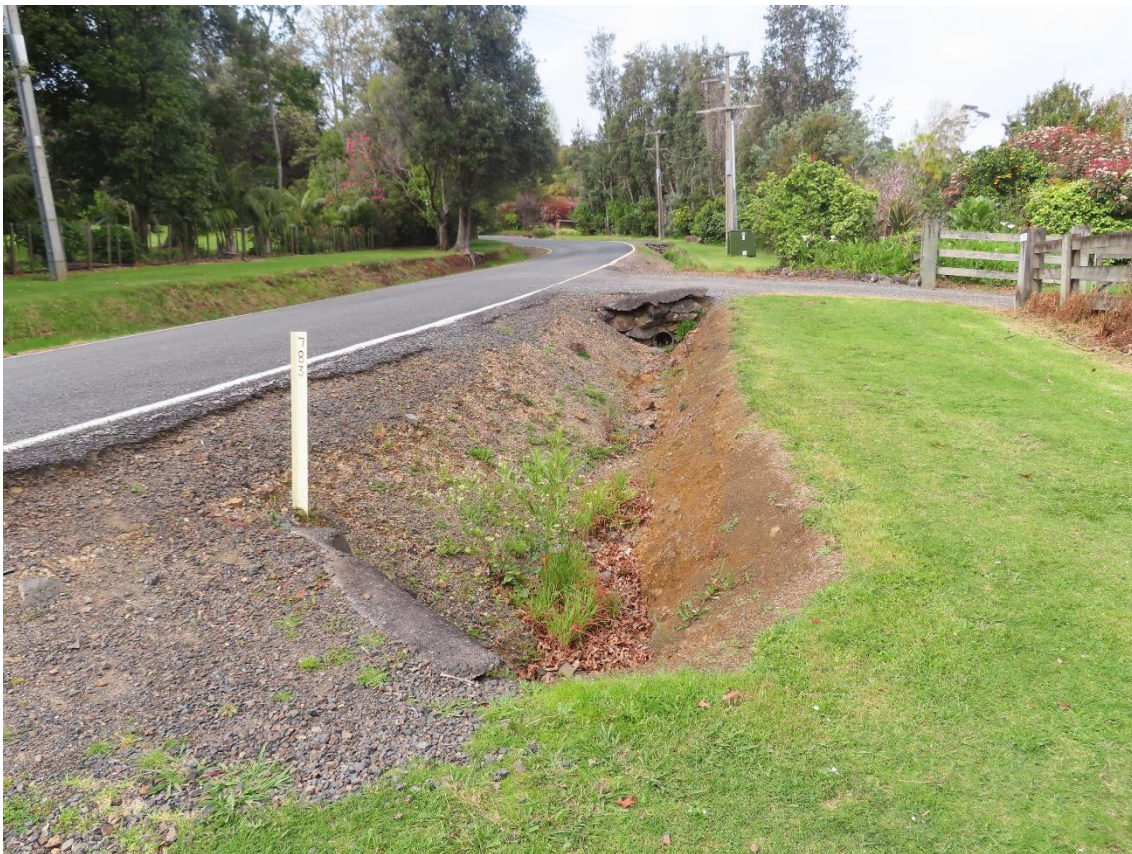
**Figure 9 : Water table Ch 780.**

In order to construct the crossing point to link the proposed footpath to the existing footpath approximately 6m of the existing roadside water table is shown to be culverted. This leaves approximately 6m remaining between this culverted section and the nearby driveway culvert. This short length presents a roadside hazard, particularly as it is on the outside of the curve. It is possible that a vehicle could crash into this short length of culvert either by losing control or by not realising its presence.

**Figure 9** shows this short length of open water table and **Figure 10** shows the proposed design showing water table to be culverted and that to remain open.

Consider extending the culverting of the water table to the adjacent driveway.

**Overall Rating: Minor**

Designer Response: Not accepted – The road is un-kerbed and open roadside drainage is a common feature. The open drain hazard is an existing feature which is not exacerbated by the proposed footpath. The depth of the drain is not considered sufficiently deep to present more than a moderate hazard, an errant vehicle would not come to a dead stop and is unlikely to roll. The depth of the ditch could be moderated by placing anti scour rock armour in the invert but even this is not considered necessary.

Action Taken: No action needed.

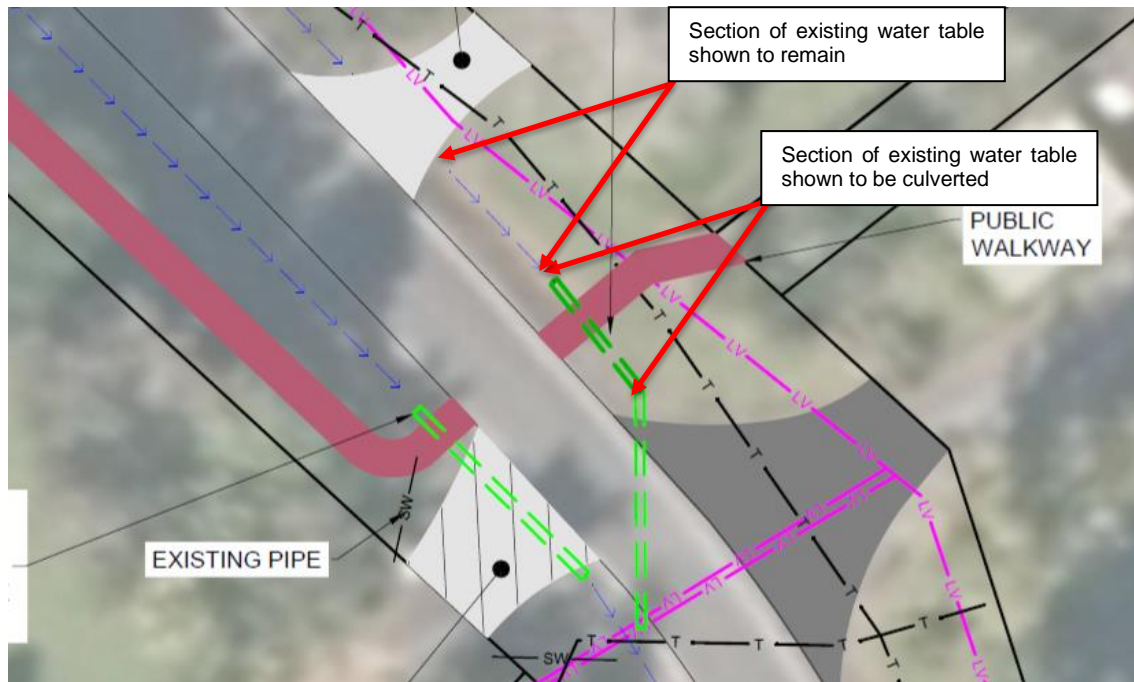
**Figure 10 : Extract of design drawings showing section of existing water table to be culverted and section to remain**
