Treeskills Tree Report

prepared for Far North District Council

Site Visit to Wendywood Lane, Kerikeri

Conducted 06.10.2022

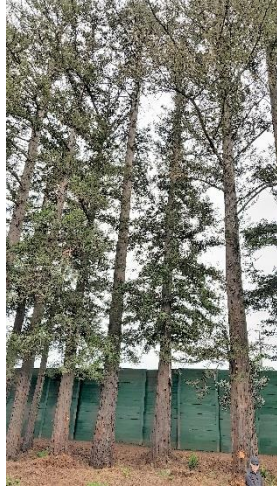
Figure 1: Showing vigorous coppice growth removal.

These trees have been cleared around their bases which will significantly reduce water retention in this area. Application of mulch is a priority to help these trees through the summer.

- Figure 2: Remove dead tree #35.
 - Hazard rating: 1
- Figure 3 and 4: Monitor the condition of these trees as they look to be slowly declining.
 - Hazard rating: 1
- Figure 1: Apply 10cm of composted mulch to the whole area to protect tree health over summer.
 - Hazard rating: 1
- In my opinion under regular weather conditions there is only a moderate risk posed by the other trees in this row, however, annual monitoring must be maintained.

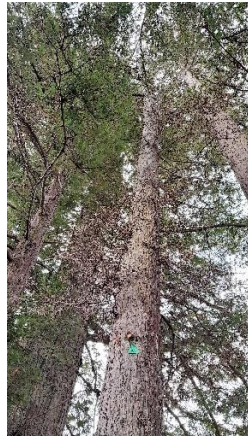
Figure 2: Showing tree #35 is dead.

Tree #35 should be removed at some time as eventually it will fall.

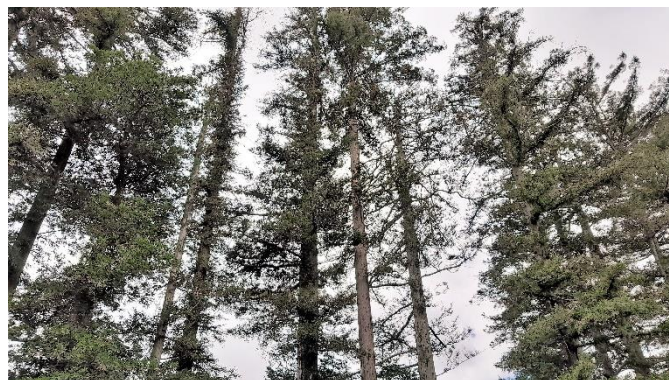
Figure 3: Showing sparse foliage.

The mulch under these trees has been largely absorbed - only 15mm is left in most areas. These trees respond well to mulch and are feeling the deficit, especially trees # 22 - 28.

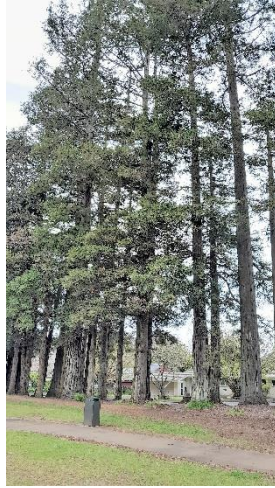
Figure 4: Showing another view of the sparse canopy area.
