Treeskills Tree Report

prepared for Far North District Council

Ruatara Drive, Kerikeri

Conducted 06.10.2022

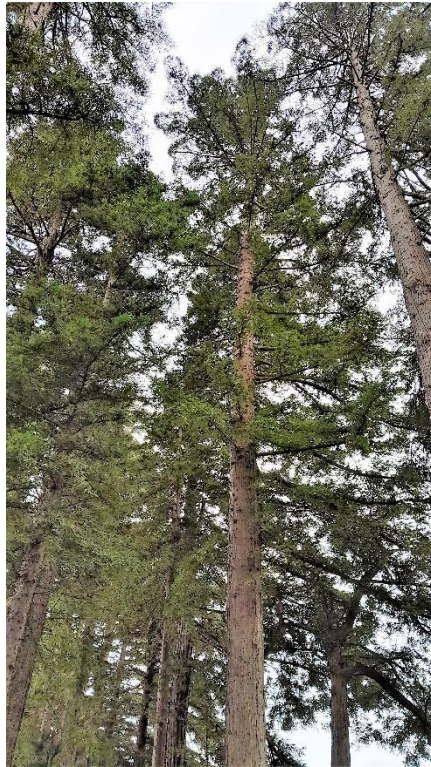
Figure 1: Showing tree #26 which has a small amount of decay.

The trees in this area were sampled for decay by arborist, Roy Hollister, Between May 2nd and the 3rd 2022. The samples established that there was a small but manageable amount of decay in this area. Tree #26 looks good now but its foliage cover and health should be monitored.

- ✚ Figure 5-8: Remove tree #36.
 - Hazard rating: 5
- ✚ Figure 2: Remove broken branch on tree #25 as it is a hazard.
 - Hazard rating: 3
- ✚ Figure 1: Apply 10cm of composted mulch under all trees to the edge of their root zones
 - Hazard rating: 1
- ✚ In my opinion under regular weather conditions there is only a moderate risk posed by the other redwoods in this row in Ruatara Lane, but annual checks need to be maintained.

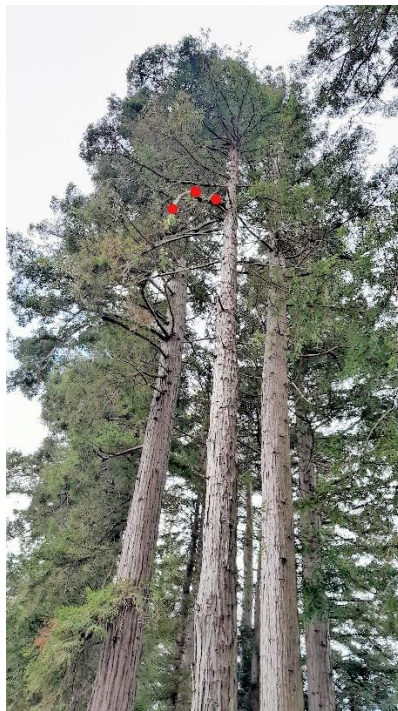
Figure 2: Showing a hanging broken limb on tree #25.

This limb on tree #25 is a hazard and should be removed at some time as eventually it will fall.

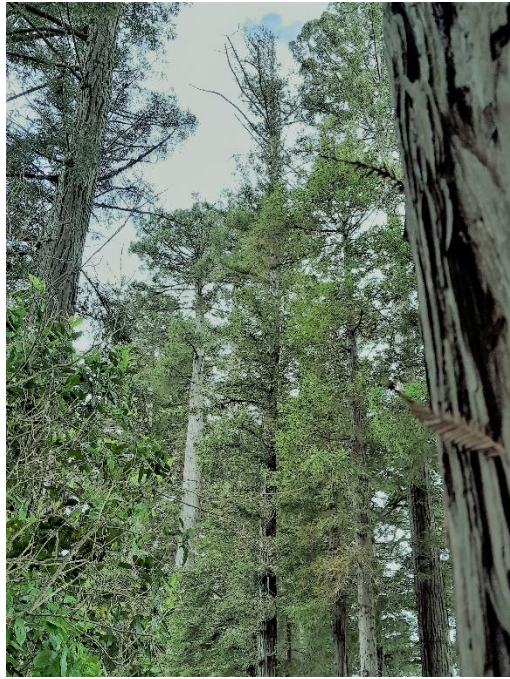
Figure 3: Showing sparse foliage in the head of tree #69.

Tree #69 has a failing head, which should be removed when and if it dies.

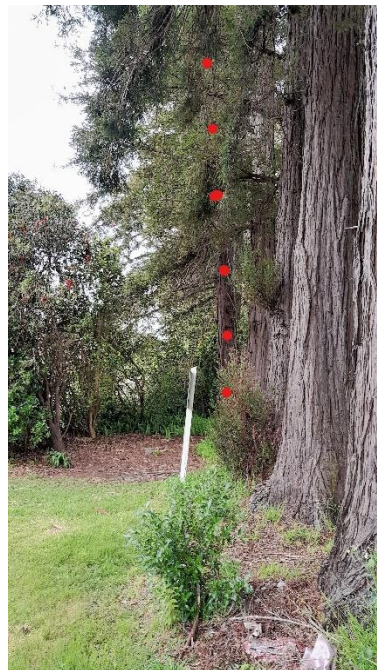
Figure 5: Showing how tree #36 is out of line with the rest of the row.

Being out of line with the rest of the edge trees exposes this tree to side loading during wind events. This sideways pressure can rock the root plate in a rotational direction causing root plate failure.

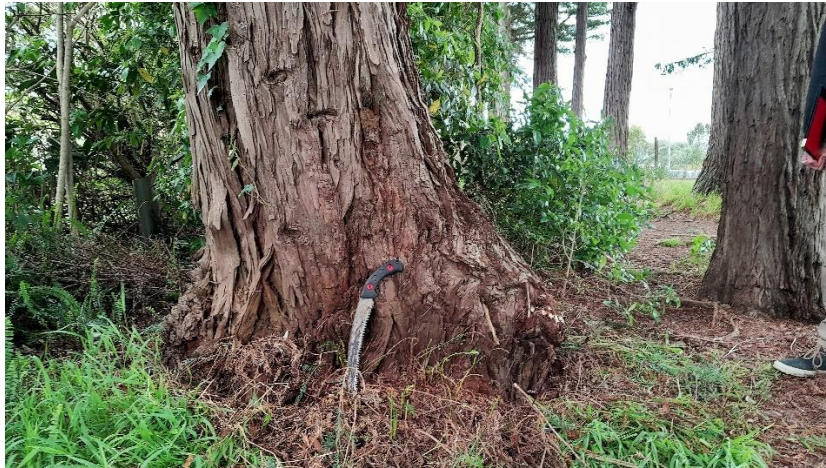
Figure 6: Showing how the base of tree #36 is out of line with the row.

This picture makes clear that the tree is leaning and suggests it has an untidy and weak attachment to the rootplate due to it being coppice growth poorly attached to a stump.

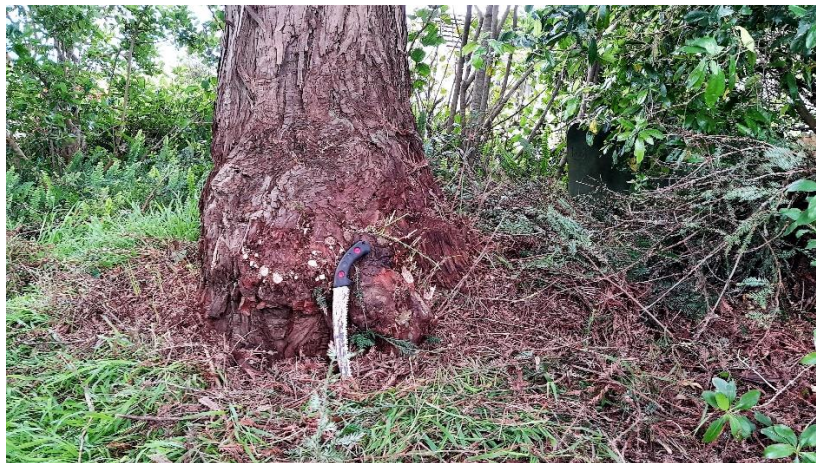
Figure 7: Showing the lean at the base of tree #36 is out of line with the row.

This view from behind the lean seems to show the remains of a previous stump.

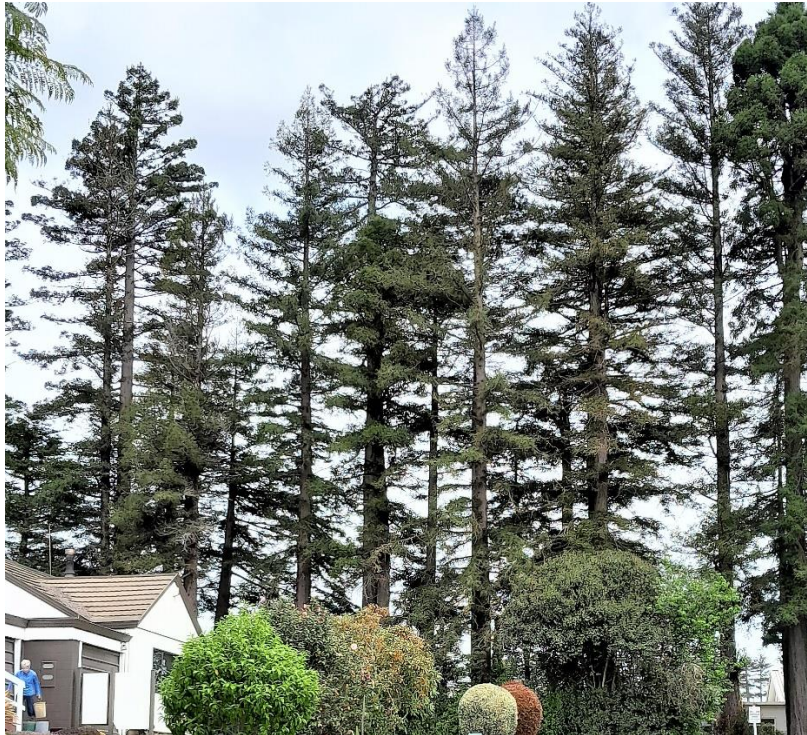
Figure 8: Showing the property into which tree #36 would fall.

This tree is unlikely to hit the house and would probably fall directly towards the camera.

It has been here a long time however, it is the most significantly hazardous tree in this copse and as it extends higher it also extends outwards. I am becoming concerned.
