# Treeskills Tree Report

## Morton Bay Fig

**33 The Strand, Russell**

**Conducted 07.10.2022**

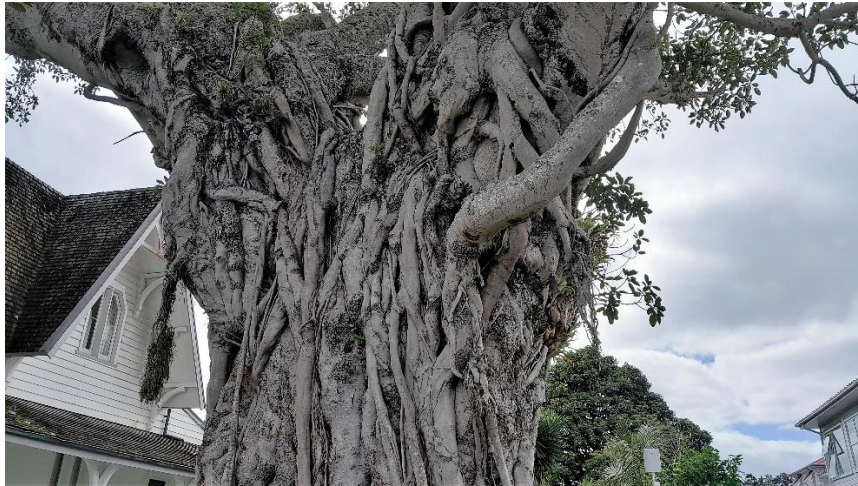
**Figure 1:** Showing vigorous aerial rooting.

This species of tree is able to cope with hard-to-access nutrient sources. It commonly grows on cliffs and as an epiphyte in the crown of other trees.

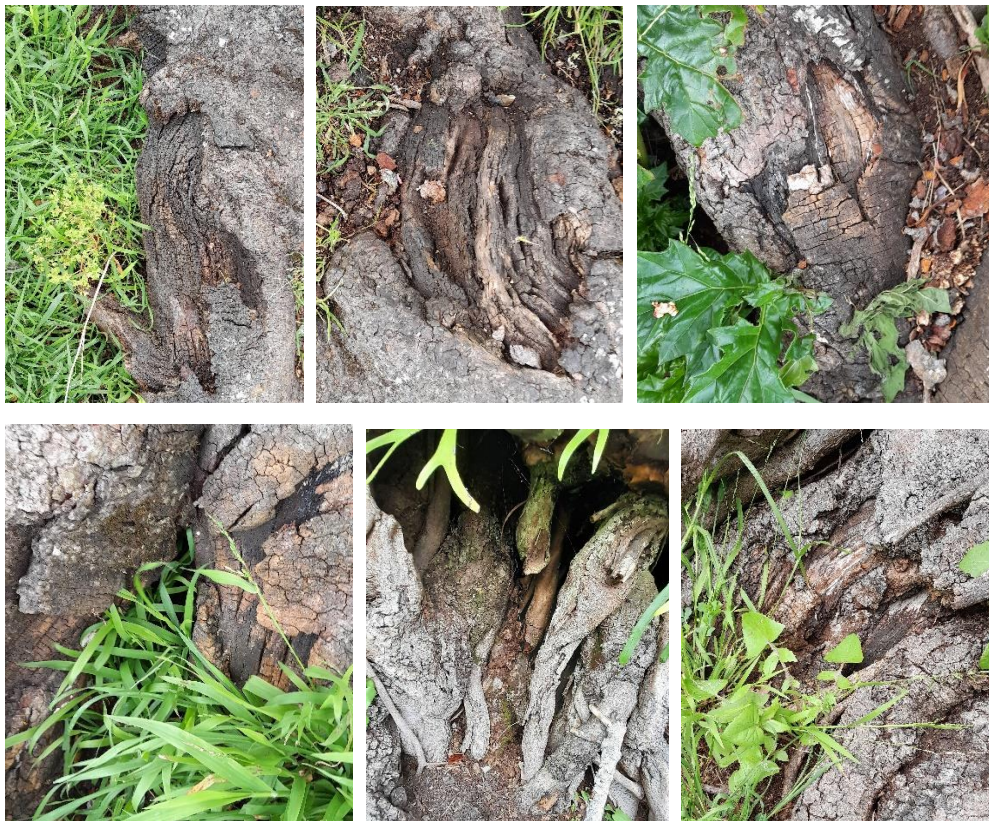
**Figure 2:** Showing extensive historic damage to root plate.

Obvious root damage is evident around the circumference of the root plate and raises the possibility of the root plate becoming unsound if this should continue to spread.

Figure 2: Continue monitoring the periphery of the root plate, especially the clear problems seen in the photos, and in particular any lifting of the root plate.  
**Hazard rating: 2**
-

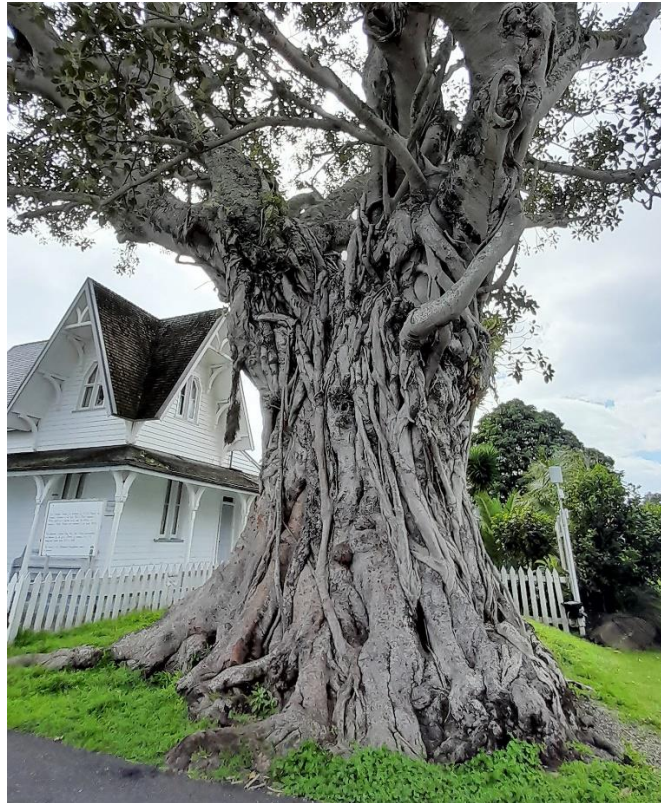
**Figure 3:** Showing poor wound healing.

The lower scaffolding in the crown has many wounds where the stubs have not healed due to slow growth. This has allowed decay to begin to make inroads into the remaining wood.

Figure 3: Monitor the wounds that have not yet healed in case decay begins to penetrate sound wood. This species does not decay easily so this is unlikely.  
**Hazard rating: 1**
-

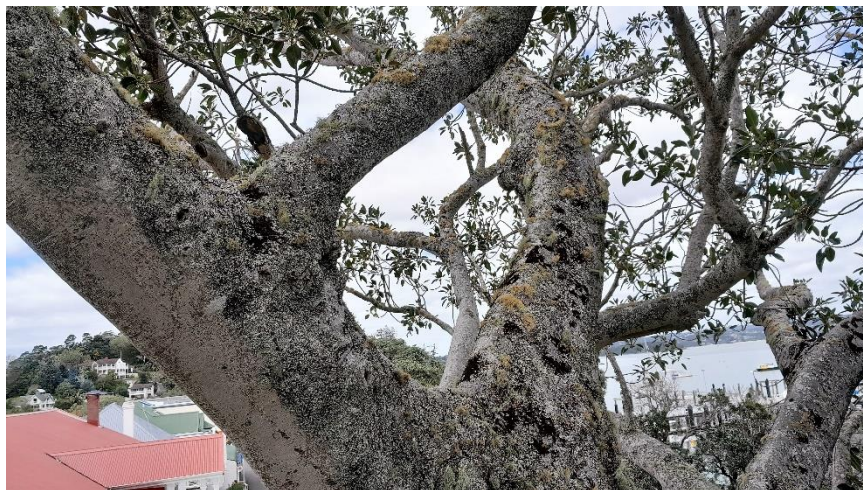
**Figure 4:** Showing Upper side of the scaffolding.

The load bearing side of the tree's scaffolding (i.e. the top of the limbs) is in excellent health and indicates that the upper structure of the tree is sound.

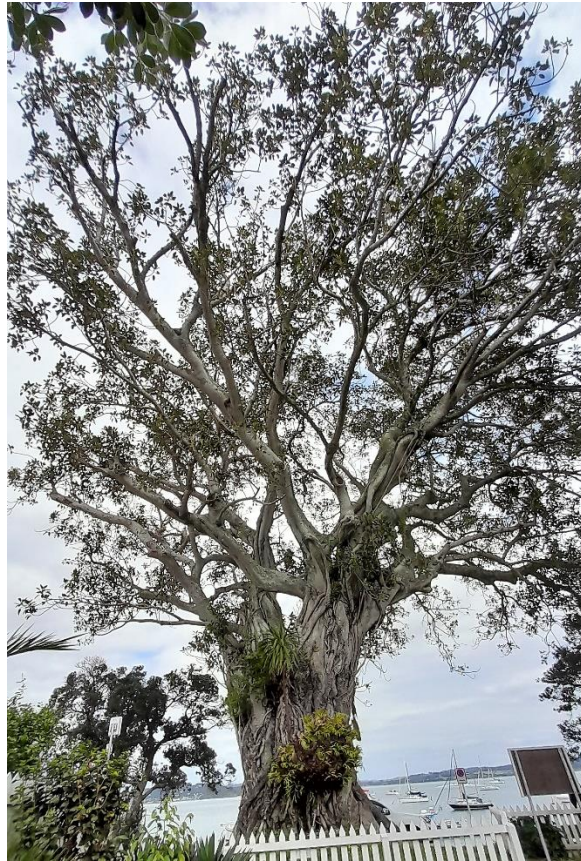
**Figure 5:** Showing the sparse canopy.

This old tree is hanging in there having plateaued out at a sustainable level at present.

Figure 5: Monitor the foliage density. This will vary with the seasons, but foliage will fall before the limbs decay. If the tree dies and all the leaves fall there will be an adequate window to dismantle the tree before it becomes unsound.  
**Hazard rating: 2**
-

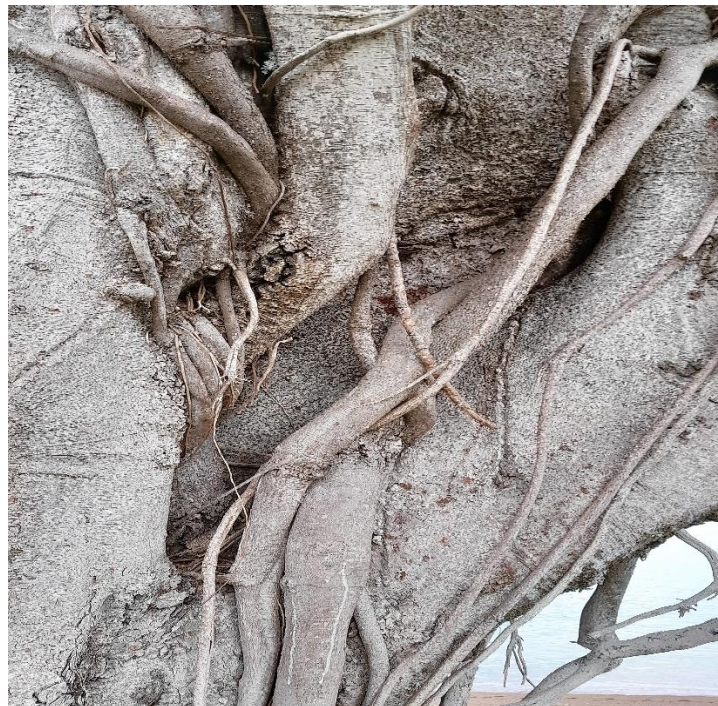
**Figure 6:** Showing a relatively healthy section of lower scaffold.

Viewing the tree from the ground and looking up at slow healing old cuts with minor decay, it is easy to get a biased impression of this tree. As a species, *Ficus macrophylla* is good at compartmentalising decay, so the effect is minimised on the rest of the tree.
