Treeskills Tree Report

prepared for Far North District Council

Long Beach Morton Bay Fig

Site Visit to 65 Long Beach Road, Russell

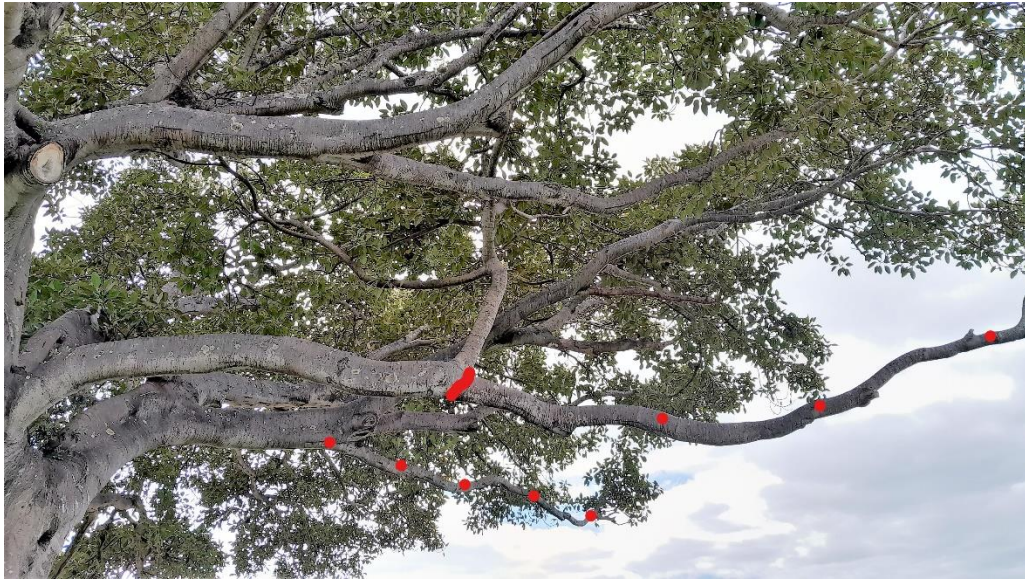
Figure 1: Showing two suppressed branches on the south side.

The near branch has died back to the vertical diversion which has remained alive due to the sunshine available to it in the crown. The rear branch is still alive however will soon die as there are not enough leaves left to keep it alive.

- ✚ Figures 1 and 2: These two limbs will die and fall. Remove.

Hazard rating: 3

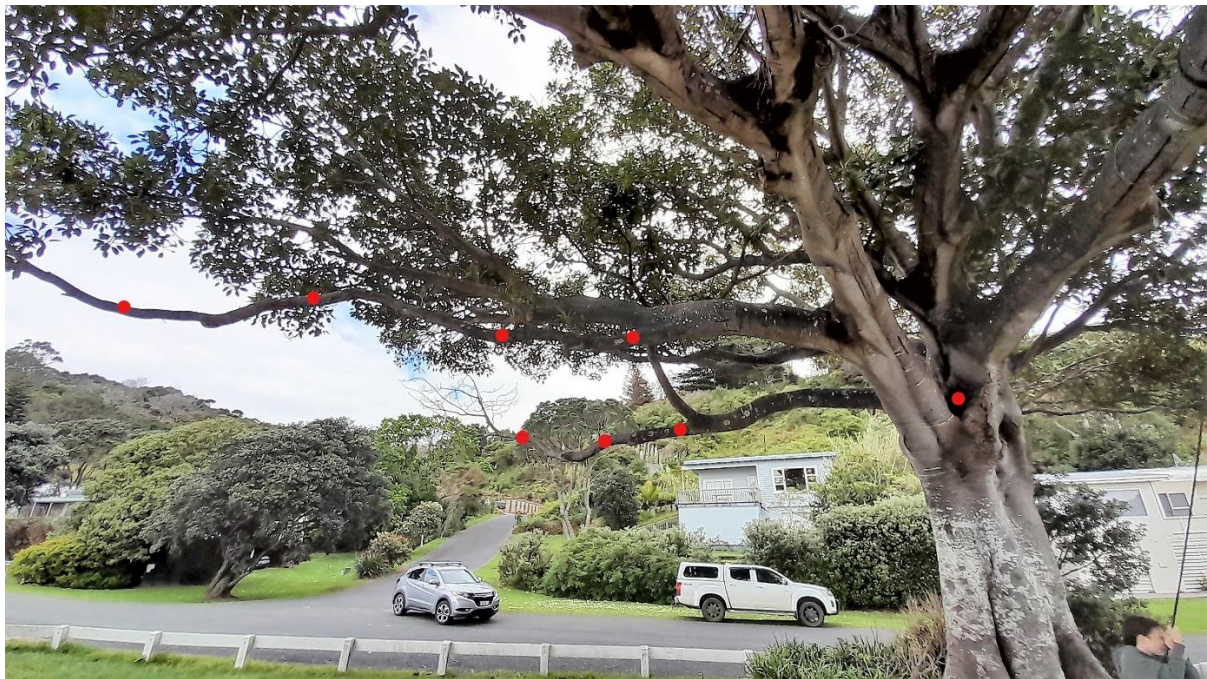
Figure 2: Showing The same two branches from the other side.

The dot on the stem is indicating a significant crotch which is addressed later in the report (figure 9).

It is evident that the rope swings on this tree are frequently used. The two stems on the left side and stretching towards the camera are the ones of most concern as they are poorly attached and could fail.

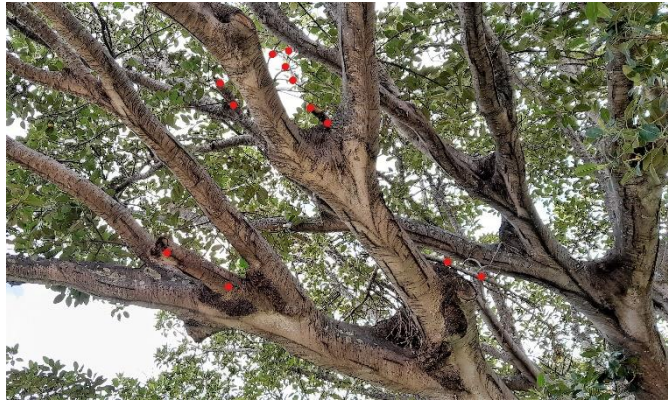
Figure 3: Showing some stubs and crown deadwood.

It is clear this tree has been shedding significant amounts of dead wood. The reason is unclear but could be related to the excessive development of crotch cavities at most unions of stems and branches.

- ✚ Figure 3, 4 and 5: This deadwood can fall so remove it. (I removed figure 5 by hand)

Hazard rating: 1

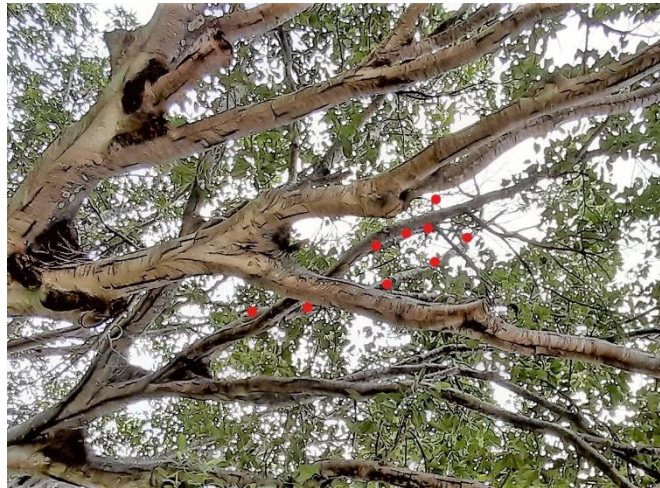
Figure 4: Showing two dead limbs in the upper crown.

The load bearing side of the scaffolding is in excellent health and means the upper structure of the tree is sound.

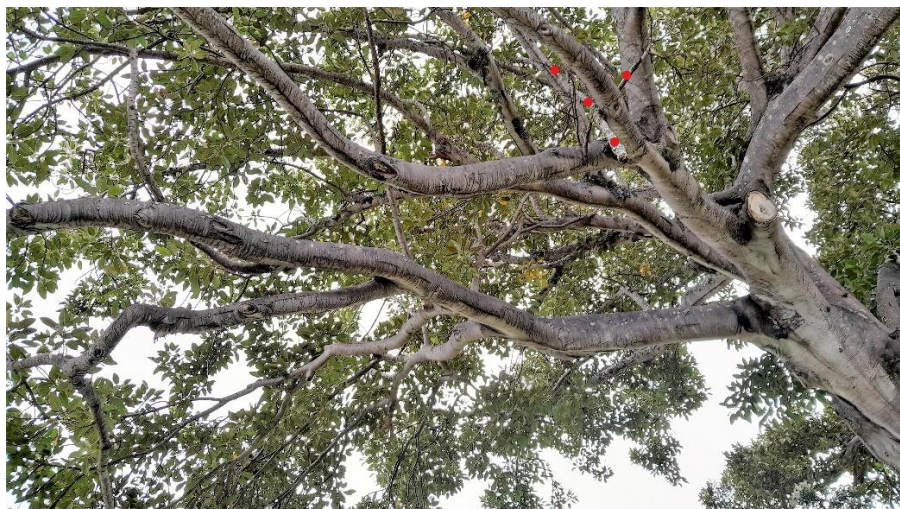
Figure 5: Showing a 10cm dead limb above the road.

This limb was a clear and present hazard, so I removed it while in the tree.

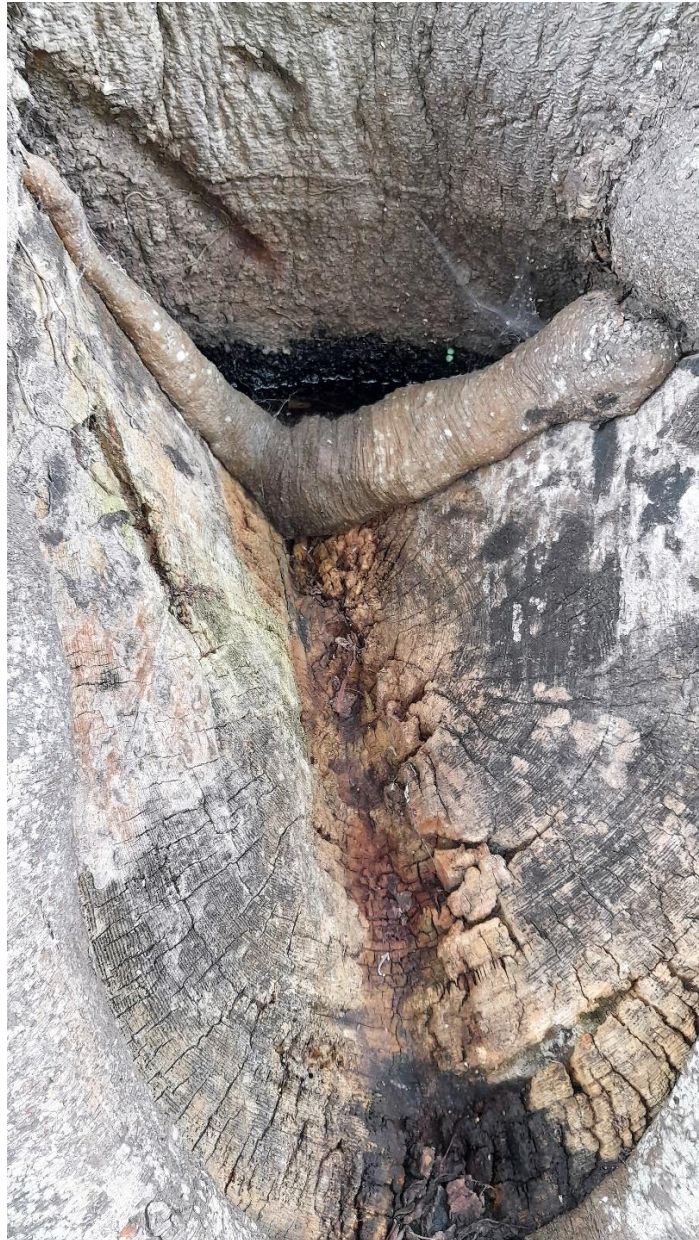
Figure 6: Showing a cavity associated with the crotch formed where a large limb grew.

I assume the water sitting in a cavity behind the limb caught humus which hosted pathogens that killed the limb and caused it to be removed. One or even three defective crotches forming cavities on a tree are manageable as the limbs associated can be reduced or removed. Unfortunately, this tree has a defective crotch on almost every union. This will lead to numerous pockets of decay and resultant interruptions to xylem and phloem which in turn would lead to patches of the crown dying. The problem this tree has is the abundant cavities associated with almost every crotch. I have researched this crotch formation problem without finding anything pertinent. This looks to be an anomalous tree, perhaps a mutant.

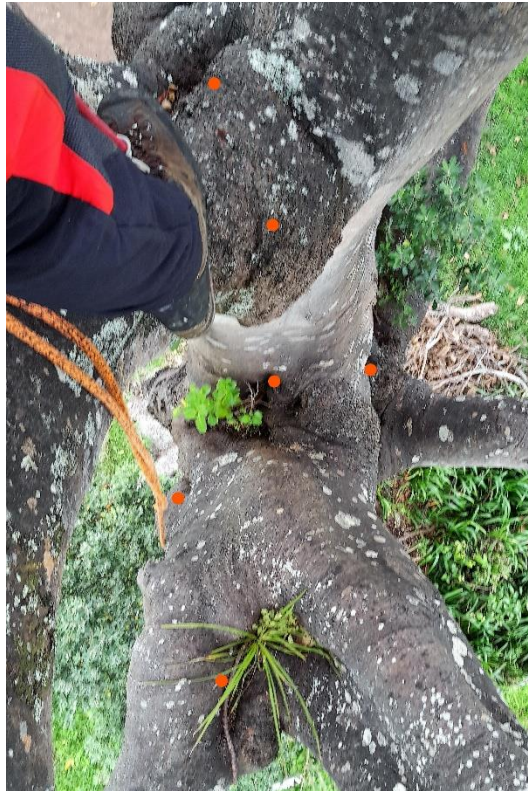
Figure 7: Showing Y crotches at every union.

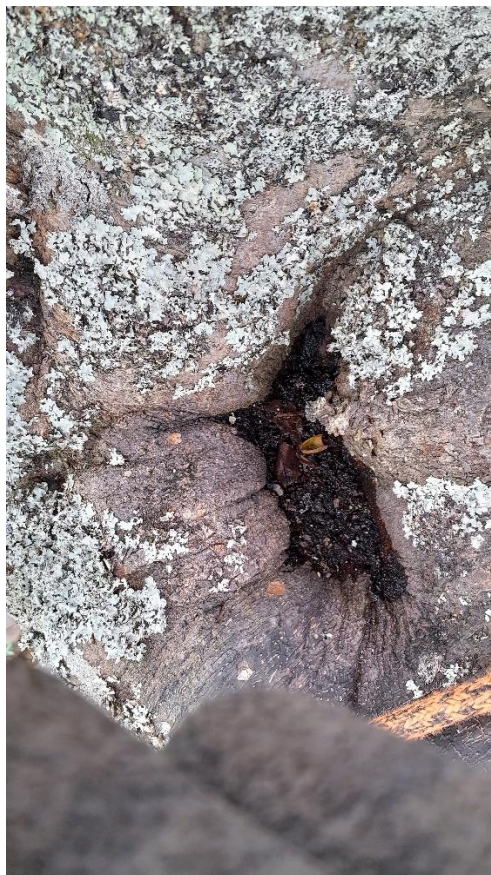
Figure 8: Showing humus build- up.

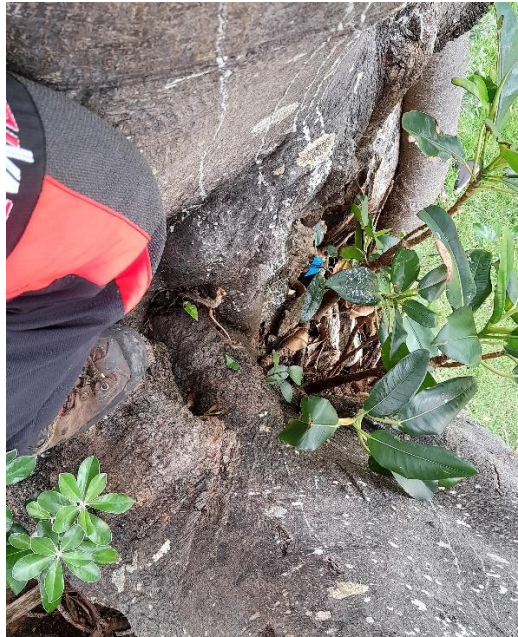
Figure 9: Showing a very large crotch with a large stem hanging on to this point.

This limb and the one below it (figure 10) should be removed as they are not securely attached. This is because the load bearing timber is not only exposed to decay, but also poorly shaped as shown in **figure 11** below.

- ✚ Figure 9 and 10: These two stems could fail, especially in a storm. Perform a heavy crown reduction on these two stems to reduce the loading on these two union points

Hazard rating: 5

Reducing these two stems would make this tree moderately safe in the interim, however, we can expect to have ongoing deadwood to remove and would need to continue monitoring this tree annually.

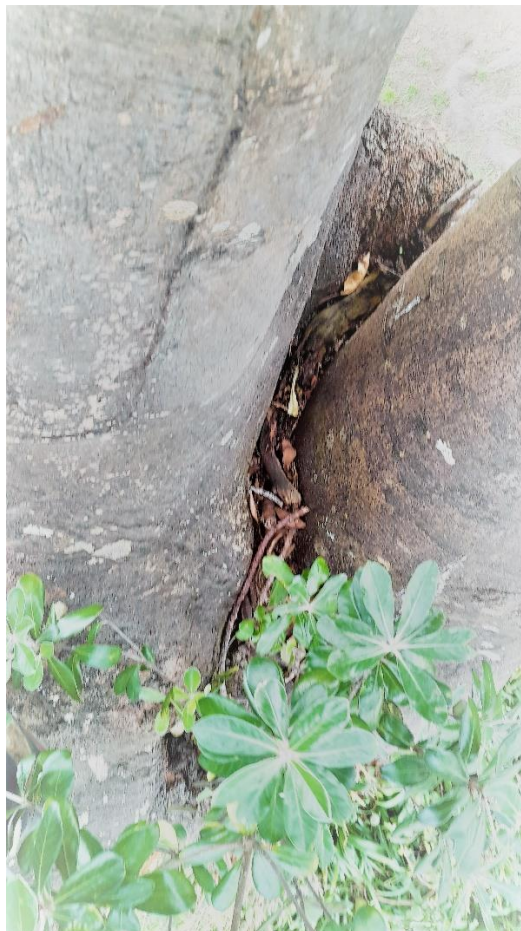
Figure 10: Showing crotch with a decay pocket and very poor attachment.

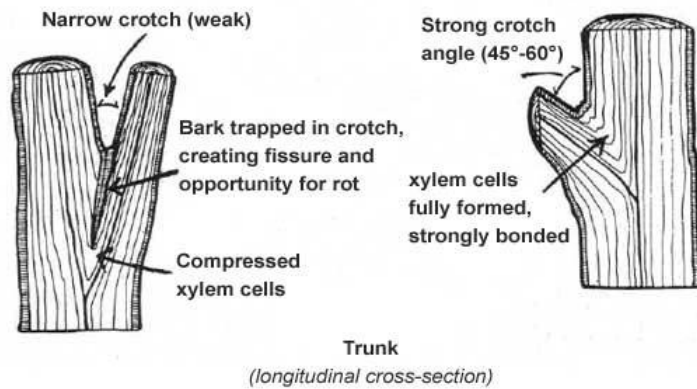
Figure 11: Showing how to identify a weak crotch with very poor attachment.

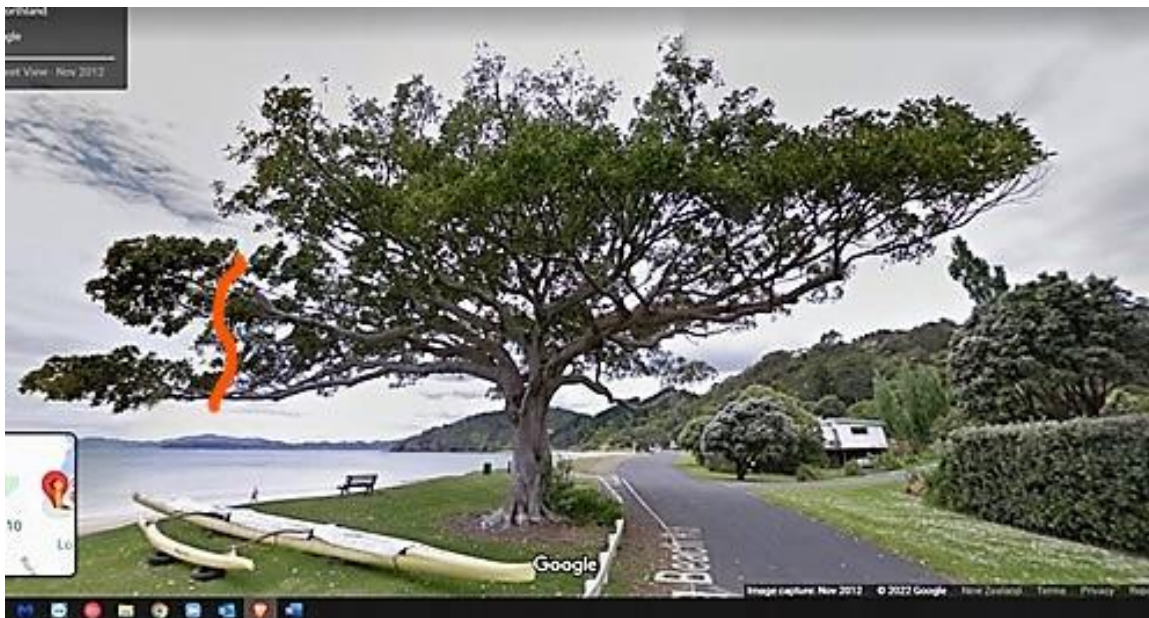
Figure 12: Showing how much needs to be removed due to decaying crotches with very poor attachment.

This essential work would remove the end of the swing limbs, some of the shade for beach goers. The systemic fault that has caused pockets of decay will continue and require ongoing monitoring and maintenance.
