Ref: EQC/2021/001295  
WSP Ref: 5-C37NB.01 (/026)

## Claim for Natural Disaster (Landslip) Damage;

1a Seaview Road, Paihia

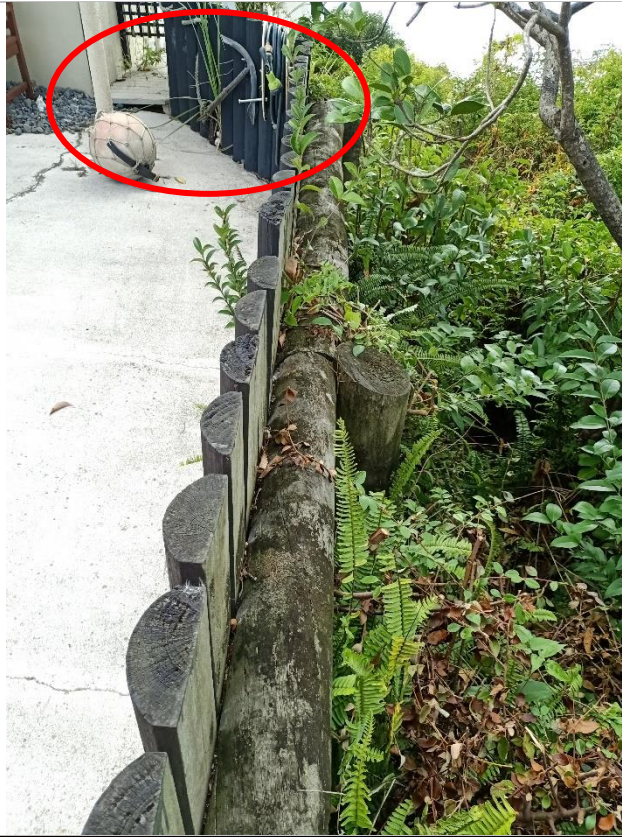
**Photo 1:** View at carparking area at top of access. Access through red circled area.

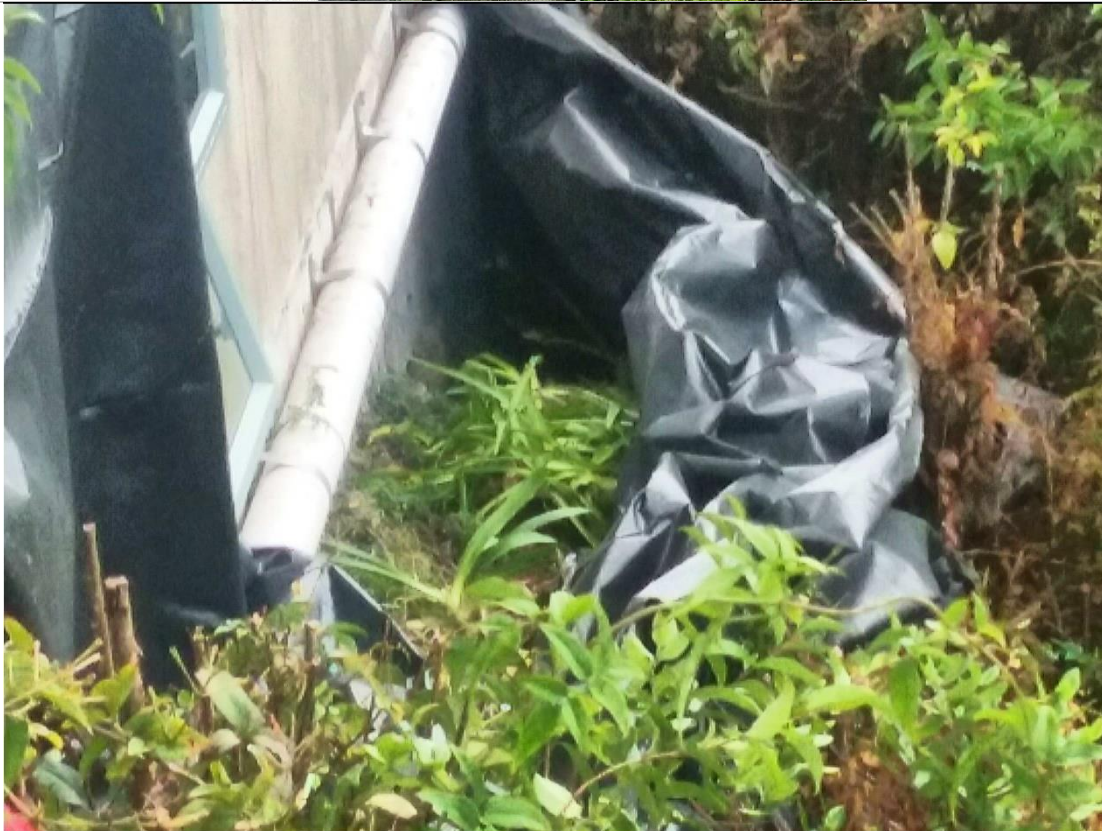
**Photo 2:** Photo repeated from Natural Disaster Event Assessment Report showing access to slip from top of access.

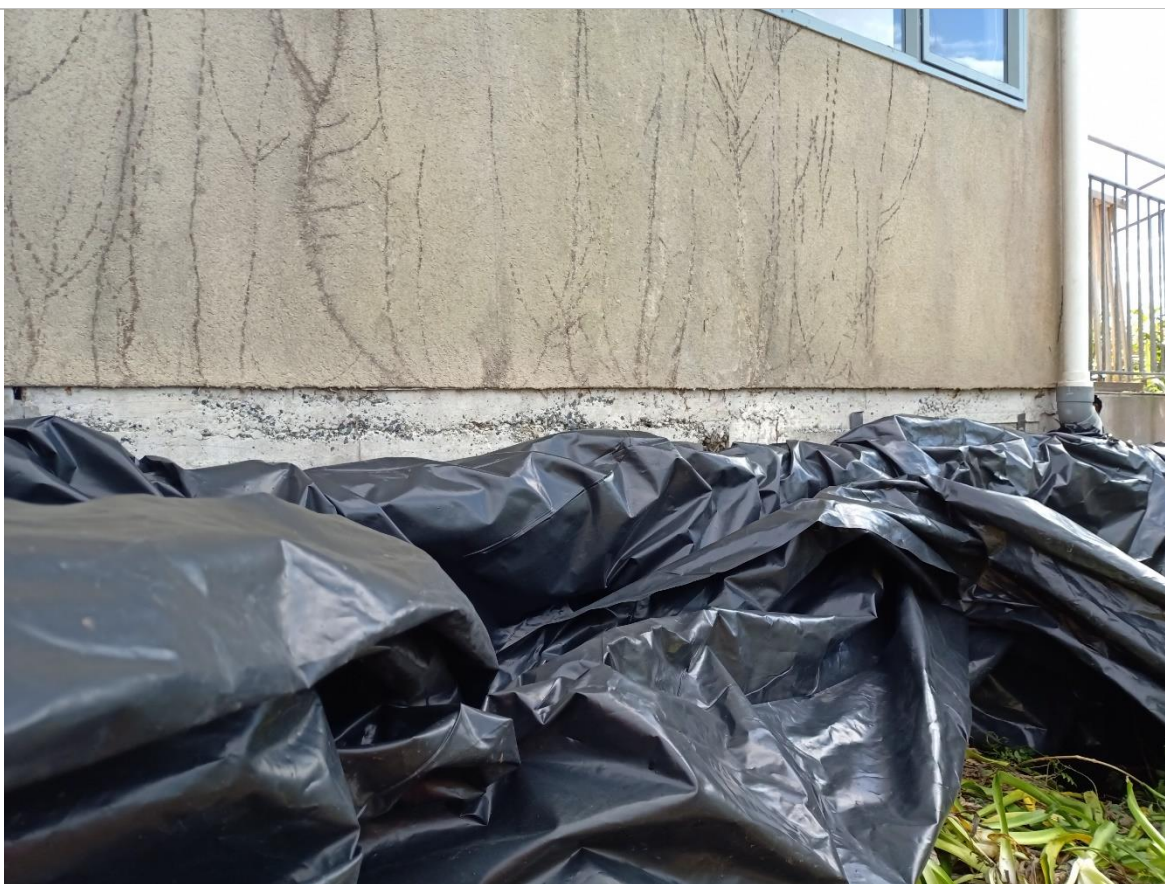
**Photo 3:** General elevation of slip area showing potential working area.  
**Photo 4:** View of slip area from above.

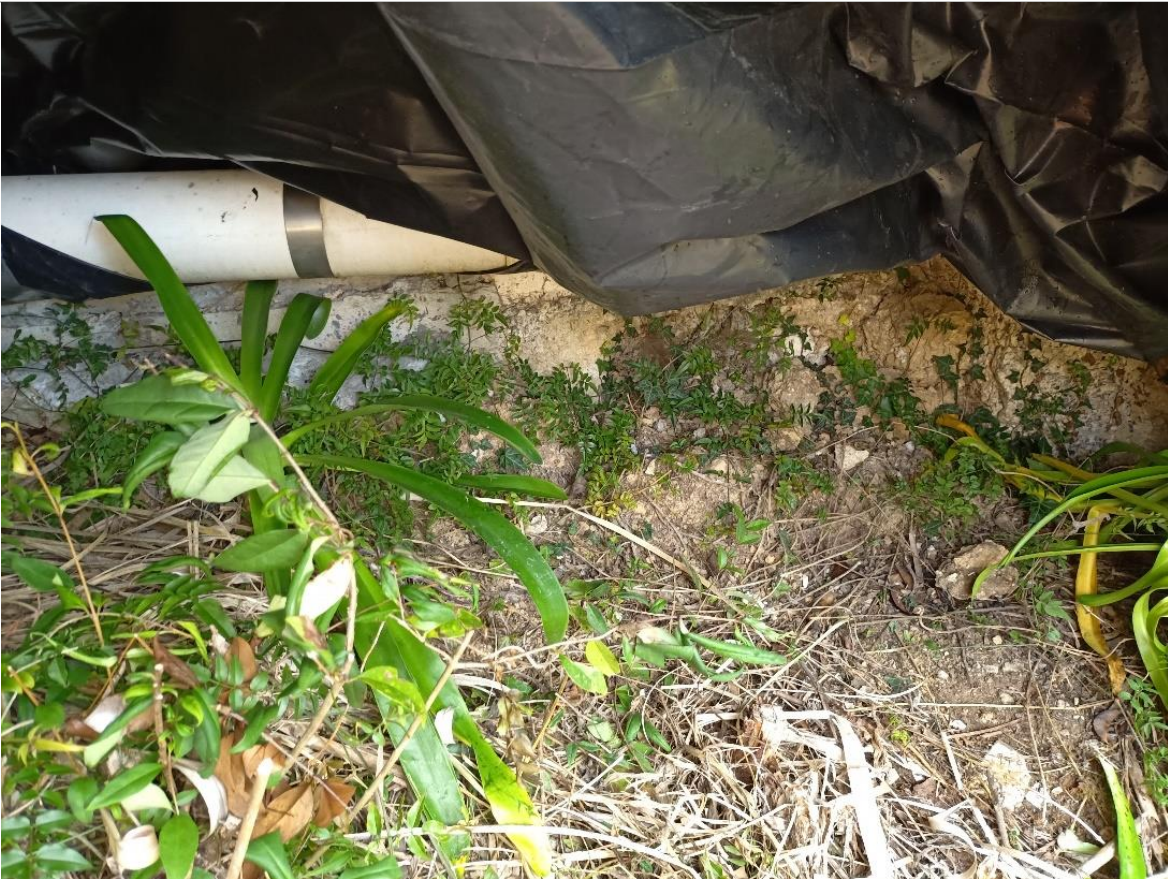
Photo 5: Western end where ground level is at concrete beam level

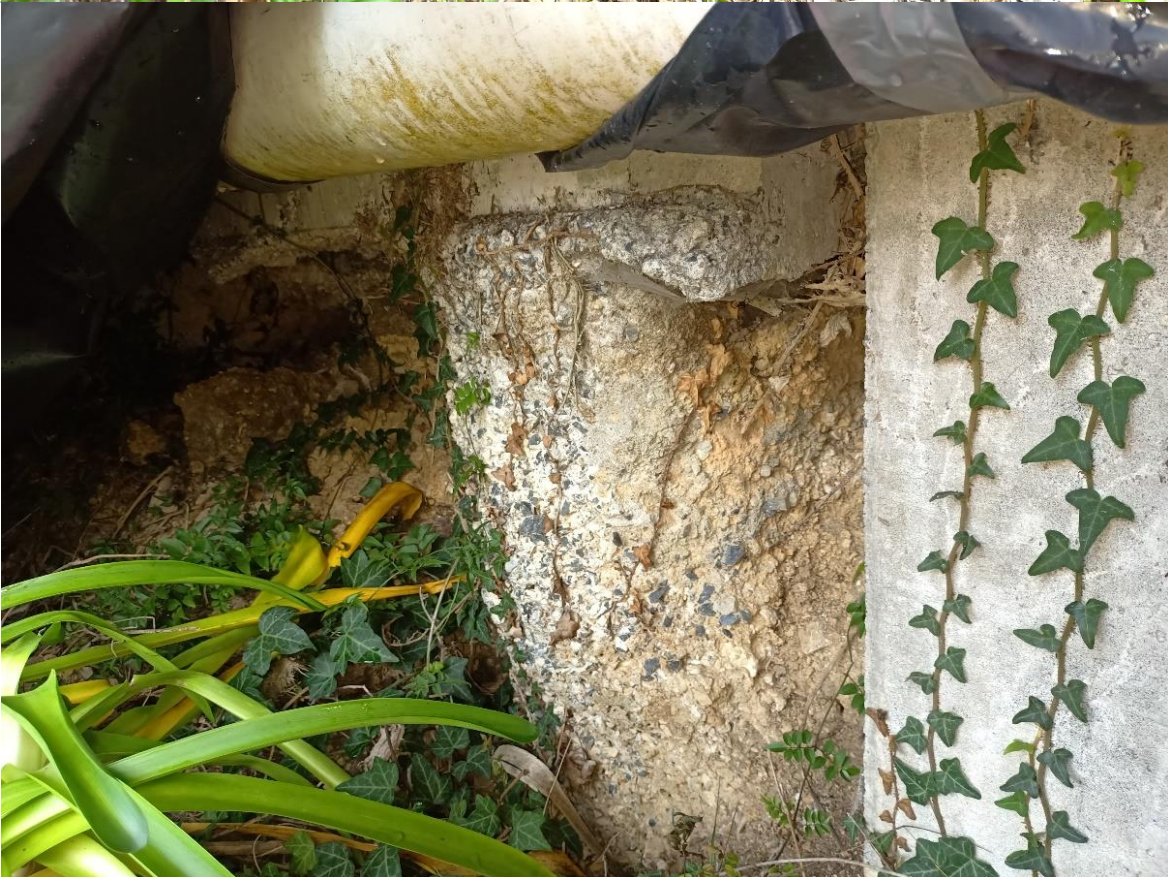
Piles were visible which appeared to have been poured against ground and subsequently exposed. It was not apparent over what timeframe the exposure occurred. No cracking was apparent in the piles or the concrete at the base of the exterior wall.

Photo 6: Exposed pile #1

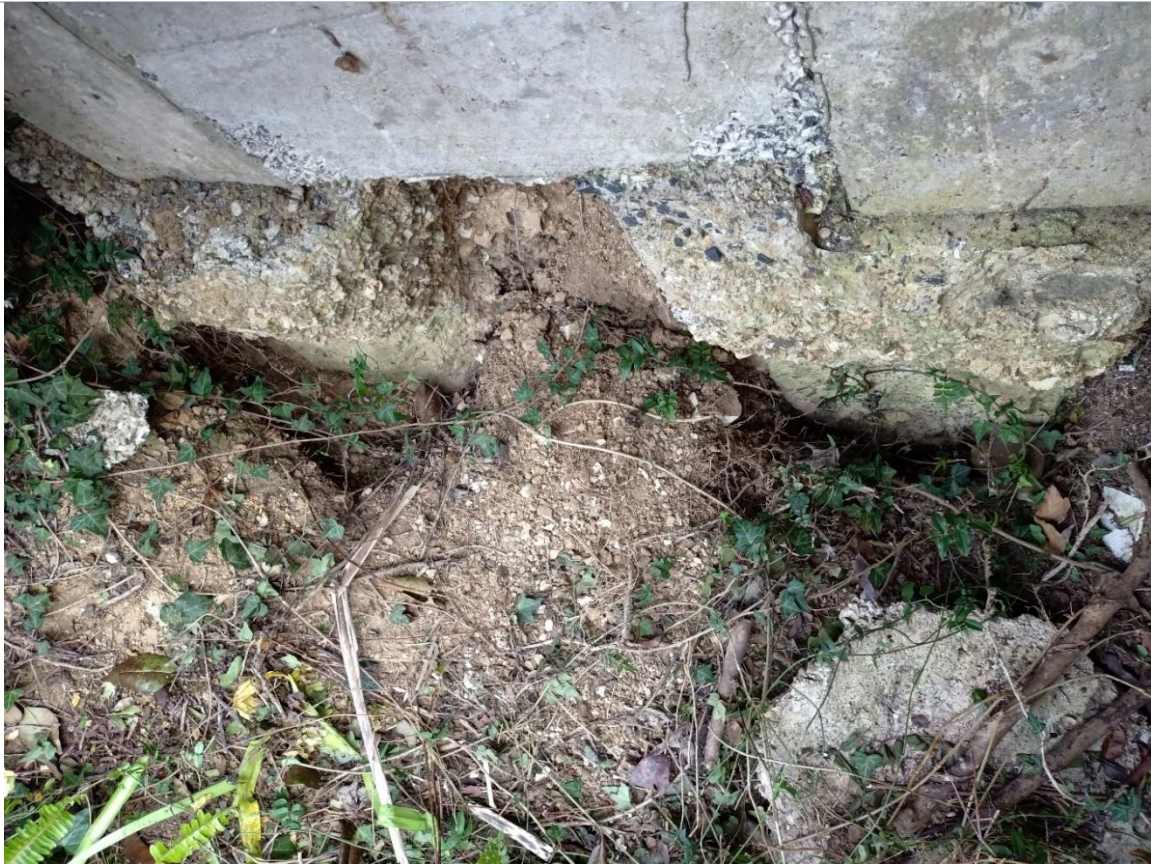
**Photo 7:** Exposed pile #2 & 3 showing scarp

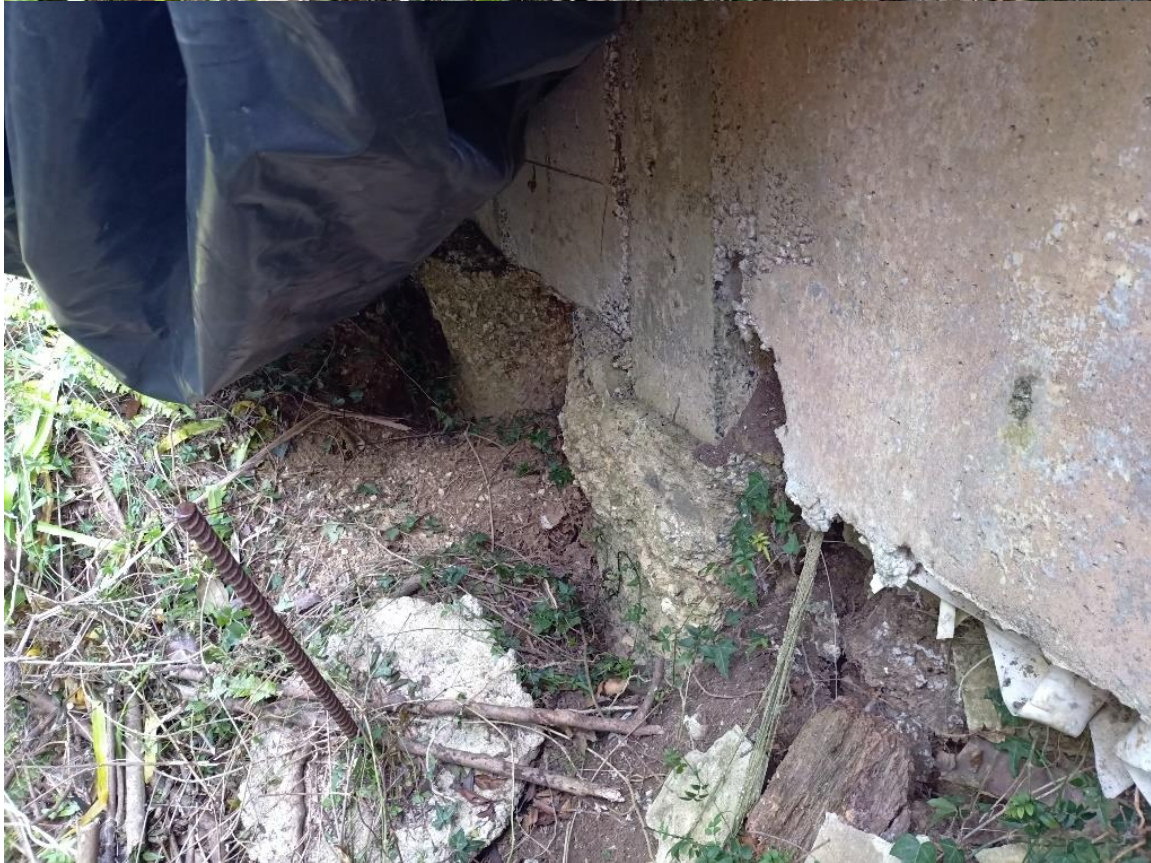
**Photo 8:** Exposed pile #2 & 3 showing uncontrolled fill under deck on right. Rebar in foreground is monitoring peg from demolition of neighbouring hotel.

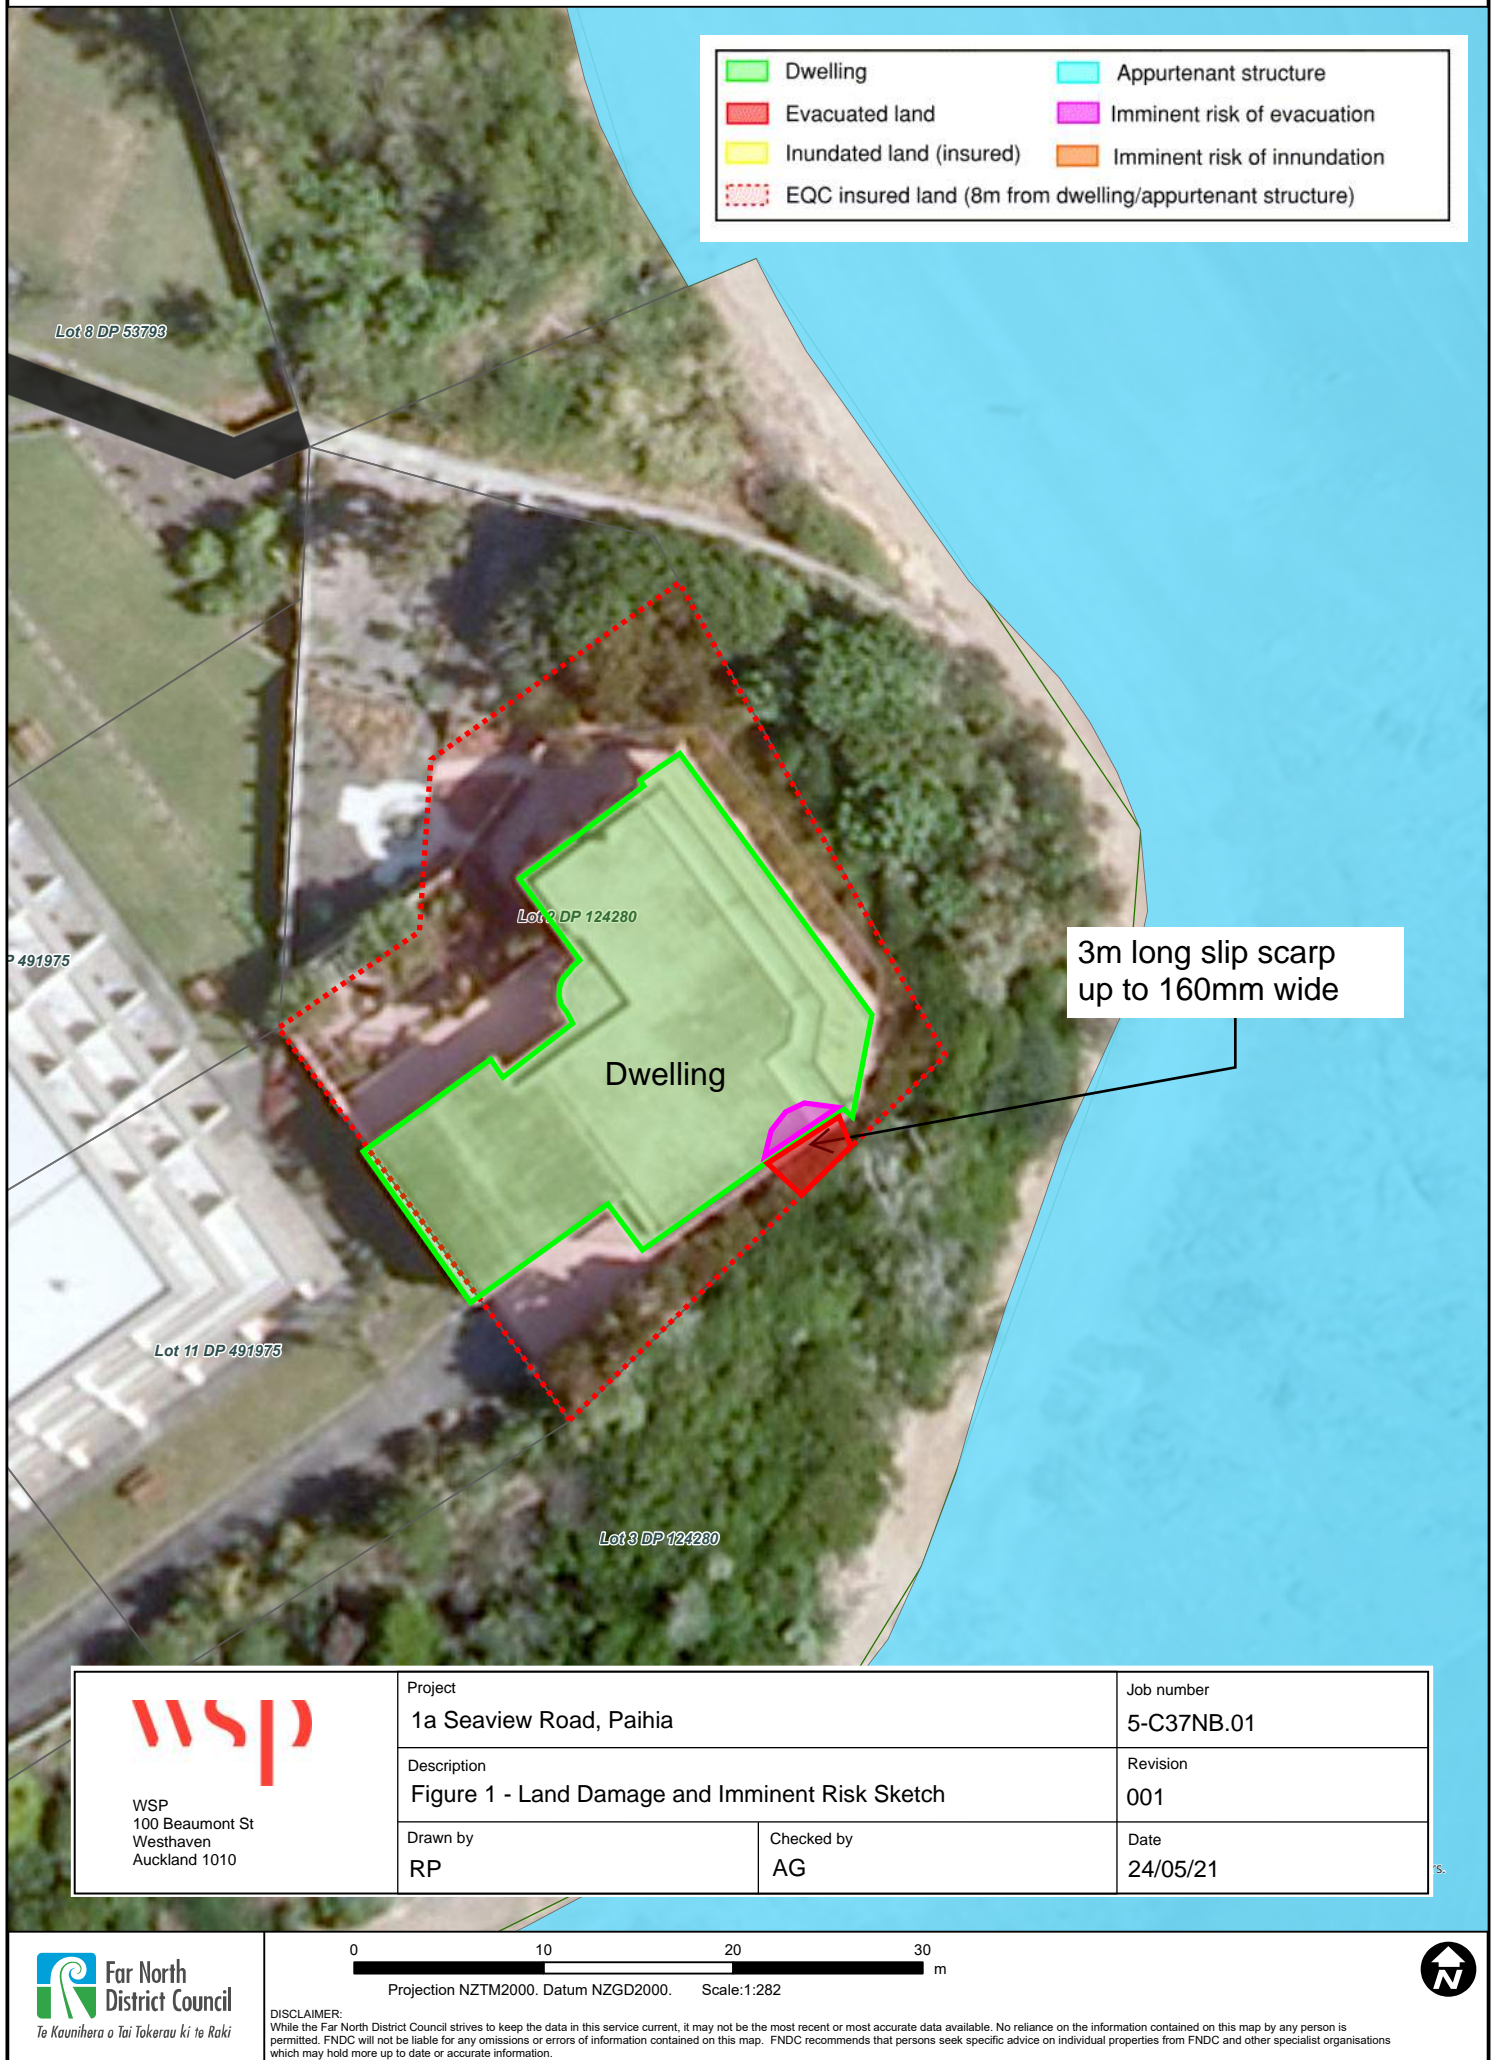
Appendix B Figure 1 shows the land damage location and extent for the site. Figure 2 shows the evacuation in elevation.

We consider that within 12 months (under normal rainfall conditions) and as a direct result of the landslip movement that has occurred there is imminent risk of damage to EQC insured property. Movement is likely to include regression of the slip scarp and damage to the structure due to the unsupported foundations. Appendix B Figure 1 shows the estimated regression. The risk is quantified as:

- Imminent risk of 5.5m<sup>2</sup> (3 m<sup>3</sup>) additional evacuation of insured land.
- Settlement of the beam above the evacuated land, resulting in settlement damage to the room above. The estimated affected floor area is 20m<sup>2</sup>.
