### Unsealed Roding Network Audit

Prepared for Far North District Council

August 2019

Ref L21634a

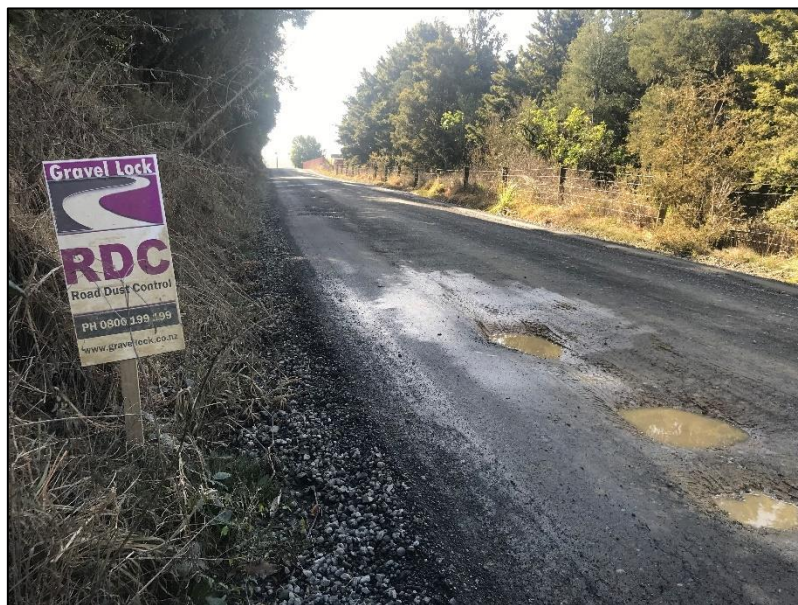
**Figure 6.1 – Orakau Road with Gravel Lock RDC section installed**

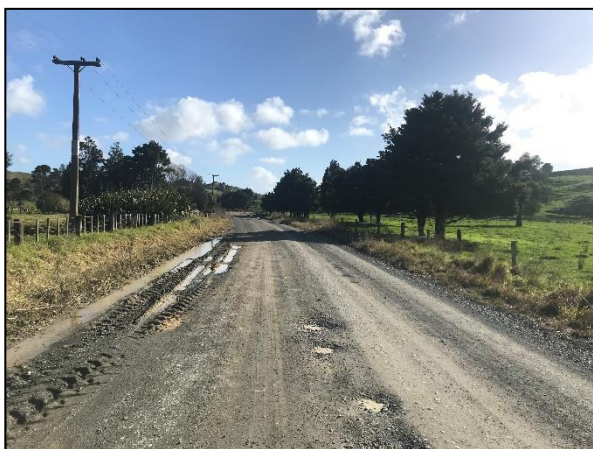
Figure 7.1.1 – Ponding, Shear Failure & Potholing

During the site observation it was noted that all three key elements of roadside drainage, carriageway shape and aggregate thickness were typically poor throughout Orakau Road. Roadside drainage was insufficient with no freeboard available to the pavement, resulting in softening of the subgrade and multiple areas of punching, rutting and shear failures. Crossfall was appropriate in sections, however corner super-elevation was typically inadequate compounding drainage issues and resulting in significant potholing on offside corner approaches. Pavement thickness also appeared to be limited, with numerous areas of exposed subgrade. Recent rain wetted the surface prior to our observation, however it was apparent from roadside deposits and a Gravel Lock trial site that dust is an issue.

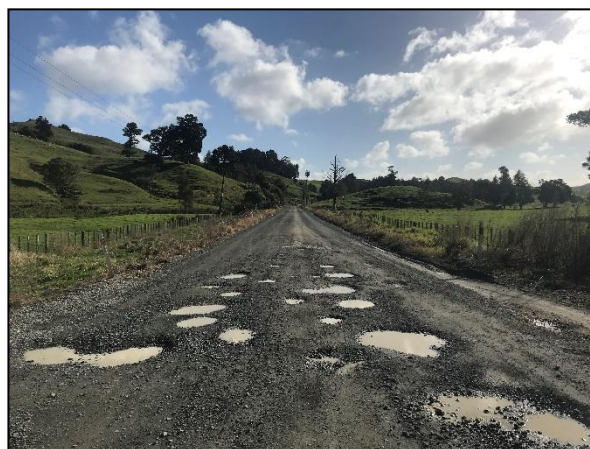
Figure 7.1.2 – Significant Potholing at Bridge Approach

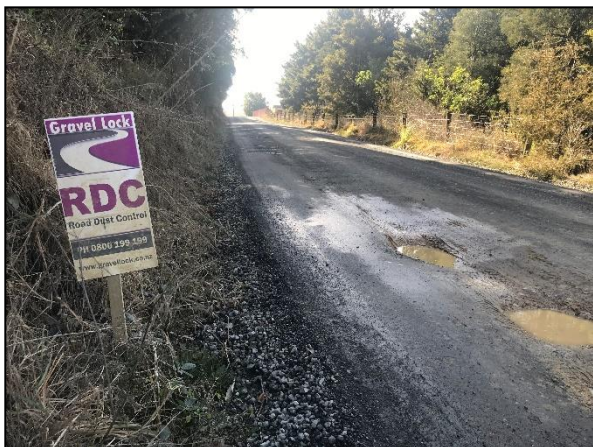
Figure 7.1.3 – Gravel Lock Trial Site Potholing

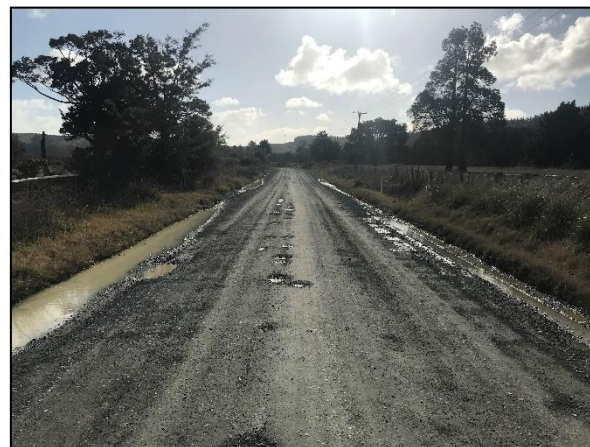
Figure 7.1.4 – Inadequate Drainage

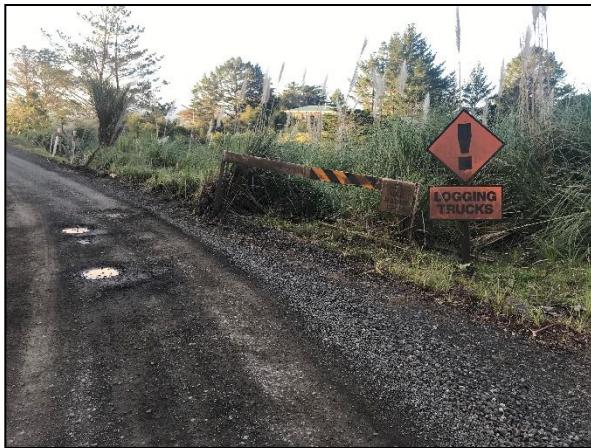
Figure 7.2.1 – Potholing & Logging Signage

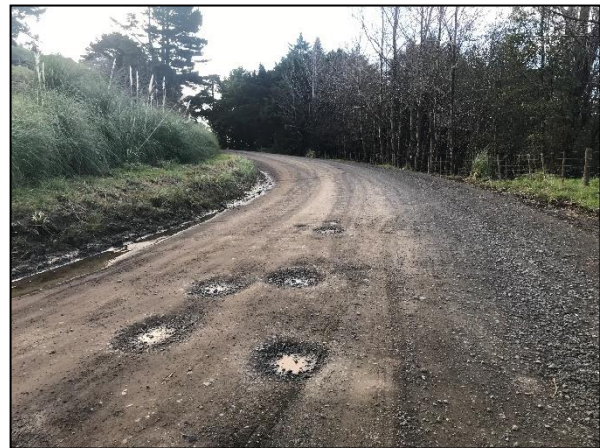
Figure 7.2.2 – Potholing & Ponding on Inside Curve

Observation of the carriageway identified inadequate roadside drainage and sections of poor carriageway shape as the two primary factors contributing the most significantly to Runaruna Roads poor condition. Ponding, corrugating and severe scouring of downhill curves are all the result of inadequate stormwater control and lack of cut-outs to direct run-off away from the carriageway. Areas of ground water seepage were also noted as being uncontrolled.

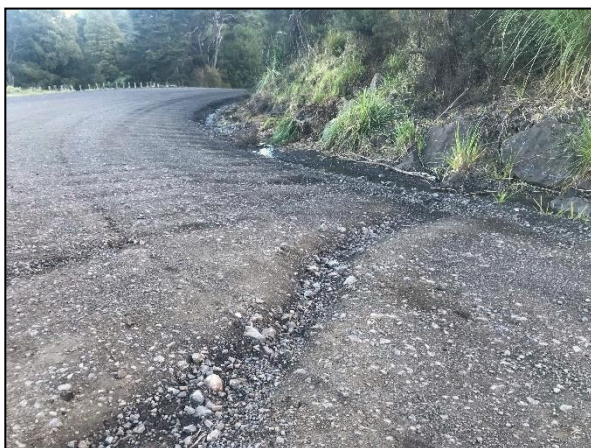
Further to the poor drainage and lack of pavement freeboard, crossfall and corner super-elevation were inappropriate in sections, leading to standing water, weakening pavement layers and ultimately resulting in significant corrugations and potholing on offside corner approaches.

Figure 7.2.3 – Severe Corrugation Causing Scouring

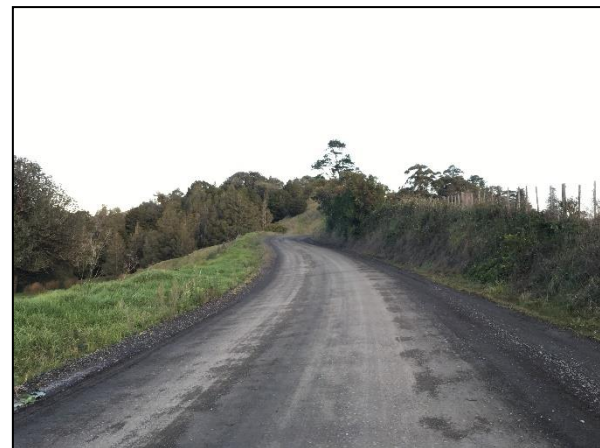
Figure 7.2.4 – Minor Corrugating

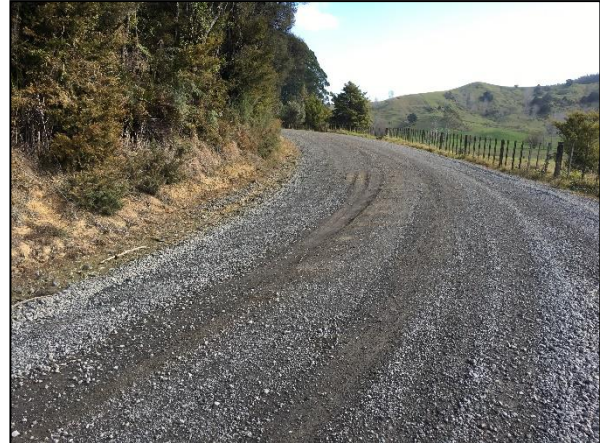
Figure 7.3.2 – Good Superelevation but Limited Drainage

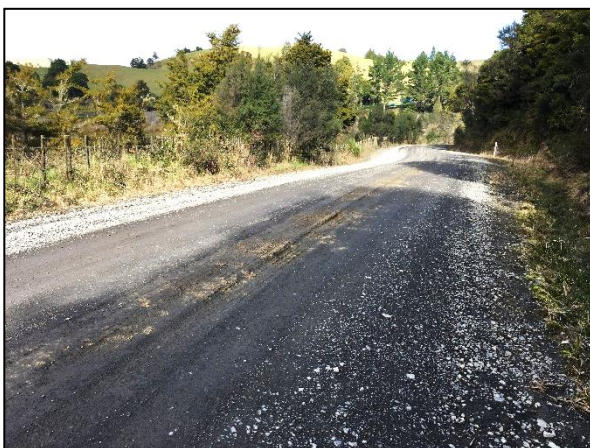
A lack of freeboard results in the wetting of the underlying subgrade which directly affects pavement strength and durability and often leads to subgrade punching and rutting failures seen on site.

Figure 7.3.3 – Exposed Subgrade

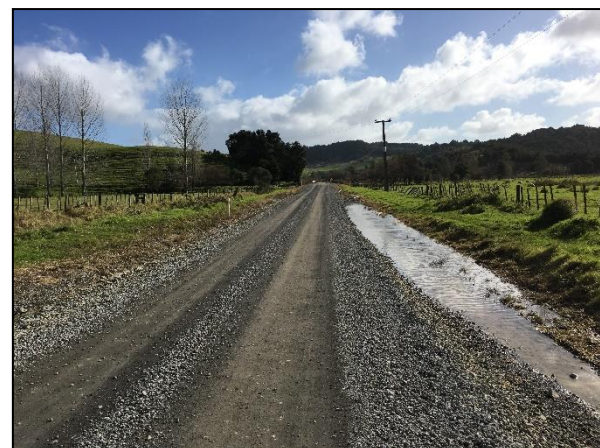
Figure 7.3.4 – Ponding at Carriageway Edge

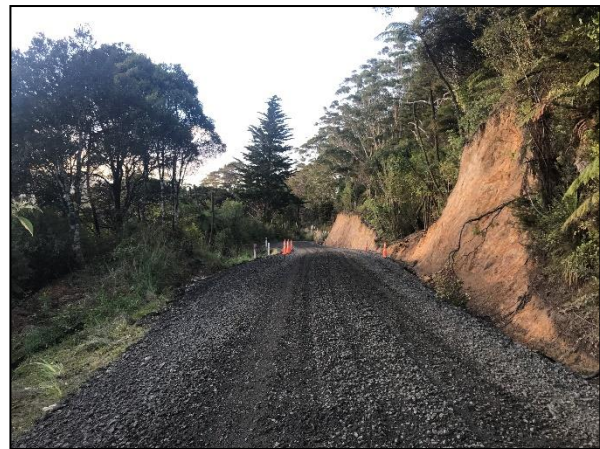
Figure 7.4.2 – Recent Overslip Repair

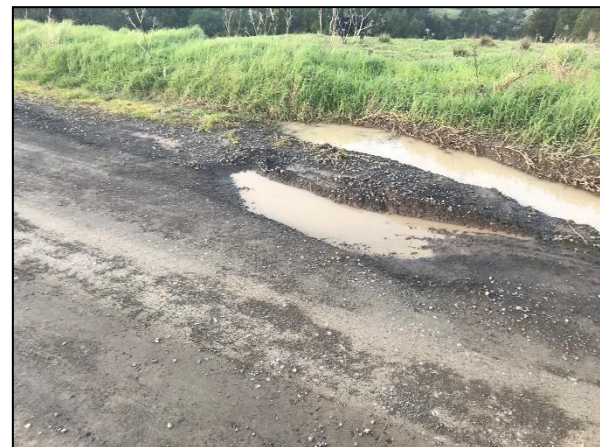
Figure 7.4.4 – Shear Failure at Carriageway Edge

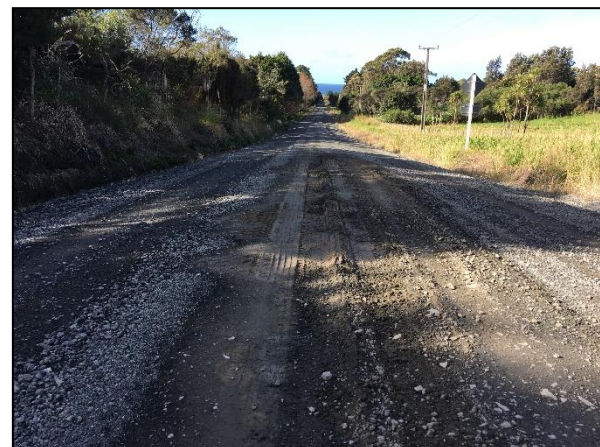
Henderson Bay Road was generally observed to be in good condition with the only defect being an isolated shear failure located at the brow of a rise. At the location of the shear failure the carriageway has been cut through the ridgeline to ease the vertical curve and it is likely that the weaker underlying subsoils have been exposed in this location. Aside from the shear failure, roadside drainage, pavement thickness and carriageway profile were satisfactory throughout the site, with adequate water tables, no other notable surface failures and crossfall and super-elevation typically within specification.

**Figure 7.5.4 – Isolated Section of Exposed Subgrade**

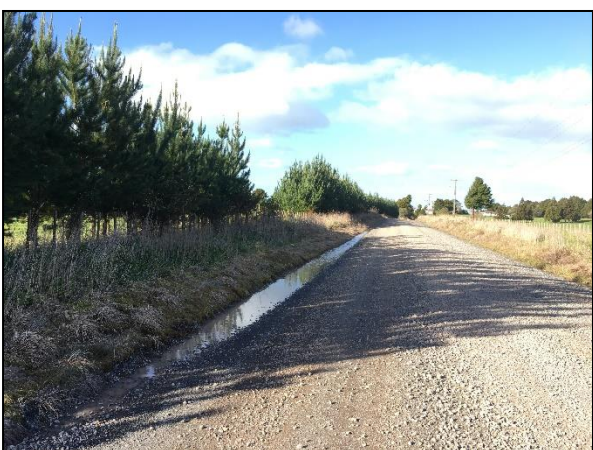
Figure 7.6.3 – Isolated Ponding Through Flats

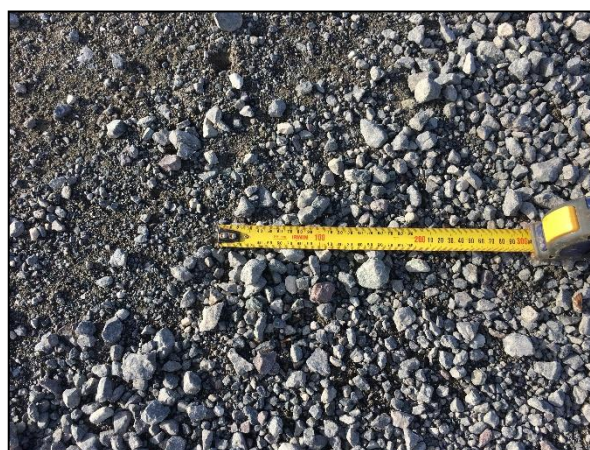
Figure 7.6.4 – Loose, Rounded Aggregates

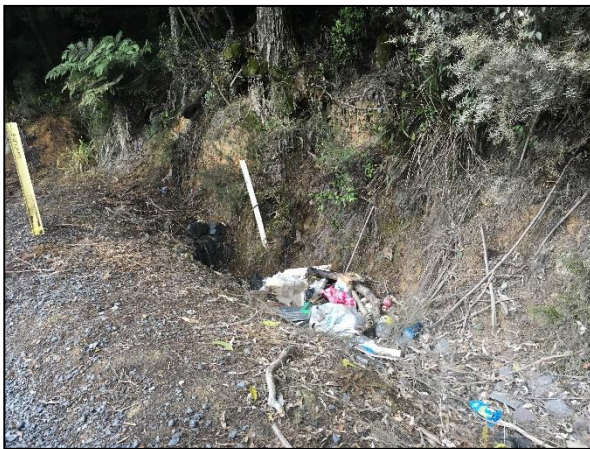
**Figure 8.1 – Waikare Road Inlet Blocked with Debris**

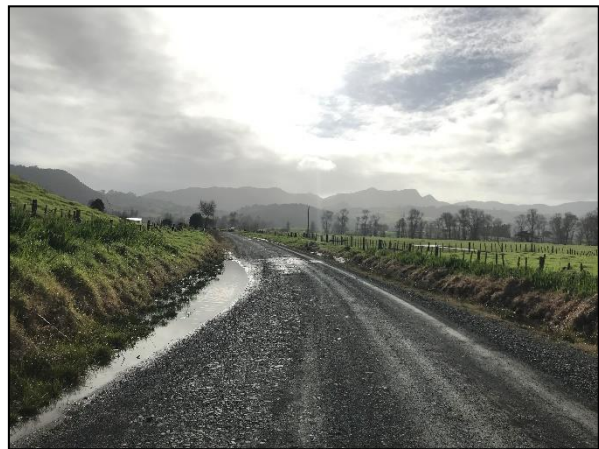
**Figure 8.2 – Waimamaku Beach Road Ponding**

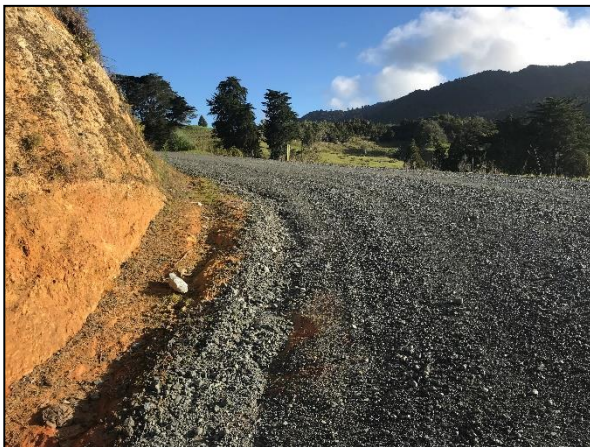
**Figure 8.3 – Diggers Valley Scouring (No Formed Swale)**

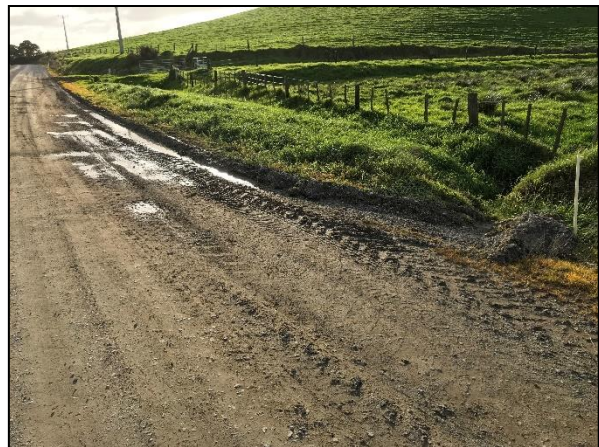
**Figure 8.4 – Martin Road Swallow Ineffective Cut-outs**

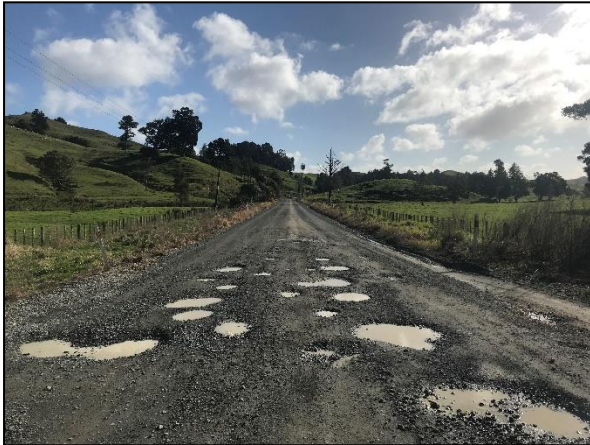
**Figure 8.5 – Orakau Road with minimal crossfall**

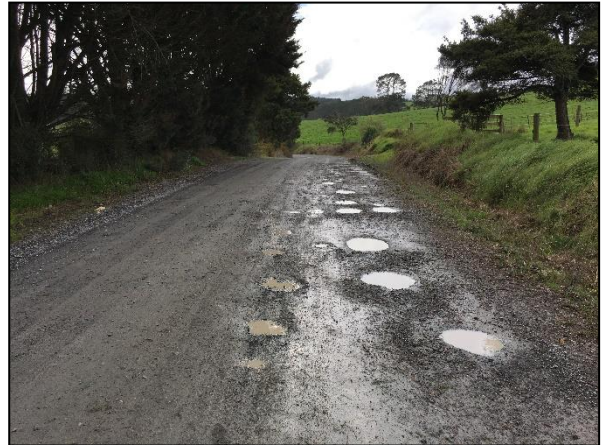
**Figure 8.6 – Tapuhi Road with limited crossfall**

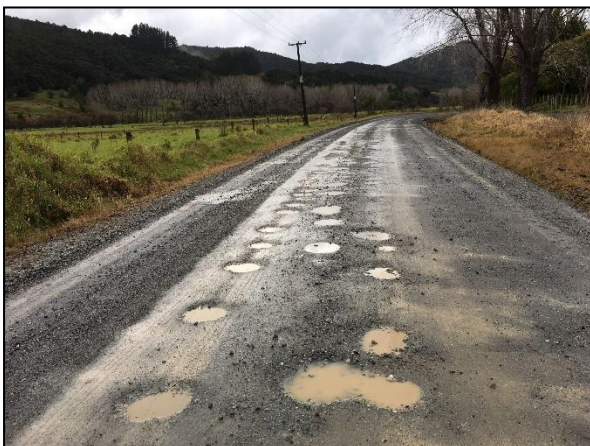
**Figure 8.7 – Horeke Road with minimal crossfall**

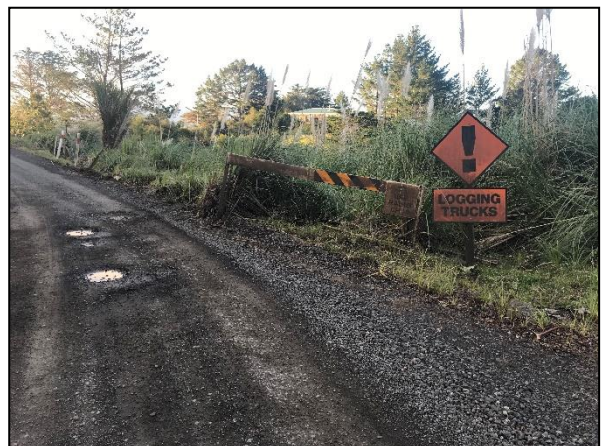
**Figure 8.8 – Runaruna Road with limited super elevation**

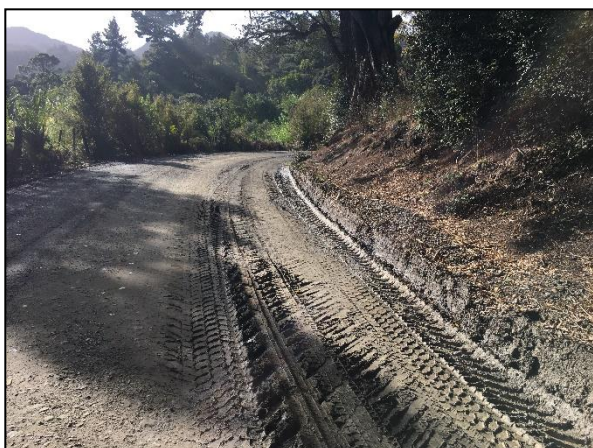
Adequate pavement thickness is key to ensuring the longevity and durability of an unsealed pavement, especially over the plastic clay subgrades beneath much of the Far North Districts network. During our site observations it was noted that small isolated portions of much of the network had areas of exposed subgrade and/or were showing shear failures as a result of inadequate pavement thickness.

**Figure 8.9** – Waitemarama Gorge Road Shear Failure

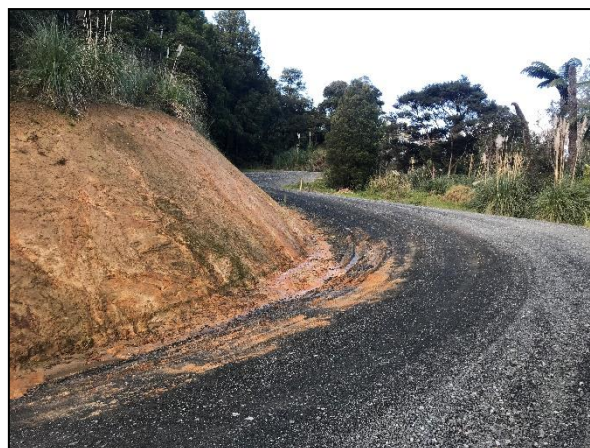
**Figure 8.10** – Diggers Valley Road, Exposed Subgrade

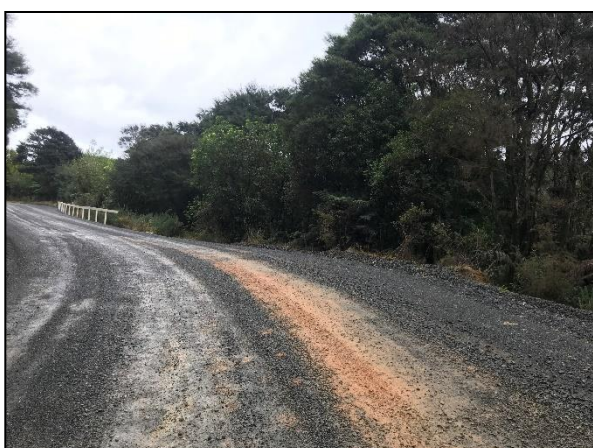
**Figure 8.11** – Waikare Road Exposed Subgrade

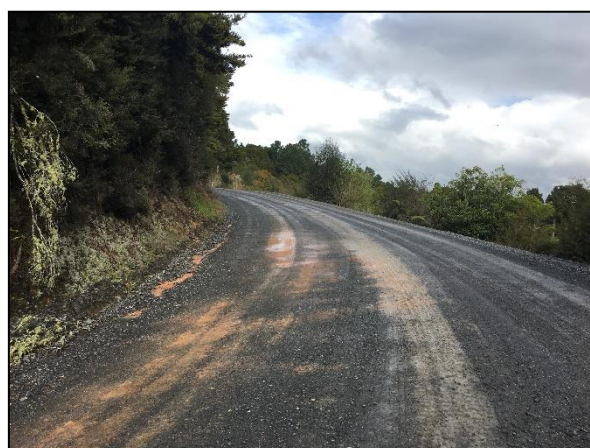
**Figure 8.12** – Tapuhi Road Contaminated Running Course
