Preliminary Present Value End of Life (PVEOL) Analysis			
Network area:	Highway:	RP:	BSN:	Structure name:	Owner:	Far North District Council	
Northland	Kahikatoa Rd	1607		Kahikatoa Road Culvert No. M35	RCA:	Far North District Council	
General Structure Data				PVEOL Questions:	Yes/No	Brief explanation of restrictions	
Year constructed:	Unknown			Is the bridge over 80 year old	No		
One Network Road Classification (ONRC):	Access (low volume)			Is there significant maintenance required in the next 3 years	Yes		
Vehicles per day:	<50			Is the bridge inspected in accordance with NZTA-S6	Yes		
% heavy vehicles:	10.0%			Is the bridge on special inspections	Yes		
Number of Spans	2			Has a live load assessment been carried out based on the known condition	No		
Total Length of Bridge	3.1m			Are there any brittle and/or vulnerable details on the bridge	Yes		
Road width between Kerbs/rails	4m (soffit 6m)			Are there live load or speed restrictions across the bridge	No

Preliminary Present Value End of Life (PVEOL) Analysis			
Network area:	Highway:	RP:	BSN:	Structure name:	Owner:		
Northland	Kahikatoa Rd	1607		Kahikatoa Road Culvert No. M35	RCA:	Far North District Council	
Other general photos

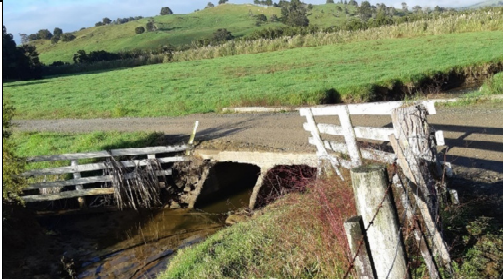
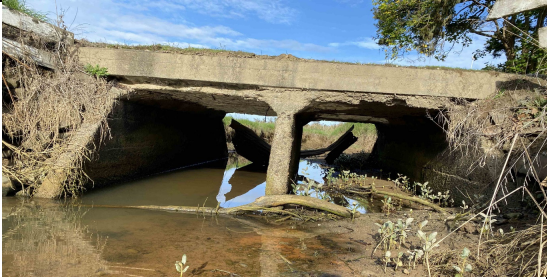
Structure description				Photo from Road Level	Photo of Elevation		
<p>The structure is a twin-barrel reinforced concrete box culvert. Each barrel is 1.2m wide by 1.5m high, and 6m long at the soffit. It is situated on a single lane unsealed road. Both the inlet and outlet of the culvert are un-armoured over their height. The deck is thin with the depth from road level to soffit of approximately 0.5m. No side protection is present.</p>

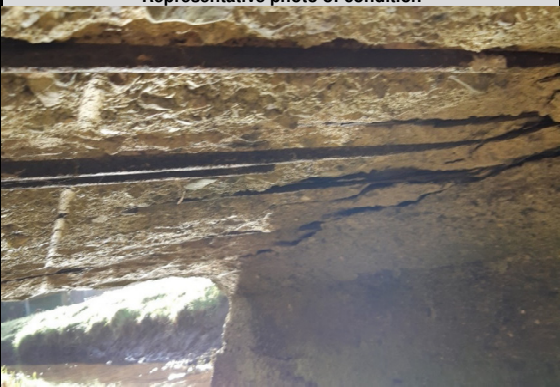
1.)					
		2.)					
		3.)					
		4.)					
Current Condition		Briefly explain the current defects			Representative photo of condition		
Superstructure		Kahikatoa Road culvert M35 is subject to significant spalling in the soffit of the culvert deck slab caused by corrosion of most of the bottom reinforcing in the slab. The majority of the reinforcement in the soffit is exposed. Corrosion is severe in places with some reinforcing bars completely corroded away or failed.

Having considered the condition of the culvert, there is potential that significant, potentially catastrophic failure may occur within 1 to 3 years if maintenance actions or replacement of the structure are not undertaken. The PVEOL analysis over 10 years of asset life gives a 19% (\$38K) saving which shows that the culvert is at the end of its economic life, and therefore the preferable option is to replace the culvert immediately. Due to the deterioration of the structure, the culvert is also effectively at the end of its useful life and will require replacement in the short to medium term, irrespective of any maintenance works level chosen.

1.) Repair the culvert through extensive repair of existing reinforcement, and lap welding of new reinforcement, together with significant concrete repairs	2021	\$75

2.) General Maintenance	2026	\$25			
		3.) Replace Structure	2031	\$175			
		4.)					
Current Condition		Briefly explain the current defects			Representative photo of condition		
Substructure		N/A					
		Maintenance Interventions Required	Year	Cost (\$k)
