<b>Preliminary Present Value End of Life (PVEOL) Analysis</b>			
<b>Network area:</b>	<b>Highway:</b>	<b>RP:</b>	<b>BSN:</b>	<b>Structure name:</b>	<b>Owner:</b>	Far North District Council	
Northland	Puhata Rd	2162		<b>Puhata Road Bridge No. D50</b>	<b>RCA:</b>	Far North District Council	
<b>General Structure Data</b>				<b>PVEOL Questions:</b>	<b>Yes/No</b>	<b>Brief explanation of restrictions</b>	
<b>Year constructed:</b>	1950			Is the bridge over 80 year old	No	The bridge is in an extremely poor condition and posted accordingly at 30% of class one, 7000kg axle limits and speed restrictions of 10km/hr.	
<b>One Network Road Classification (ONRC):</b>	Access (low volume)			Is there significant maintenance required in the next 3 years	Yes		
<b>Vehicles per day:</b>	<50			Is the bridge inspected in accordance with NZTA-S6	Yes		
<b>% heavy vehicles:</b>	10.0%			Is the bridge on special inspections	Yes

<b>Preliminary Present Value End of Life (PVEOL) Analysis</b>			
Network area:	Highway:	RP:	BSN:	Structure name:	Owner:	Far North District Council	
Northland	Puhata Rd	2162		Puhata Road Bridge No. D50	RCA:	Far North District Council

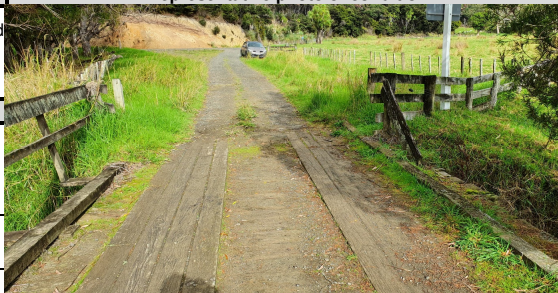
<b>Parapets / Barriers / Surfacing</b>	The deck is in a heavily deteriorated state. Timber elements are heavily worn, and spongy when wet. Railings are only present on one side. These are in a rotten state.

1.) Install new handrails		2021	\$15			
	2.) Replace severely worn portions of deck		2021	\$15			
	3.) Replace severely worn portions of deck		2026	\$15

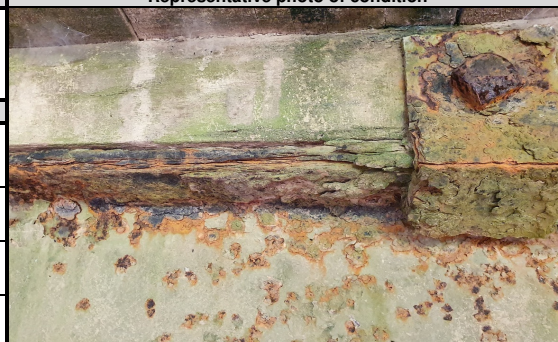
4.)							
<b>Current Condition</b>	<b>Briefly explain the current defects</b>				<b>Representative photo of condition</b>		
<b>Superstructure</b>	The steel beams have significant corrosion and section loss across most of the beams. Due to the ends of the beams being covered in layers of mud for a significant period, the beam ends are severely corroded at bearing positions.

1.) Repair/strengthen existing beams		2021	\$30			
	2.) Replace superstructure		2031	\$125			
	3.)						
4.)							
<b>Current Condition</b>	<b>Briefly explain the current defects</b>				<b>Representative photo of condition</b>		
<b>Substructure</b>	As noted in the structure description, on inspection, no abutments were identified. The structure is founded on wooden planks in-ground. The adjacent picture shows the end of one of the beams when exposed from behind. End fixity is non-existent.
