Preliminary Present Value End of Life (PVEOL) Analysis			
Network area:	Highway:	RP:	BSN:	Structure name:	Owner:	Far North District Council	
Northland	Kaitaia - Awaroa Road	23729		Kaitaia-Awaroa Culvert No. D41	RCA:	Far North District Council	
General Structure Data				PVEOL Questions:	Yes/No	Brief explanation of restrictions	
Year constructed:	1975			Is the bridge over 80 year old	No		
One Network Road Classification (ONRC):	Primary Collector			Is there significant maintenance required in the next 3 years	Yes		
Vehicles per day:	487			Is the bridge inspected in accordance with NZTA-S6	Yes		
% heavy vehicles:	10.0%			Is the bridge on special inspections	Yes		
Number of Spans	1			Has a live load assessment been carried out based on the known condition	No		
Total Length of Bridge	2.5m (diameter)			Are there any brittle and/or vulnerable details on the bridge	Yes		
Road width between Kerbs/rails	11m (at soffit level), 15m (at invert)			Are there live load or speed restrictions across the bridge	No

Network area:	Highway:	RP:	BSN:	Structure name:	Owner:	Far North District Council
Northland	Kaitaia - Awaroa Road	23729		Kaitaia-Awaroa Culvert No. D41	RCA:	Far North District Council

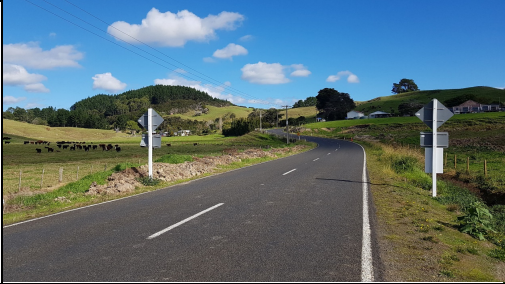
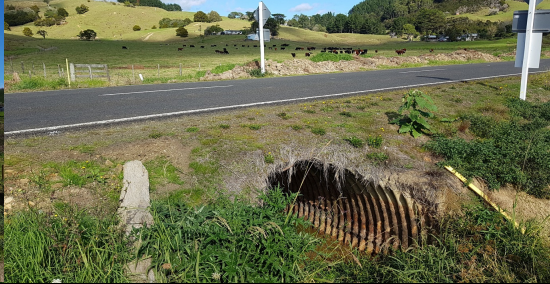
Structure description				Photo from Road Level	Photo of Elevation		
Kaitaia-Awaroa Road culvert D41 is a corrugated steel pipe that is 2.5m in diameter and is approximately 11 m long at soffit level and is 15m long at invert level. It is situated on a two-lane sealed road. Prior to draining, the majority of the culvert was permanently submerged. Both the inlet and outlet of the culvert are un-armoured. The depth of fill over the culvert is approximately 0.5m. No barriers are present.

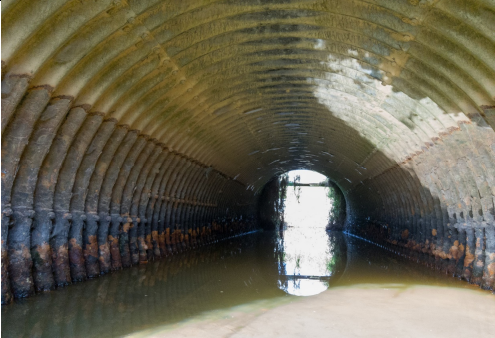
1.)					
		2.)					
		3.)					
		4.)					
Current Condition		Briefly explain the current defects			Representative photo of condition		
Superstructure		The culvert is heavily corroded with severe corrosion and flaking of the steel structure along its entire length. The corrosion covers approximately 60-70% of the internal area of the culvert and above mid height (the vertical return point) of the culvert on both sides. The flaking is very severe in the bottom third of the culvert.

1.) Repair the culvert by welding on new steel reinforcing and placing of extensive concrete lining if possible and permitted by Resource Consent.	2021	\$125

2.) General maintenance	2026	\$25			
		3.) Replace the culvert	2031	\$275			
Current Condition		Briefly explain the current defects			Representative photo of condition		
Substructure							
		Maintenance Interventions Required	Year	Cost (\$k)

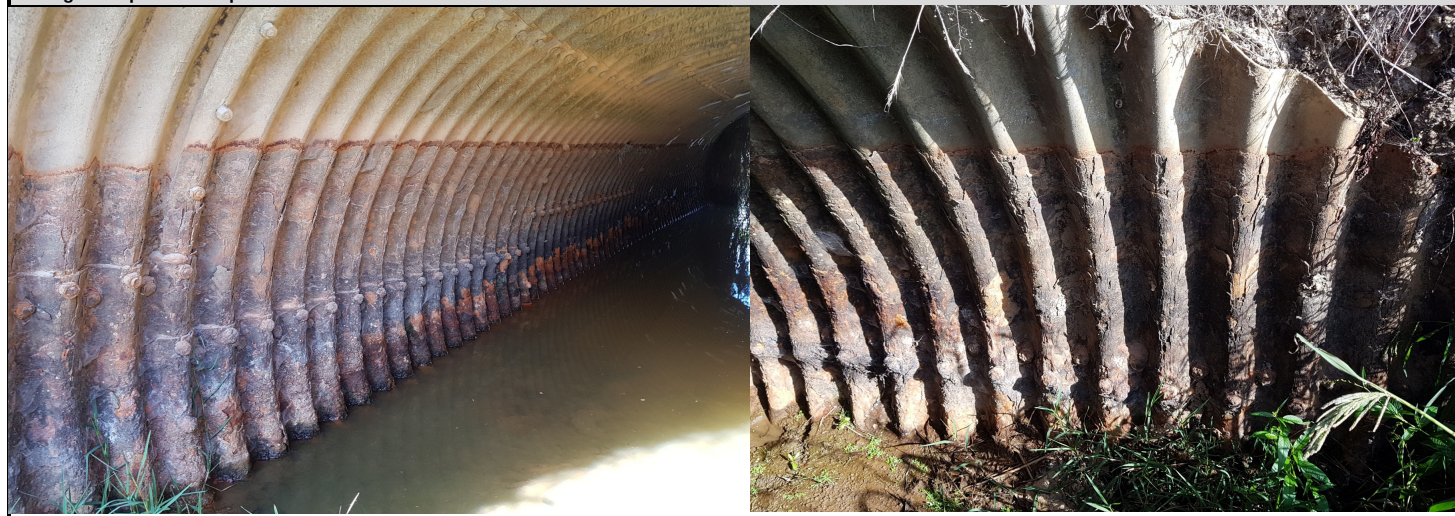
Other general photos to represent current condition
