# Asbestos Demolition Survey

**Address:** Te Pua Rd Paua

Samples taken: 14-02-2019.  
Issued date: 19-02.2019

Momentum Services was commissioned to conduct an Asbestos Demolition Survey for the **Far North District Council** of the Fertilizer shed structure at **Te Pua Rd Paua**.

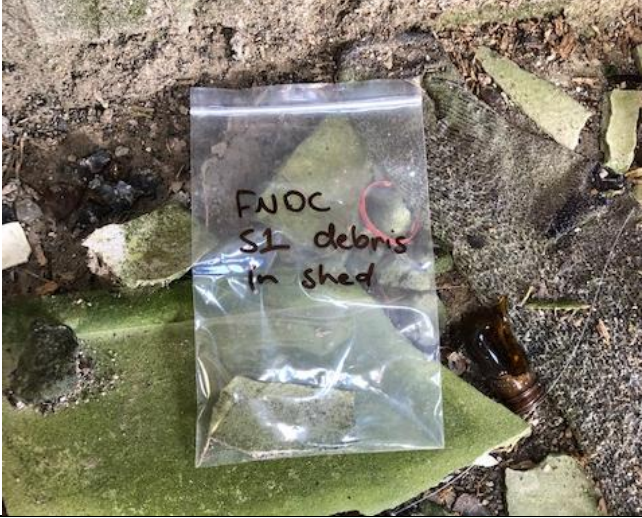
| Sample number | Sample 1 - 001 | Accessibility | Easy (1) |
|---|---|---|---|
| Quantity | Approximately 350M2 | Condition | Poor |
| Area / Location | Debris in shed | Item / Material | Dust and Debris |
| Material risk no | 6 | Analysis | Positive |

| Sample number | Sample 1 - 001 | Accessibility | Easy (1) |
|---|---|---|---|
| | | <p>A control plan needs to be developed for its removal by a suitably qualified contractor.</p> | |

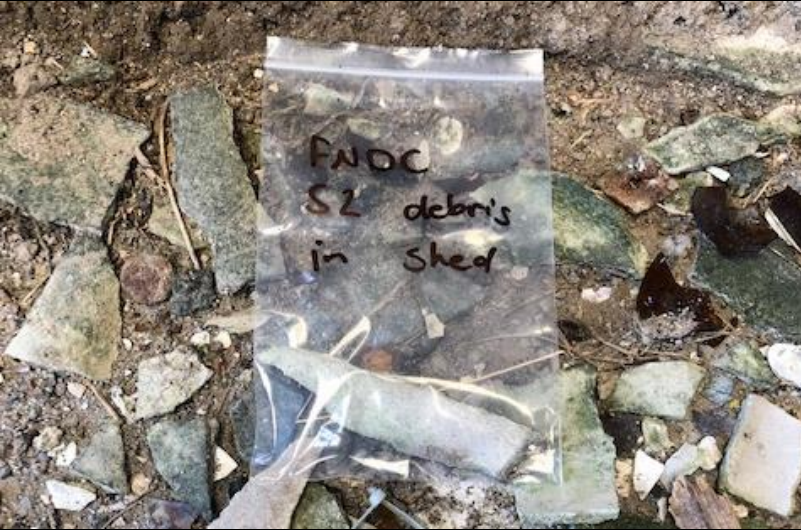
| Sample number | Sample 2 - 002 | Accessibility | Easy (1) |

| Sample number | Sample 2 - 002 | Accessibility | Easy (1) |
|---|---|---|---|
| Quantity | Approximately 350 M2 | Condition | Poor |
| Area / Location | Debris in shed | Item / Material | Dust and debris |
| Material risk no | 6 | Analysis | Positive |

| Sample number | Sample 2 - 002 | Accessibility | Easy (1) |
|---|---|---|---|
| | | <p>A control plan needs to be developed for its removal by a suitably qualified contractor.</p> | |

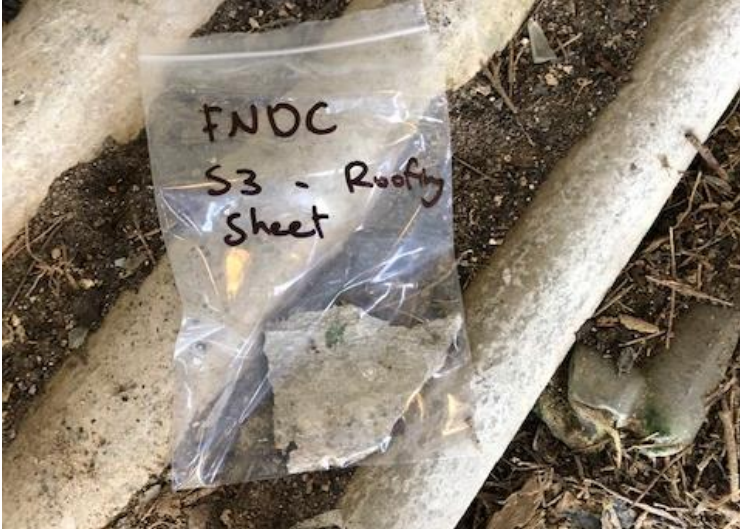
| Sample number | Sample 3 - 003 | Accessibility | Easy (1) |

| Quantity | Approximately 300 M2 | Condition | Good |
| Area / Location | Roof Sheeting | Item / Material | Cement Sheet |
| Material risk no | 6 | Analysis | Positive |

| | | <p>A control plan needs to be developed for its removal by a suitably qualified contractor.</p> | |

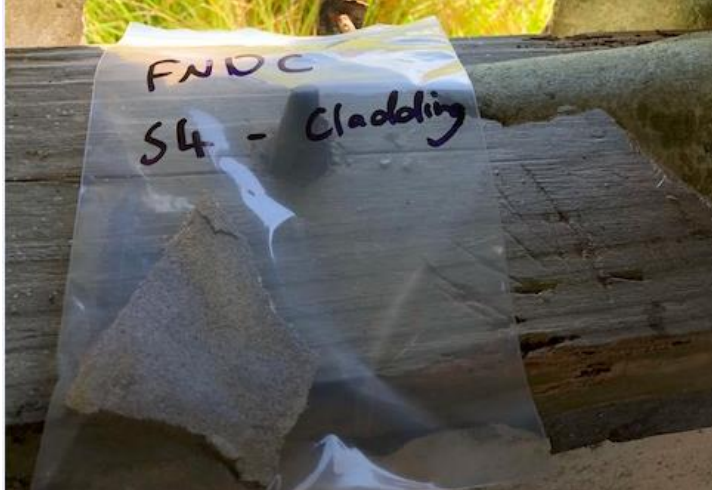
| Sample number | Sample 4 - 004 | Accessibility | Easy (1) |

| Quantity | Approximately 120 M2 | Condition | Good |
| Area / Location | Cladding | Item / Material | Cement Sheet |
| Material risk no | 6 | Analysis | Positive |

| | | <p>A control plan needs to be developed for its removal by a suitably qualified contractor.</p> | |

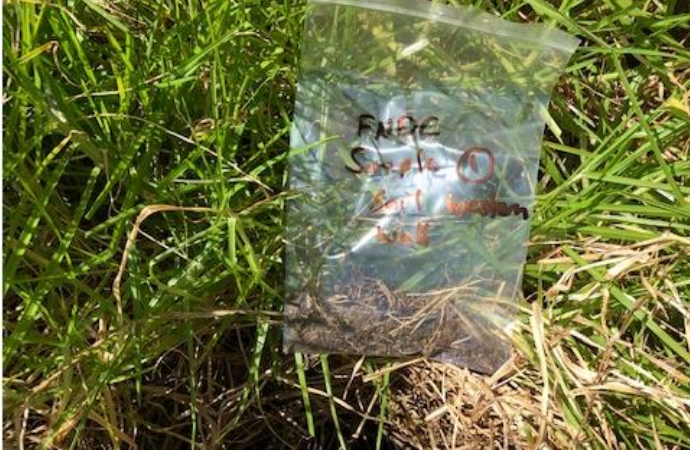
| Quantity | Approximately M2 | Condition | Poor |
| Area / Location | Western Wall | Item / Material | Soil |
| Material risk no | 0 | Analysis | Negative |

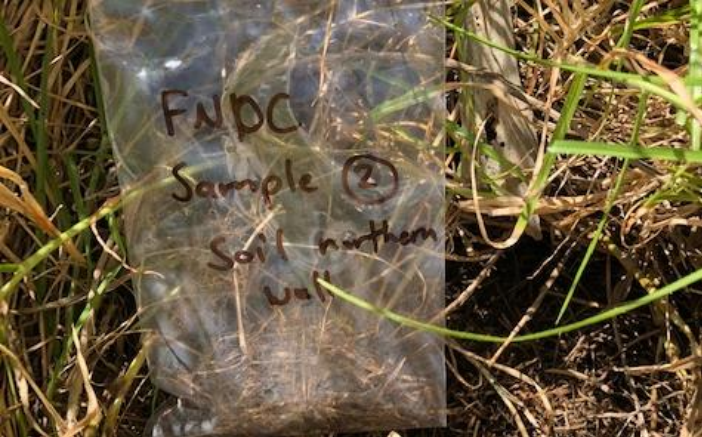
| Sample number | Sample 2 – 00S | Accessibility | Easy (1) |

| Quantity | Approximately M2 | Condition | Poor |
| Area / Location | Northern Wall | Item / Material | Soil |
| Material risk no | 0 | Analysis | Negative |

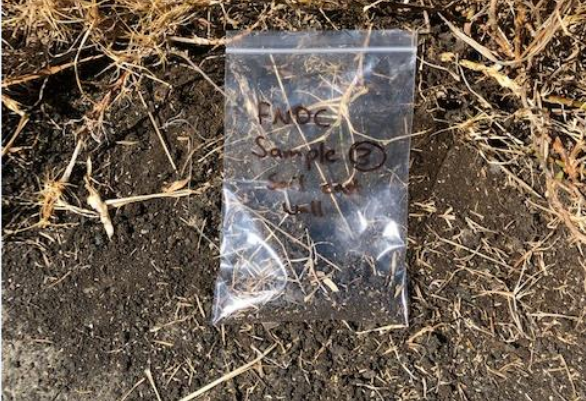
| Sample number | Sample 3 - 00S | Accessibility | Easy (1) |

| Quantity | Approximately M2 | Condition | Poor |
| Area / Location | Eastern wall | Item / Material | Soil |
| Material risk no | 0 | Analysis | Negative |

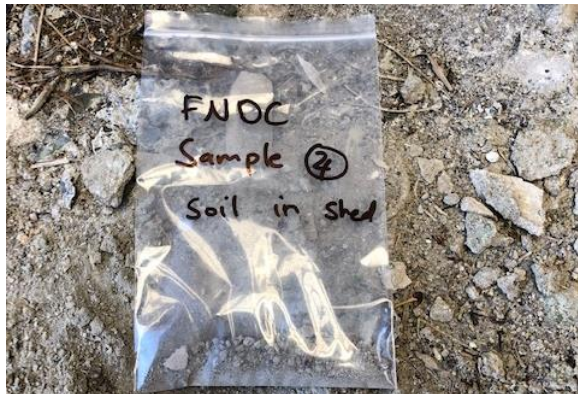
| Sample number | Sample 4 - 00S | Accessibility | Easy (1) |

| Quantity | Approximately M2 | Condition | Poor |
| Area / Location | In Shed | Item / Material | Soil |
| Material risk no | 6 | Analysis | Positive |

| | | Surveyor comments | A control plan needs to be developed for its removal by a suitably qualified contractor. |

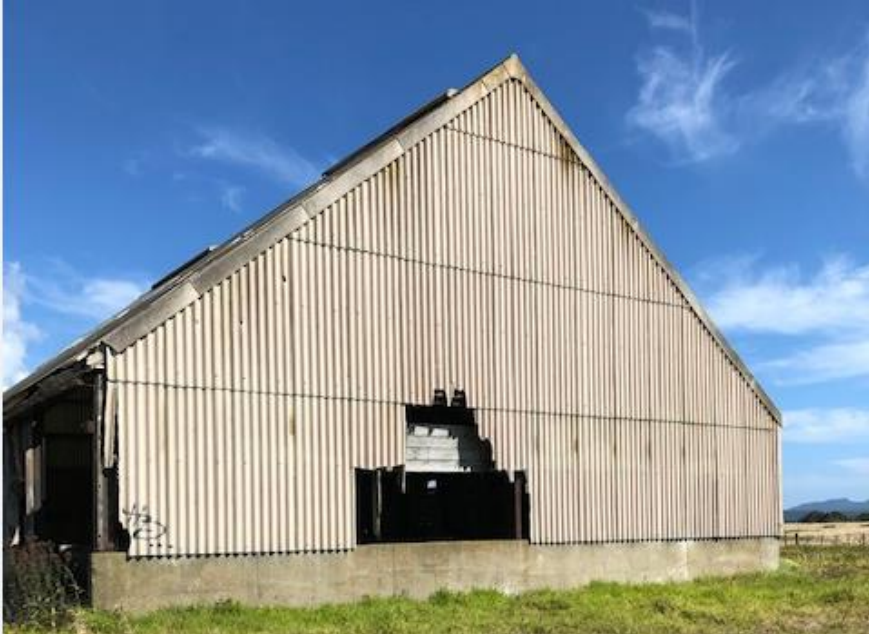
| Image number | 001 |

| <p><b>Surveyor comments</b></p> <p>All cement sheet tested positive for Asbestos. A control plan needs to be developed for its removal by a suitably qualified contractor.</p> | |

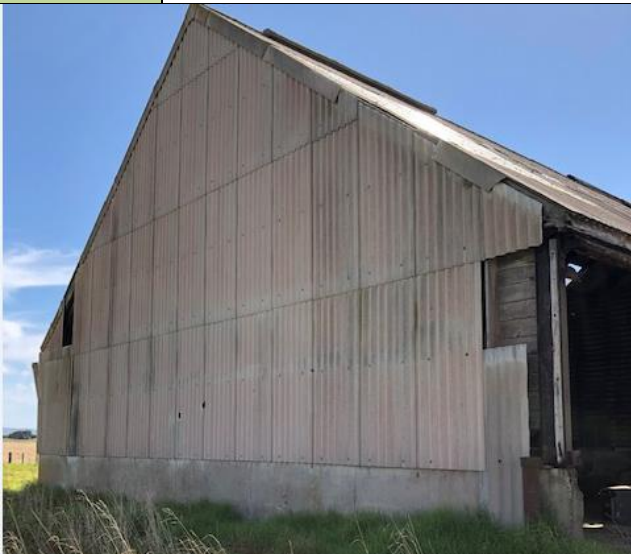
| Image number | 002 |

| <p><b>Surveyor comments</b></p> <p>All cement sheet tested positive for Asbestos. A control plan needs to be developed for its removal by a suitably qualified contractor.</p> | |

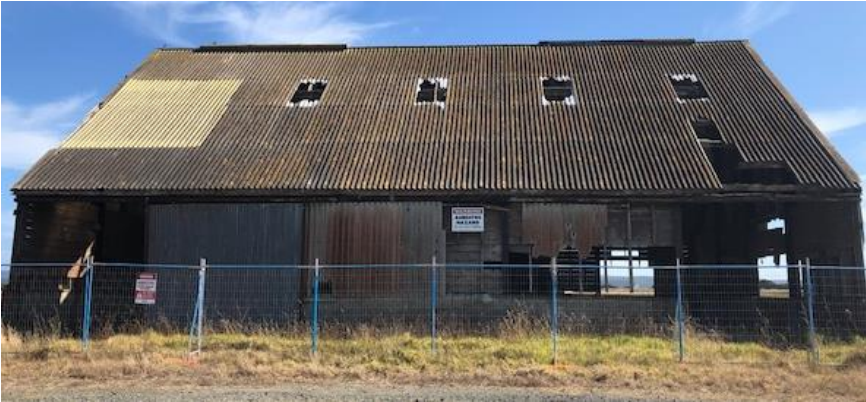
| Image number | 003 | Surveyor comments |

| | | <p>All cement sheet tested positive for Asbestos.<br/>A control plan needs to be developed for its removal by a suitably qualified contractor.</p> |

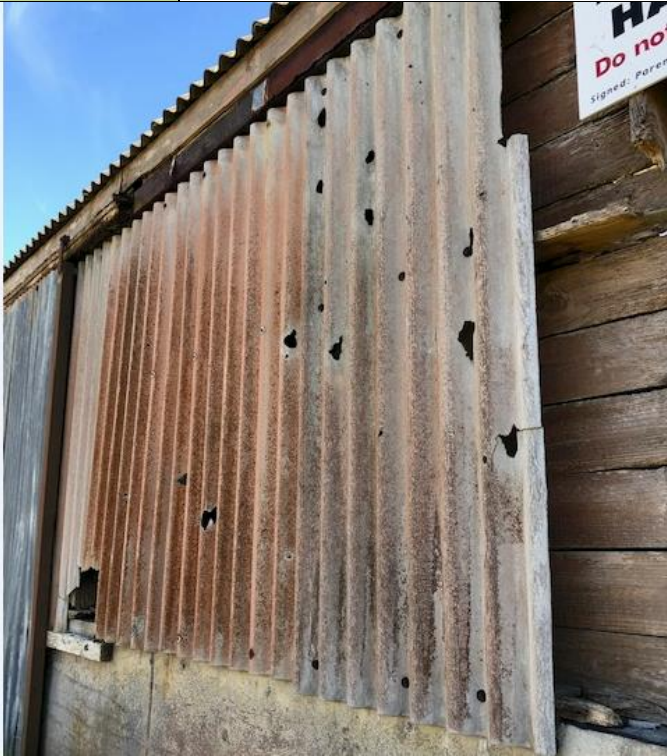
| | | <p>All cement sheet tested positive for Asbestos.<br/>This is a typical close up of the cement sheets condition.<br/>A control plan needs to be developed for its removal by a suitably qualified contractor.</p> |

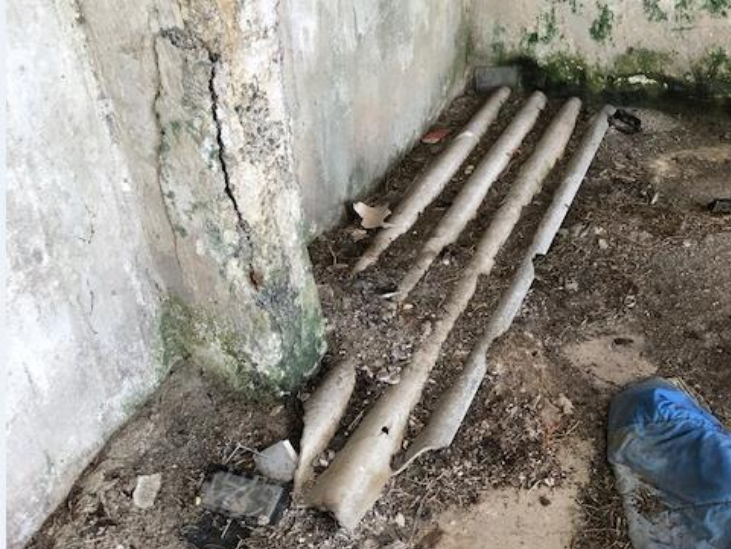
| | <p>All cement sheet tested positive for Asbestos.<br/>The debris on the interior of the building is extensive and in very poor condition.<br/>A control plan needs to be developed for its removal by a suitably qualified contractor.</p> |

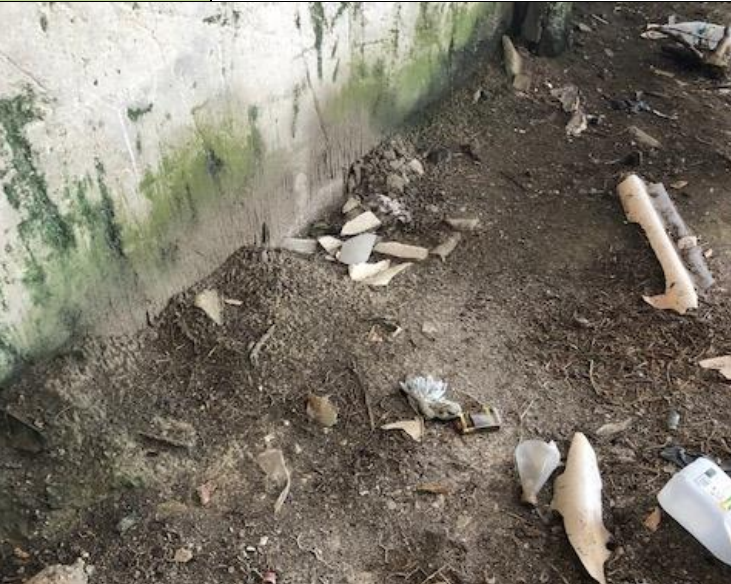
| Image number | 006 |

| | <p>All cement sheet tested positive for Asbestos.<br/>A control plan needs to be developed for its removal by a suitably qualified contractor.</p> |

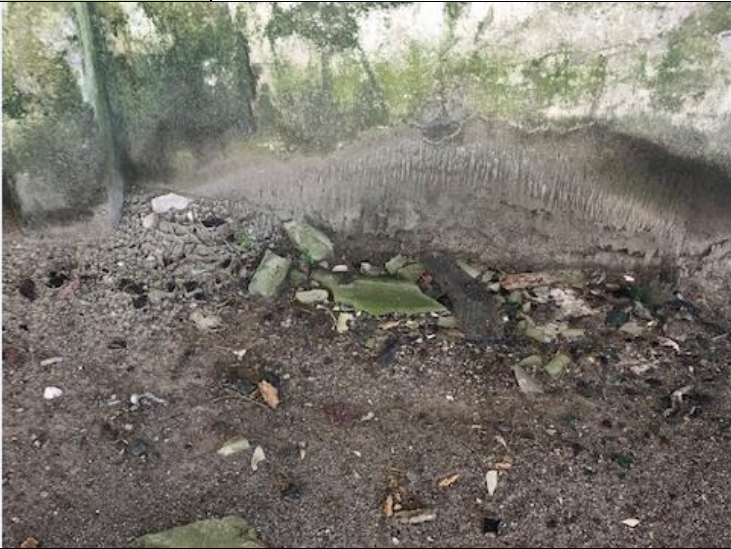
| Image number | 007 |

| | <p>All cement sheet tested positive for Asbestos.<br/>The contamination on the interior is extensive .<br/>A control plan needs to be developed for its removal by a suitably qualified contractor.</p> |

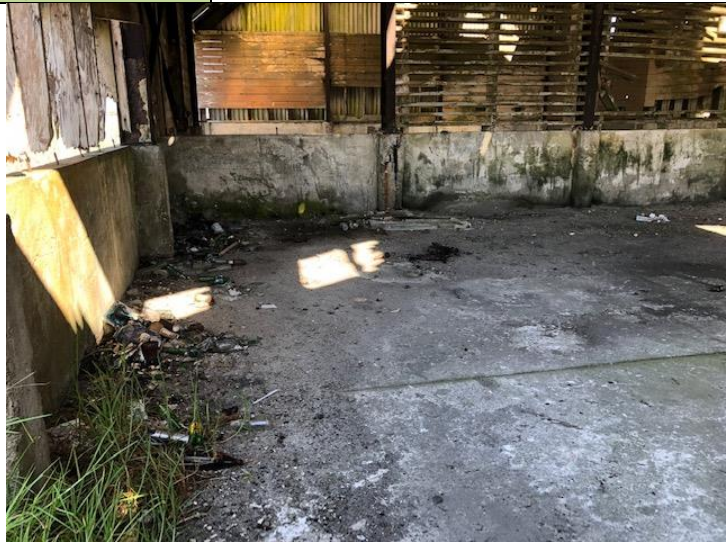
| Image number | 008 |

| | <p>All cement sheet tested positive for Asbestos.<br/>A control plan needs to be developed for its removal by a suitably qualified contractor.</p> |

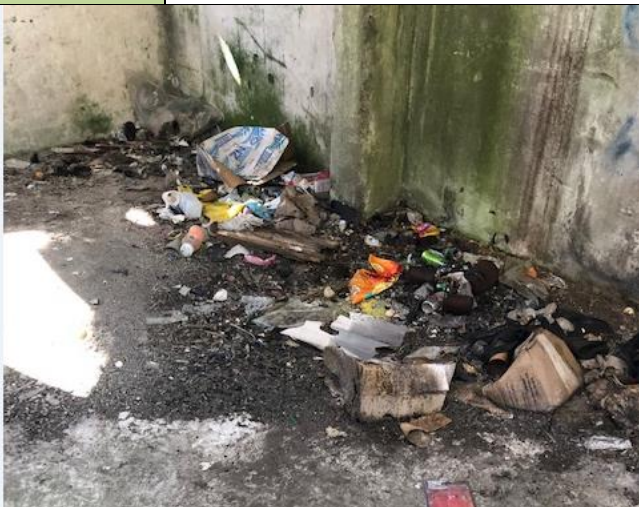
| | | | <p>All cement sheet tested positive for Asbestos.</p> <p>All rubbish is to be treated as contaminated.</p> <p>A control plan needs to be developed for its removal by a suitably qualified contractor.</p> |

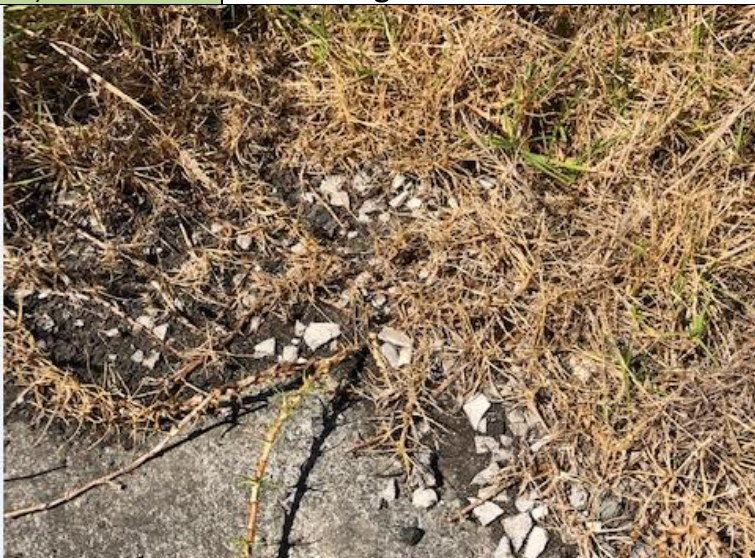
| | | | <p>The soil in the surrounding area is littered with cement sheet.</p> <p>As we have positive lab results for cement sheet, we should Strongly Presume all cement sheet product to contain Asbestos. A control plan needs to be developed for its removal by a suitably qualified contractor.</p> |

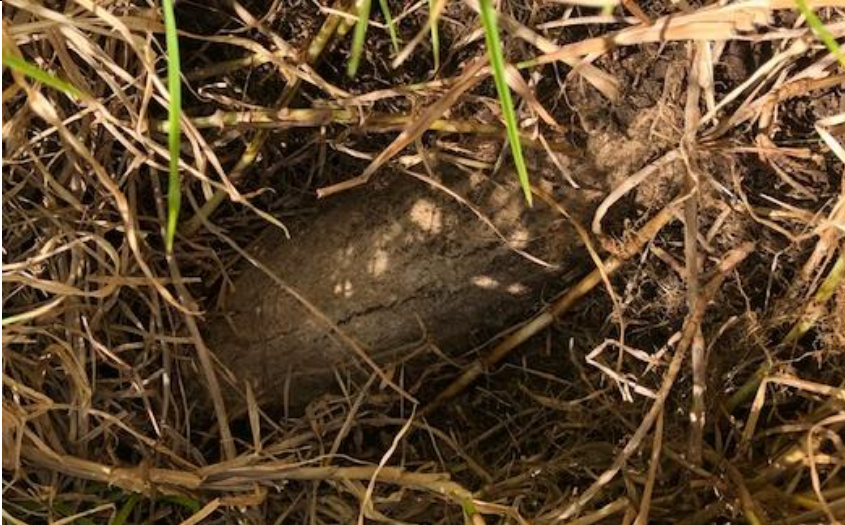
| | | <p>The grass in the surrounding area is littered with cement sheet.</p> <p>As we have positive lab results for cement sheet, we should Strongly Presume all cement sheet product to contain Asbestos. A control plan needs to be developed for its removal by a suitably qualified contractor.</p> |

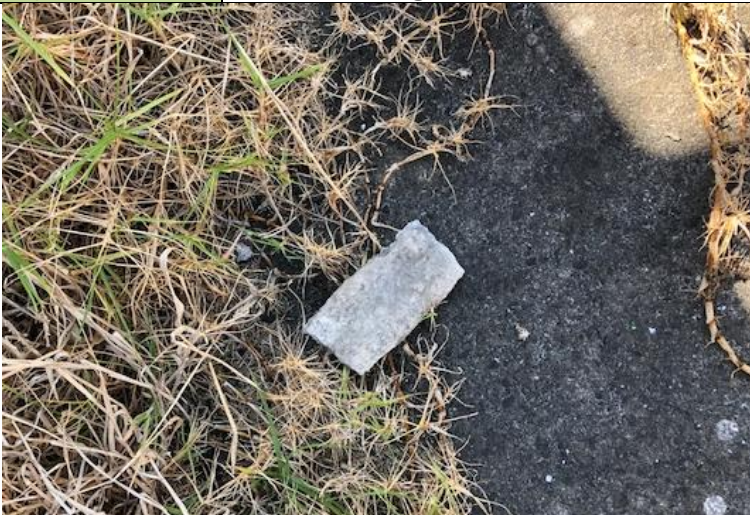
| | | <p>The soil in the surrounding area is littered with cement sheet.</p> <p>As we have positive lab results for cement sheet, we should Strongly Presume all cement sheet product to contain Asbestos. A control plan needs to be developed for its removal by a suitably qualified contractor.</p> |

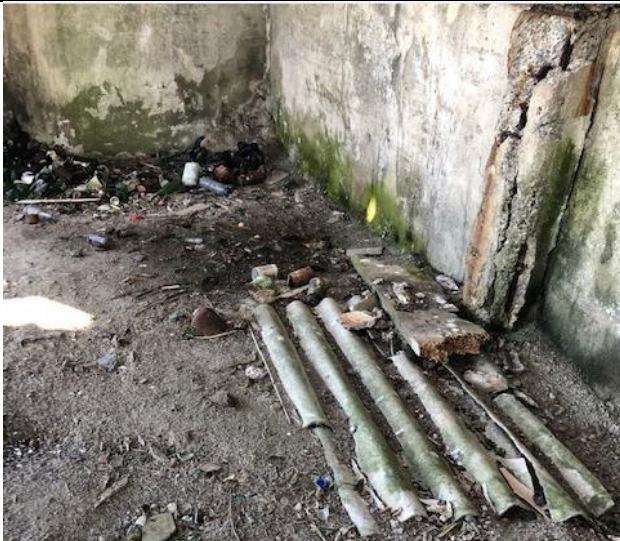
| | | <p>The soil in the surrounding area is littered with cement sheet.</p> <p>As we have positive lab results for cement sheet, we should Strongly Presume all cement sheet product to contain Asbestos. A control plan needs to be developed for its removal by a suitably qualified contractor.</p> |

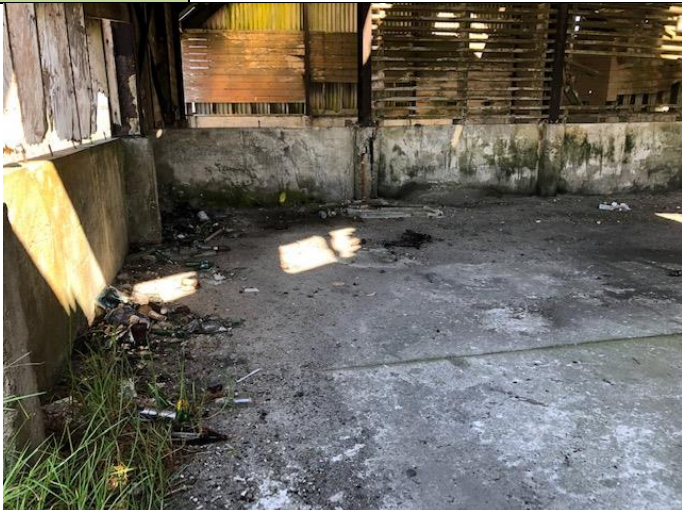
| | | <p>All cement sheet tested positive for Asbestos.</p> <p>All rubbish is to be treated as contaminated.</p> <p>A control plan needs to be developed for its removal by a suitably qualified contractor.</p> |

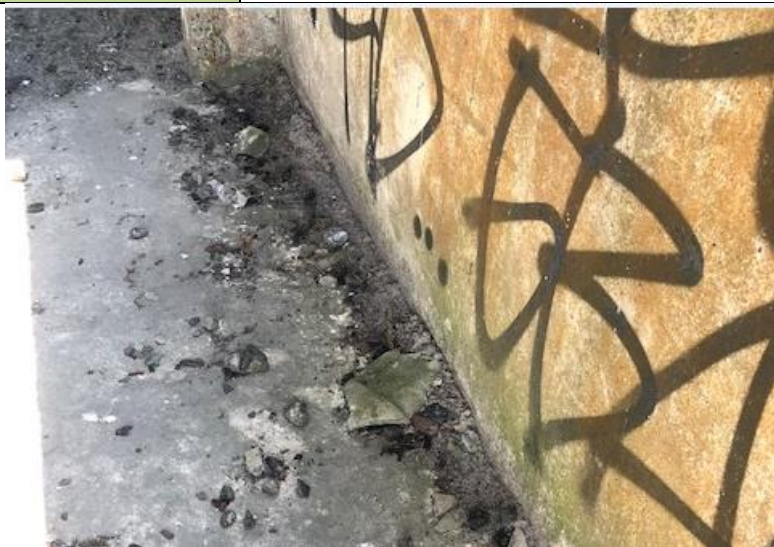
| | | <p>All cement sheet tested positive for Asbestos.</p> <p>All rubbish is to be treated as contaminated.</p> <p>A control plan needs to be developed for its removal by a suitably qualified contractor.</p> |

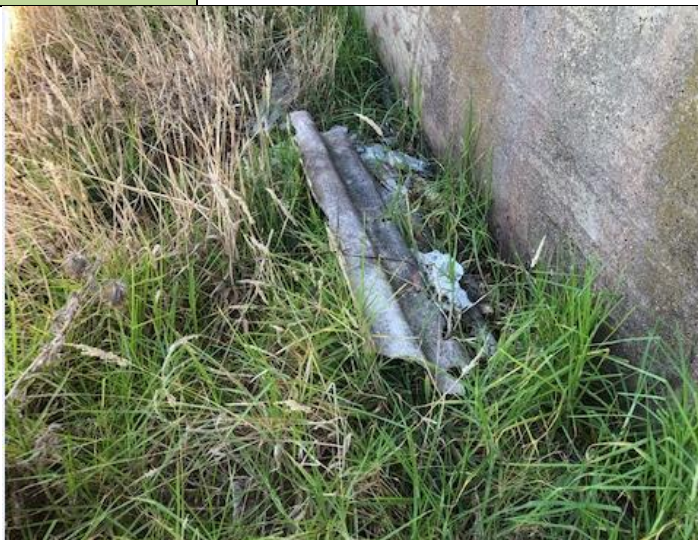
| | | <p>The soil in the surrounding area is littered with cement sheet.</p> <p>As we have positive lab results for cement sheet, we should Strongly Presume all cement sheet product to contain Asbestos. A control plan needs to be developed for its removal by a suitably qualified contractor.</p> |

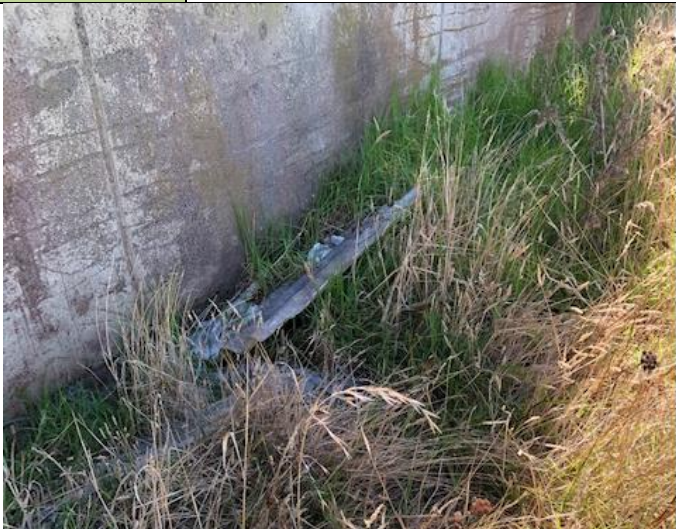
| | | | <b>Surveyor comments</b> <p>The soil in the surrounding area is littered with cement sheet.</p> <p>As we have positive lab results for cement sheet, we should Strongly Presume all cement sheet product to contain Asbestos. A control plan needs to be developed for its removal by a suitably qualified contractor.</p> |

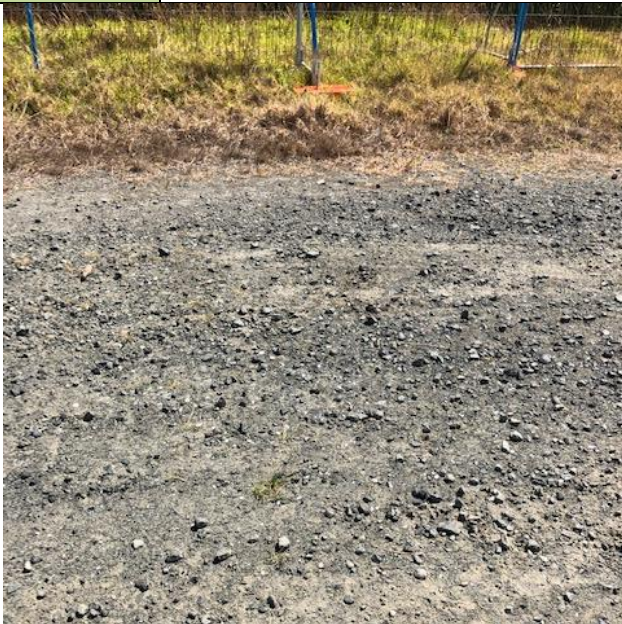
| | | | <b>Surveyor comments</b> <p>The soil in the surrounding area is littered with cement sheet.</p> <p>As we have positive lab results for cement sheet, we should Strongly Presume all cement sheet product to contain Asbestos. A control plan needs to be developed for its removal by a suitably qualified contractor.</p> |

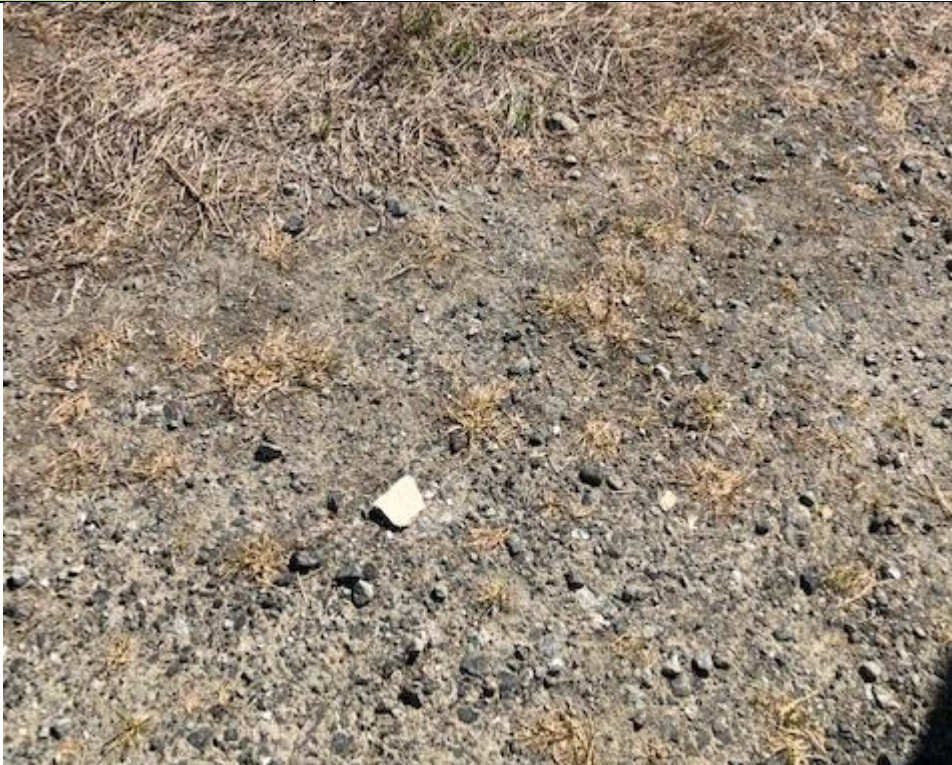
| | <p>The soil in the surrounding area is littered with cement sheet.</p> <p>As we have positive lab results for cement sheet, we should Strongly Presume all cement sheet product to contain Asbestos. A control plan needs to be developed for its removal by a suitably qualified contractor.</p> | |
