PROPERTY INSPECTION REPORT FOR: Far North District Council

Lighthouse

Kaitaia

DATE: 24-3-2018

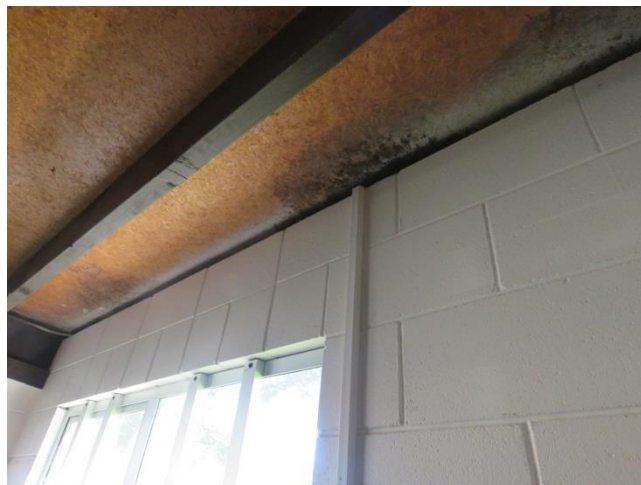
The sheet metal roof appears to be in a reasonable serviceable however there are issues related to the roof and spouting installation that likely relate to the water damage in the back ceilings

The water mark in the photo above aligns with damage in the spouting and fire flue flashing. However this damage and the water marking likely relate to the blocked downpipe

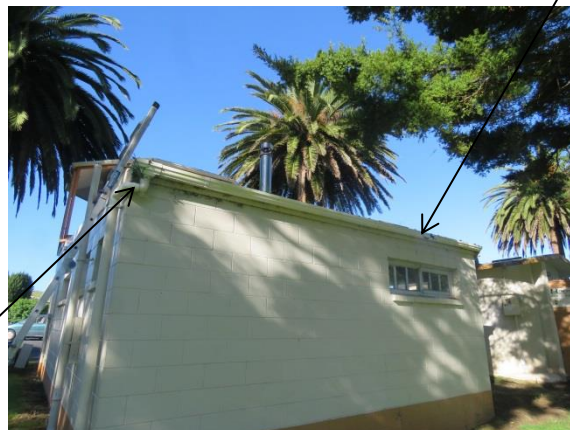
The plant growth in the downpipe indicates that it is and has been blocked for sometime

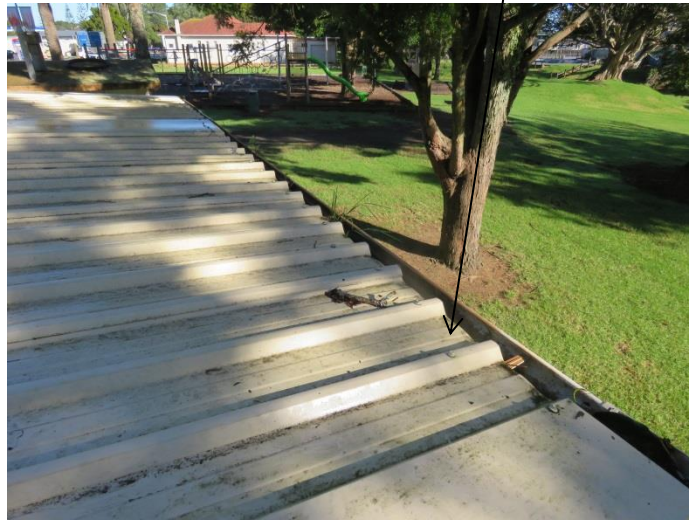
The new roof installation is not ideal as the bottom of the tray roof has not been turned down into the spouting and thus water is able to run back under the roofing and eventually rust will start along the bottom edge.

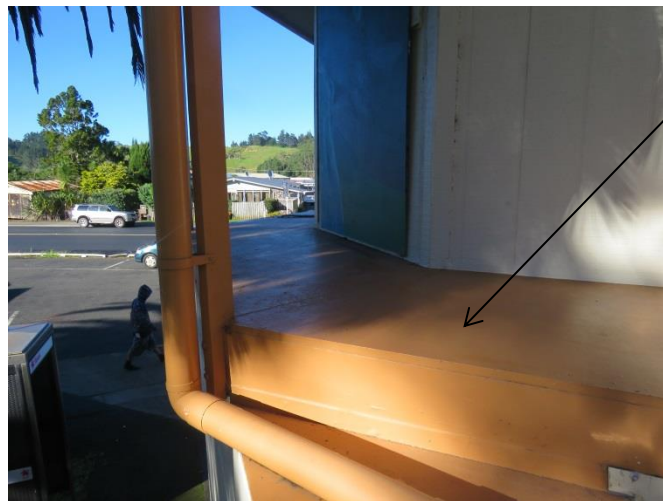
The light house section of the building has a shingle roof however there is a membrane application to the small perimeter deck

Even though at the time of inspection there were no visible signs of water ingress via the membrane or the shingles this type of acrylic membrane requires regular re-coating and on-going monitoring

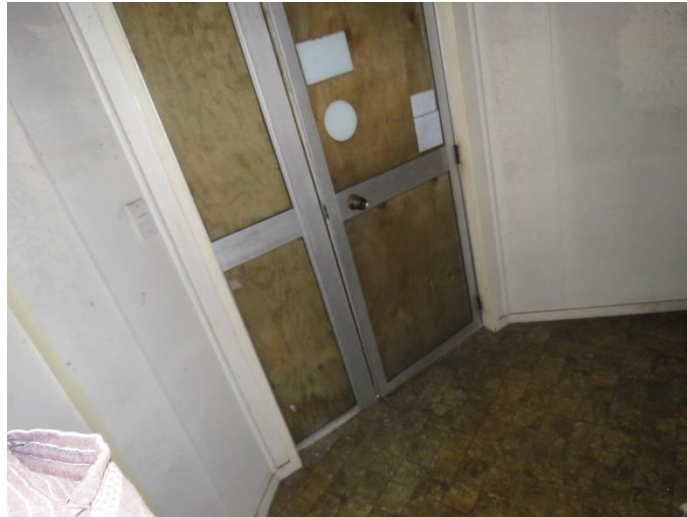
The other issue is that ply sheets have been fixed over the original lighthouse windows and doors and these are not water tight as detailed in the following photo

Loose fitted ply over door that does not close

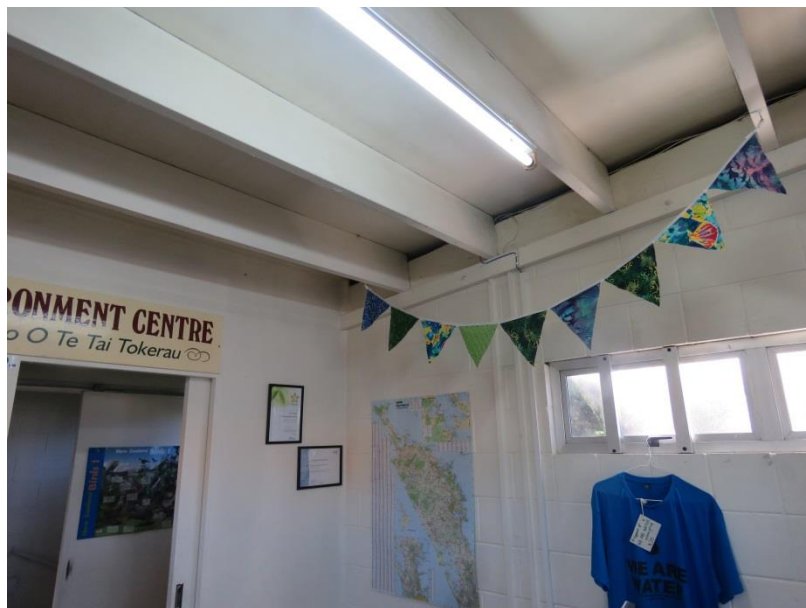
The tenant advised of damp musty smells and visible mould on the ceilings and in general this likely relates to the construction detailing of the building and the lack of insulation and ventilation

There is an option to pack and line the interior walls however minimal if any evidence of mould on exterior walls at time of inspection.

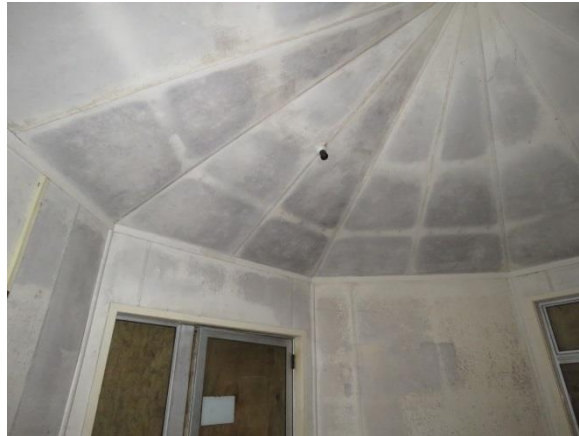
It should be possible to insulate and line in between the existing rafters over the back of the building once the indicated roof/spouting/downpipe repairs have been completed however the main issue will probably relate excessive mould and moisture damage in the enclosed lighthouse portion of the building (Part of the damp smell is very likely to be coming from this area)

Mould in enclosed light house

To reduce the impact of mould and dampness this entire lighthouse area will need to be insulated but also suitably ventilated and by doing so the entire roof will then be insulated. The issue is that to enable suitable thickness of insulation in the lighthouse area it is likely that most of the lighthouse structure/cladding and roof will be damaged or need replacement?
