Hihi Wastewater Treatment Plant

CAPITAL WORKS BUSINESS CASE

Project Code:	AAPXXXX	Project ID (Finance):	551302
Objective ref:	A1833495	Objective version #:	22

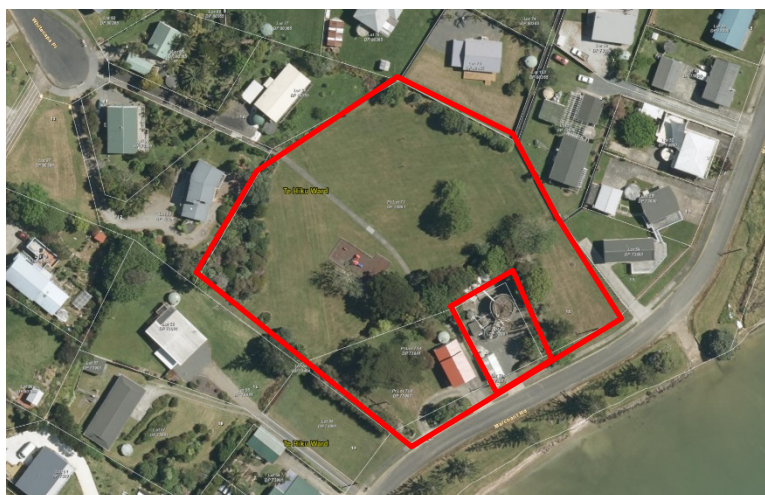
Figure 2) WWTP shown inside recreational reserve

The Hihi Wastewater treatment plant (WWTP) was built around 1975, it is located alongside the Hihi Marchant Road Reserve which sits within the boundary of residential properties, and the wetland marshes are located off Hihi Road, approximately 800m away from the plant. The plant undertakes both primary and secondary treatment processes, effluent is then pumped from the plant to wetland marshes for tertiary treatment before it is discharged by gravity to Hihi stream, a minor watercourse that runs through the settlement of Hihi before reaching the coast at Hihi beach. This WWTP employs an extended aeration, activated sludge process. The plant consists of two aerations tanks that operate in series followed by a sedimentation tank, which collects the clarified wastewater in an effluent storage tank, from here it is pumped through a rising main to a series of wetland cells.

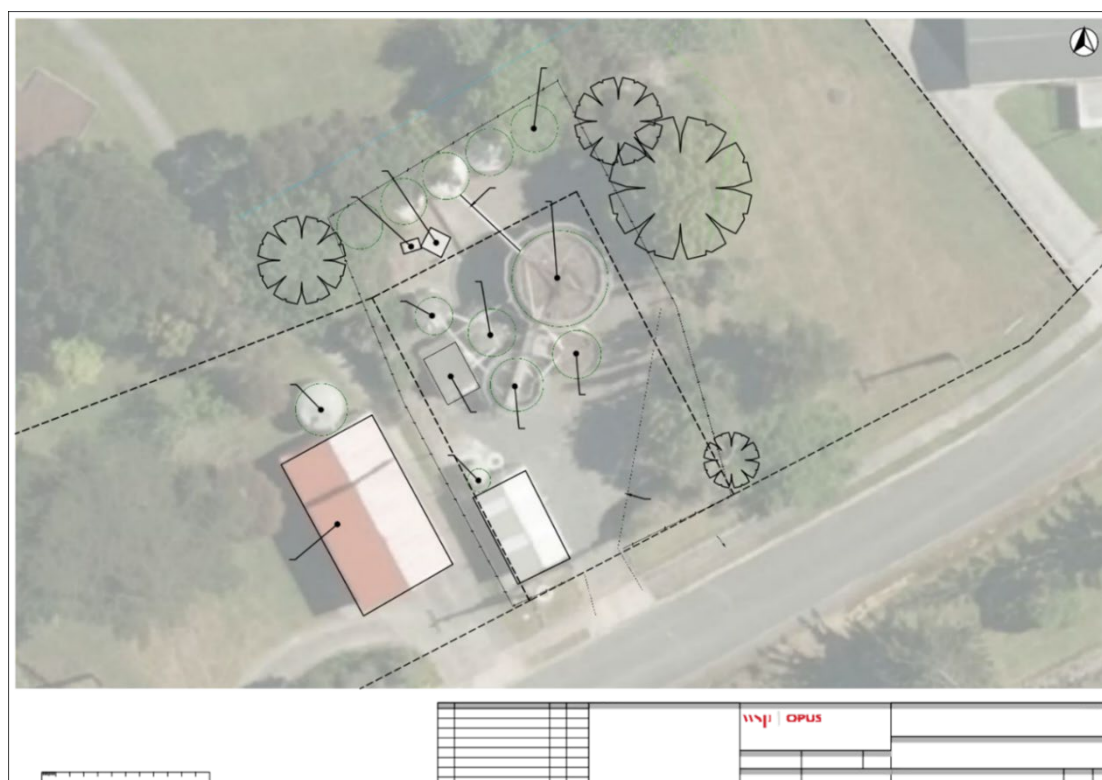
Figure 3) Hihi WWTP, Marchant Road – Site boundary and existing asset layout.

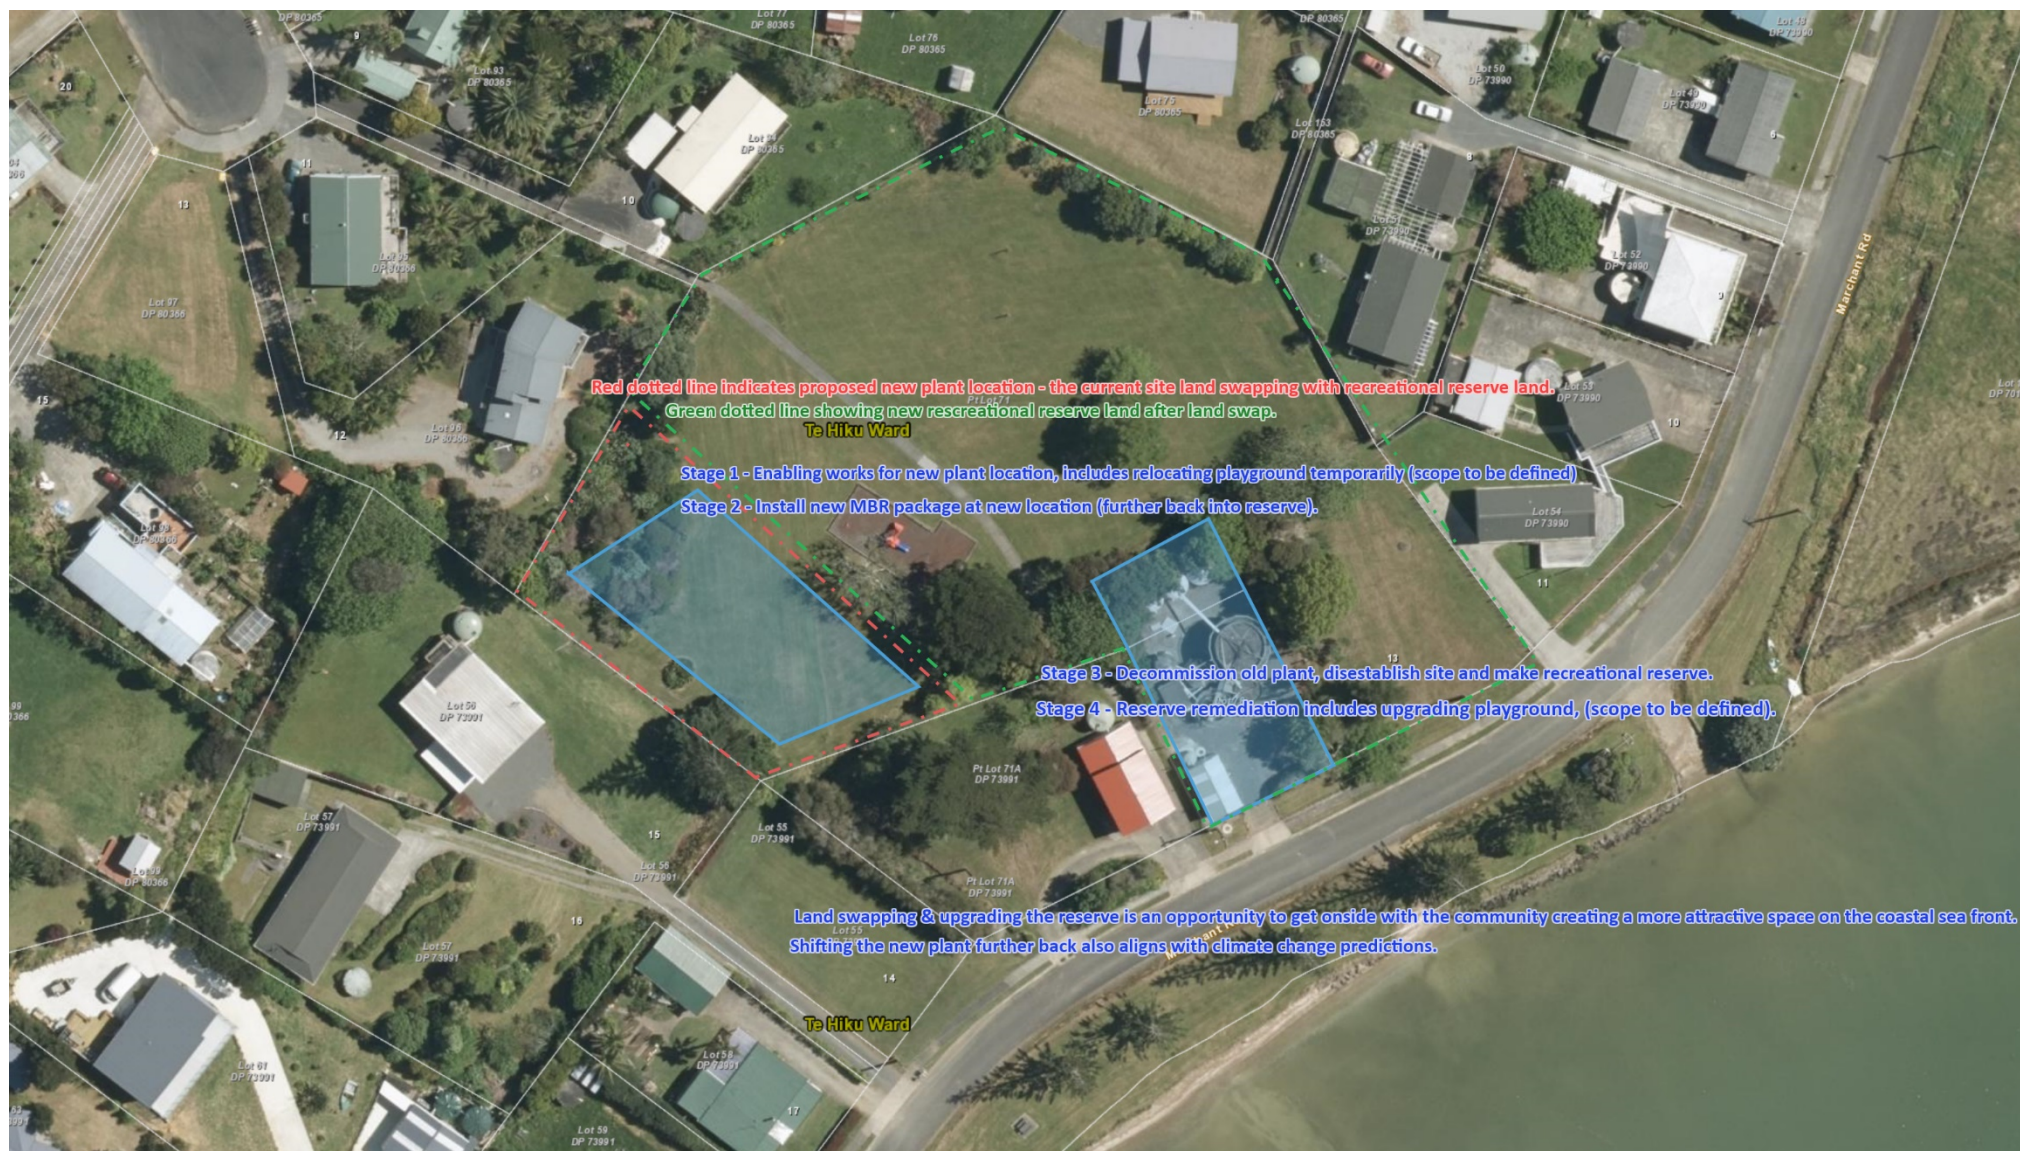
Figure 4) Option 3 - Site layout proposed solution

- Option 1 – Do minimum
- Option 2 – Relocation of WWTP to wetlands
- Option 3 – Upgrade existing plant and install new MBR system – refer to Figure 4) Option 3 - Site layout proposed solution

- 2) The land swap proposal shown in Figure 4) Option 3 - Site layout proposed solution, has been identified as a key element for providing the best value and long-term solution for Hihi and FNDC;

- Opportunity to upgrade the reserve for the community and provide an improved accessible recreational reserve footprint,
 - Moving the plant further back behind the fire station is a better use of space and footprint,

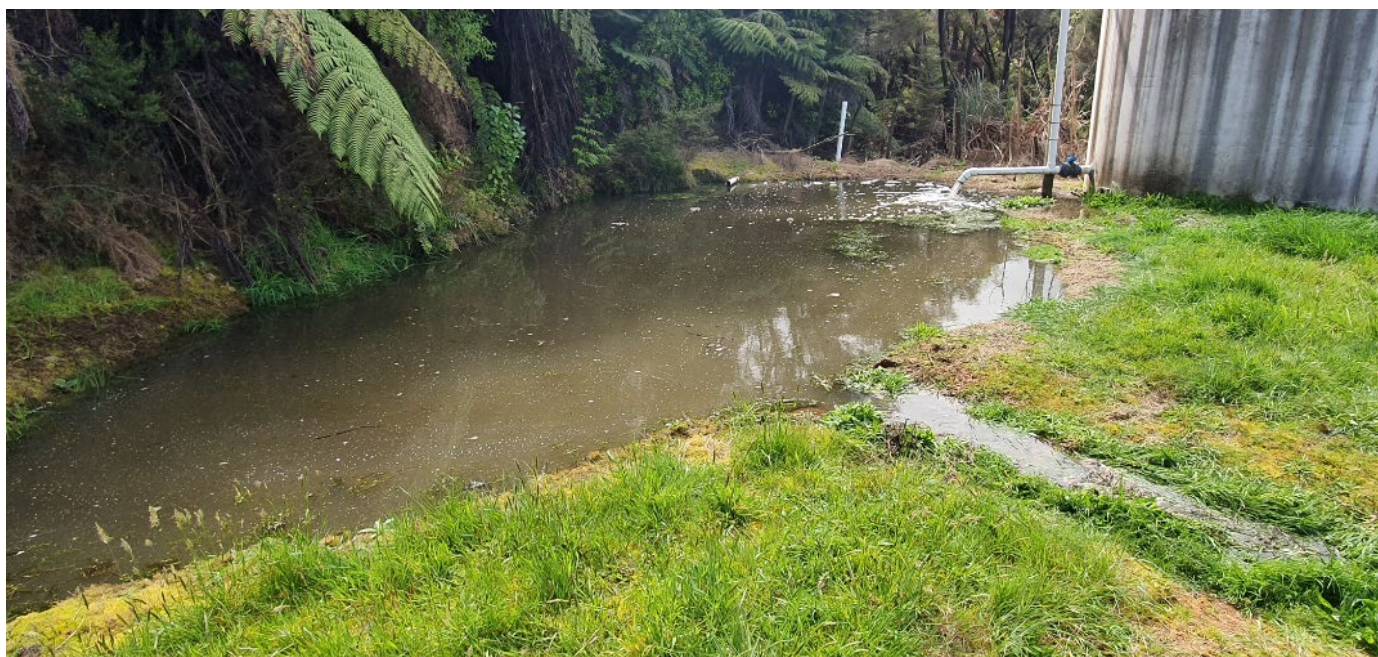
Figure 6) Constructed wetlands, the first cell overflowing into the open drain which goes directly into cell 2.

- Residual life for each asset was given between 4-12 years, this indicated the plant would require replacement by 2013,
- The wetland cells have not been maintained and now require remediation and possible redesign, pipe blockages continue to restrict effluent from reaching all cells resulting in overflows from the first basin directly into open drains immediately adjacent to the basins,

The constructed wetlands have also been neglected due to insufficient funding and maintenance. Observations made from a recent site visit confirmed a lack of operational maintenance resulted in wetland basins that were performing poorly. Several prior reports indicate the wetlands poor condition is nothing new, stating the basins overflow due to blocked pipes regularly. At the site visit the first cell was clearly struggling to perform showing the basin overflowing into an open drain caused from blocked pipes. The marshes are covered in weeds, there is minimal visibility of scheduled plant life, vegetation or aquatic planting and no sign of animal life – these natural elements are key to a wetlands function and success.

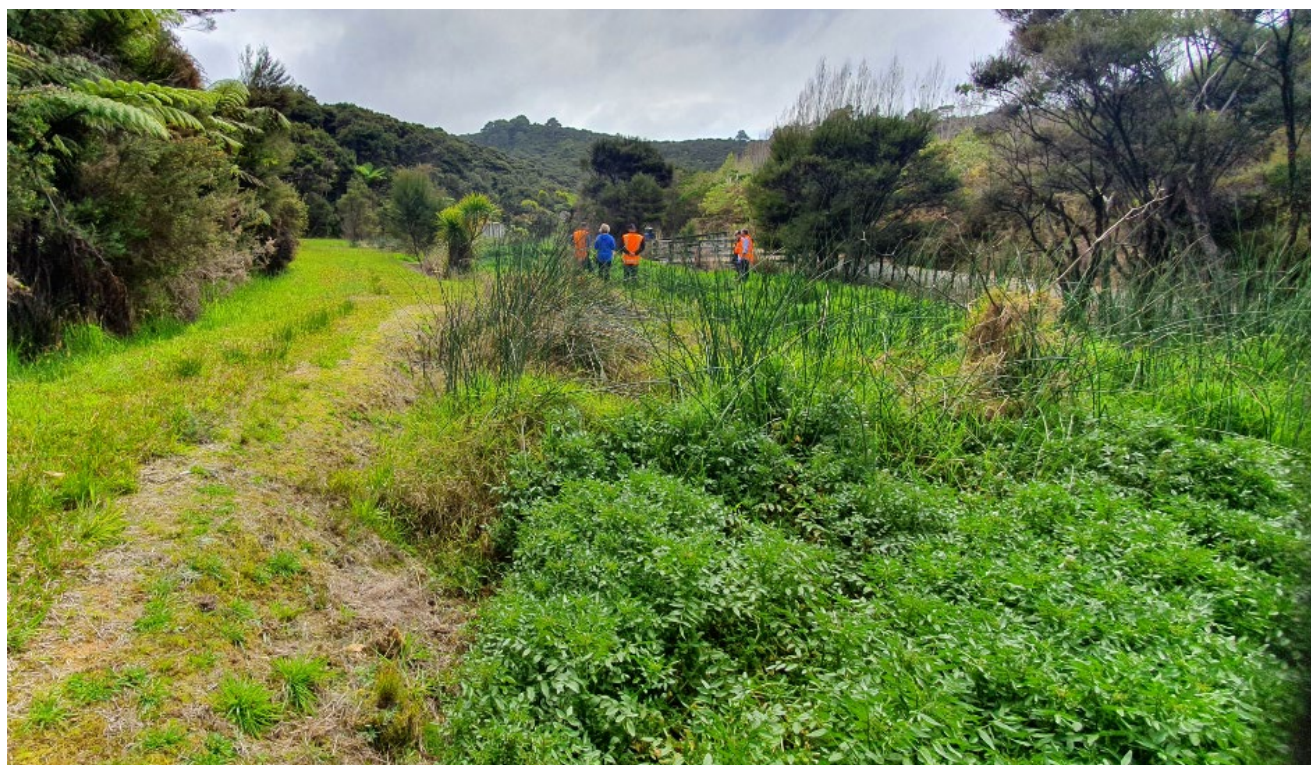
Figure 7) Overgrown marshes and high sludge levels within the wetland cells indicating substantial loss of biomass from the treatment plant.

- High sludge levels were identified within the wetland cells indicating substantial loss of biomass from the treatment plant,
- Monitoring results show high-quality effluent generally still obtained after wetland treatment,

- The wetland marshes are overgrown with weeds and unable to perform within the natural environment,
- There have been instances where excessive inflow and infiltration have caused the aeration tank to overflow and spill raw sewage and biosolids into the environment,

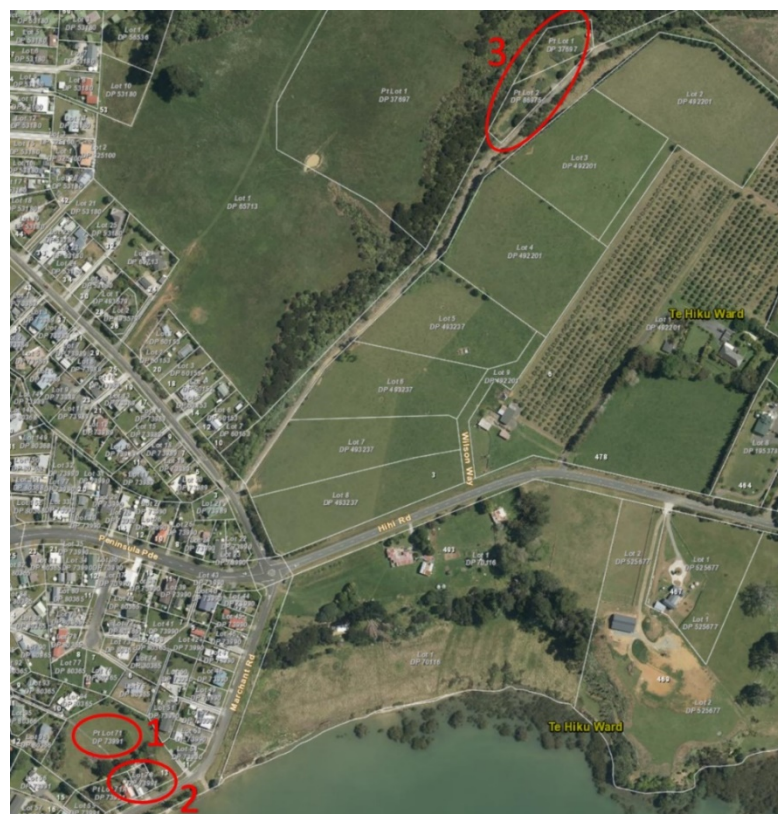
Figure 8) Treatment Plant - Consented Site Locations
