**Far North
District Council**

Supplementary Reports Extraordinary Council Meeting

5.2 1A SEAVIEW ROAD, PAIHIA - APPROVAL TO GRANT EASEMENT ON LOCAL PURPOSE ESPLANADE RESERVE UNDER THE RESERVES ACT 1977

GEOTECHNICAL DESIGN REPORT FOR LANDSLIP MITIGATION

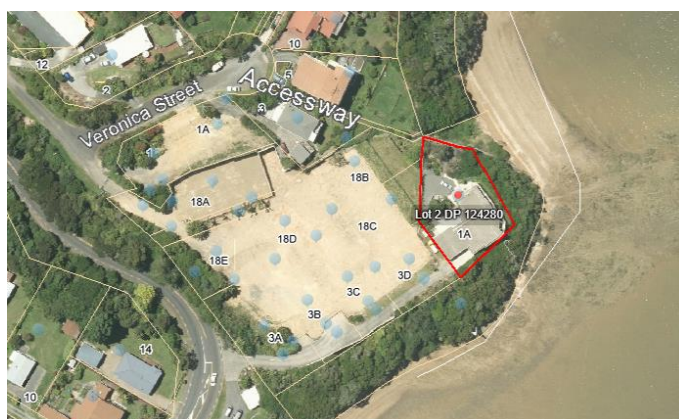
Figure 1 – Prover Aerial

The residential site contains an existing dwelling which is located at the end of a small promontory and enjoys elevated views across the Te Haumi estuary and the waters of the Kawakawa River. Access is attained via an existing concrete drive which extends from State Highway 11.

The site adjoins an Esplanade Reserve along the eastern and southern boundaries, which separates the site from the Coastal Marine Area. This Reserve, Lot 3 DP 124280, is covered in coastal vegetation and has received spoil as a result of the ground slippage.

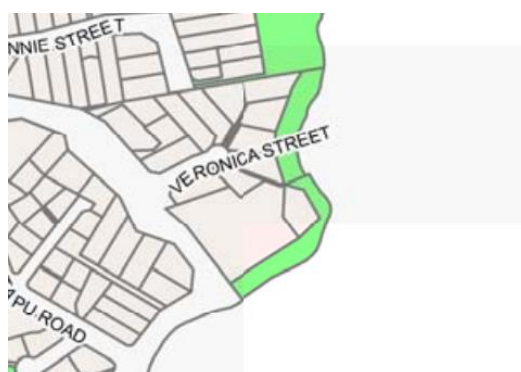
Figure 2 - Zoning of the site (FN Maps)

The Far North District Plan Zone Maps depict Janes site as **Residential** and the Esplanade Reserve as **Conservation**. No other special resource features apply to the two properties.

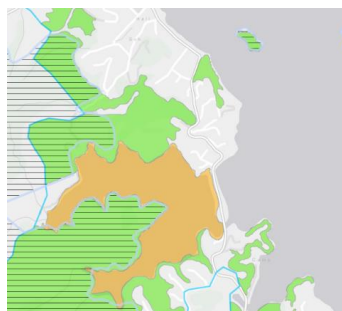
Figure 5 – Northland Regional Policy Statement Maps

The subject site is within the Northland region and is subject to the governing objectives and policies of the operative Northland Regional Policy Statement (operative May 2016). With respect to any identified features, the site is within the Coastal Environment boundary.

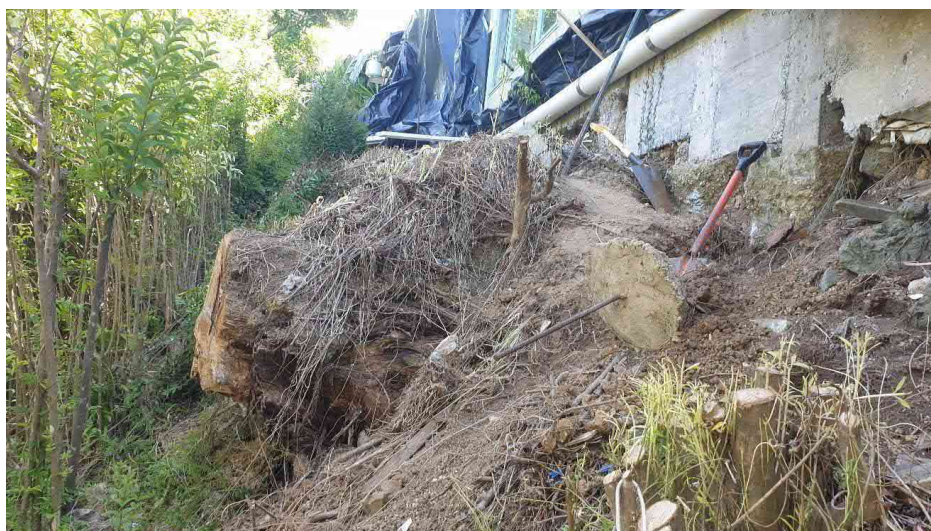
The landslide which occurred in February 2021 is located at the eastern end of the southern edge of the dwelling on the steep slope to the south. The landslide is steep and shallow (<1m deep). Shallow dwelling foundations have been exposed. A large tree to the west of the slip has previously been cut down, with the remaining tree stump also causing tension in the area around the foundations. (Ref Photo 1 below).

Photo 1: View to west along southern edge of dwelling showing exposed shallow foundation (right) and tree stump (left)

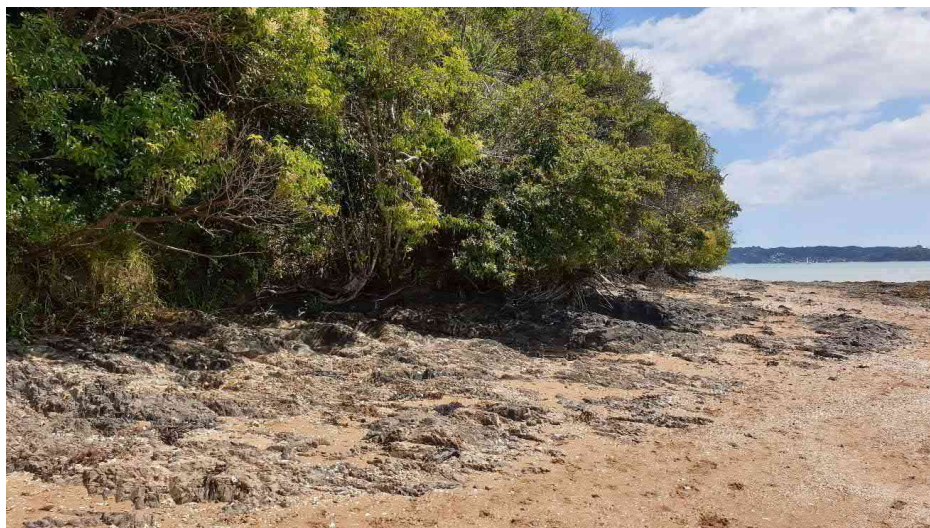
A walkover of the foreshore indicates outcrops of slightly to moderately weathered intact greywacke rock are present at the base of the slopes, as shown in Photo 2, below.

Photo 2: View to east along the base of the southern slope

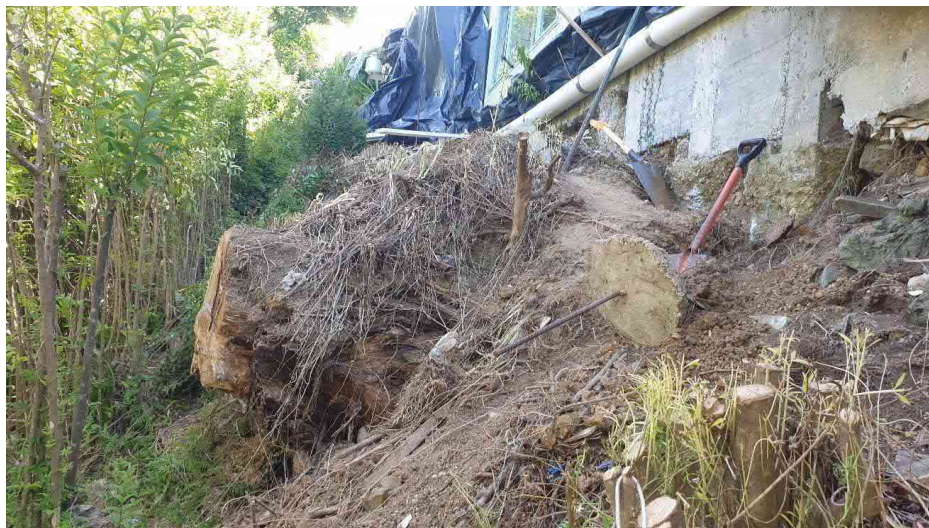
The landslide which occurred in February 2021 is located at the eastern end of the southern edge of the dwelling on the steep slope to the south. The landslide is steep and shallow (<1m deep). Shallow dwelling foundations have been exposed. A large tree to the west of the slip has previously been cut down, with the remaining tree stump also causing tension in the area around the foundations. (Ref Photo 1 below).

Photo 1: View to west along southern edge of dwelling showing exposed shallow foundation (right) and tree stump (left)

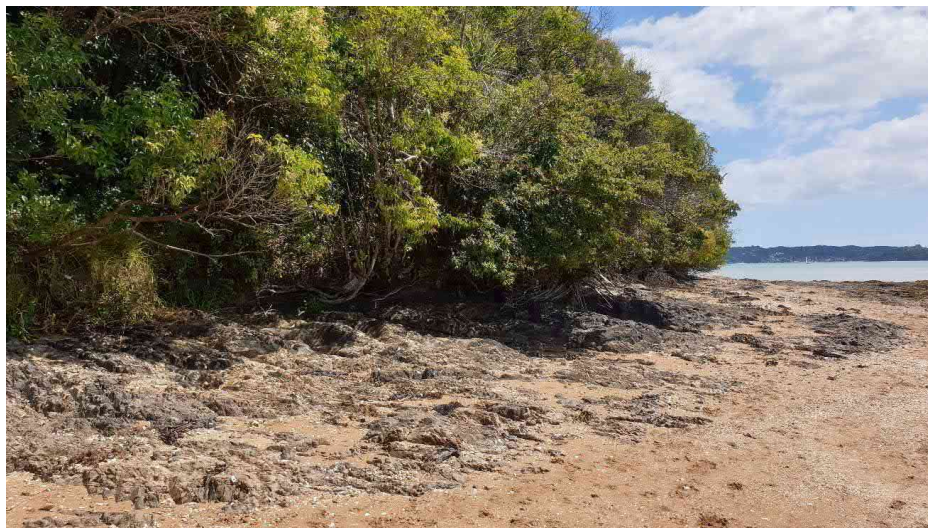
A walkover of the foreshore indicates outcrops of slightly to moderately weathered intact greywacke rock are present at the base of the slopes, as shown in Photo 2, below.

Photo 2: View to east along the base of the southern slope

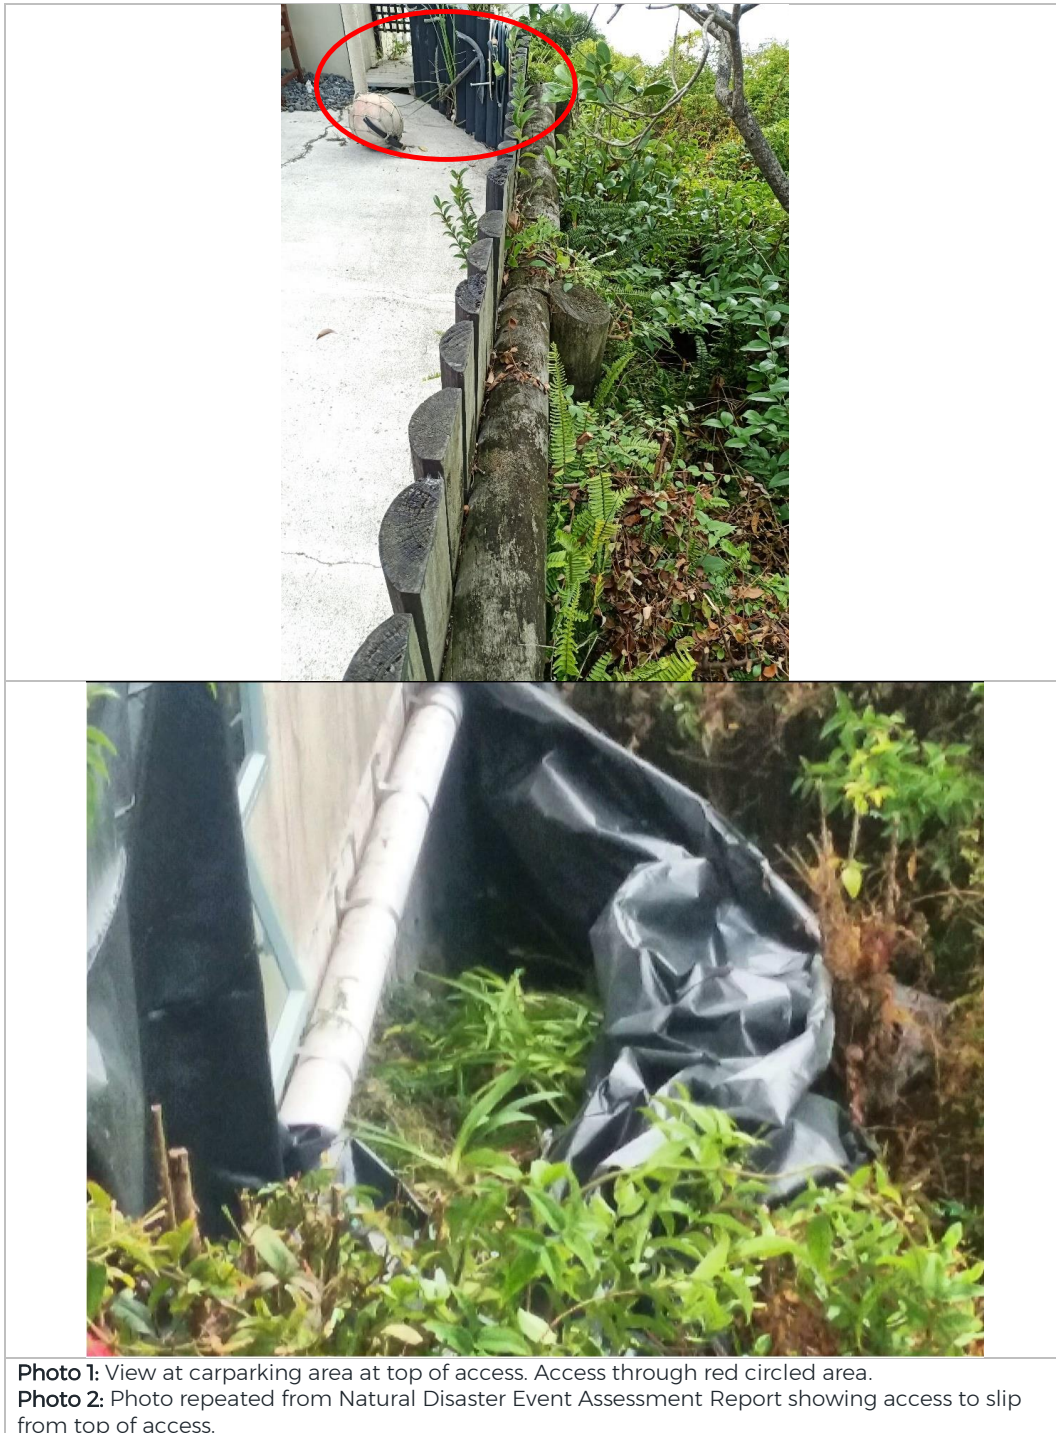
Photo 1: View at carparking area at top of access. Access through red circled area.

Photo 2: Photo repeated from Natural Disaster Event Assessment Report showing access to slip from top of access.

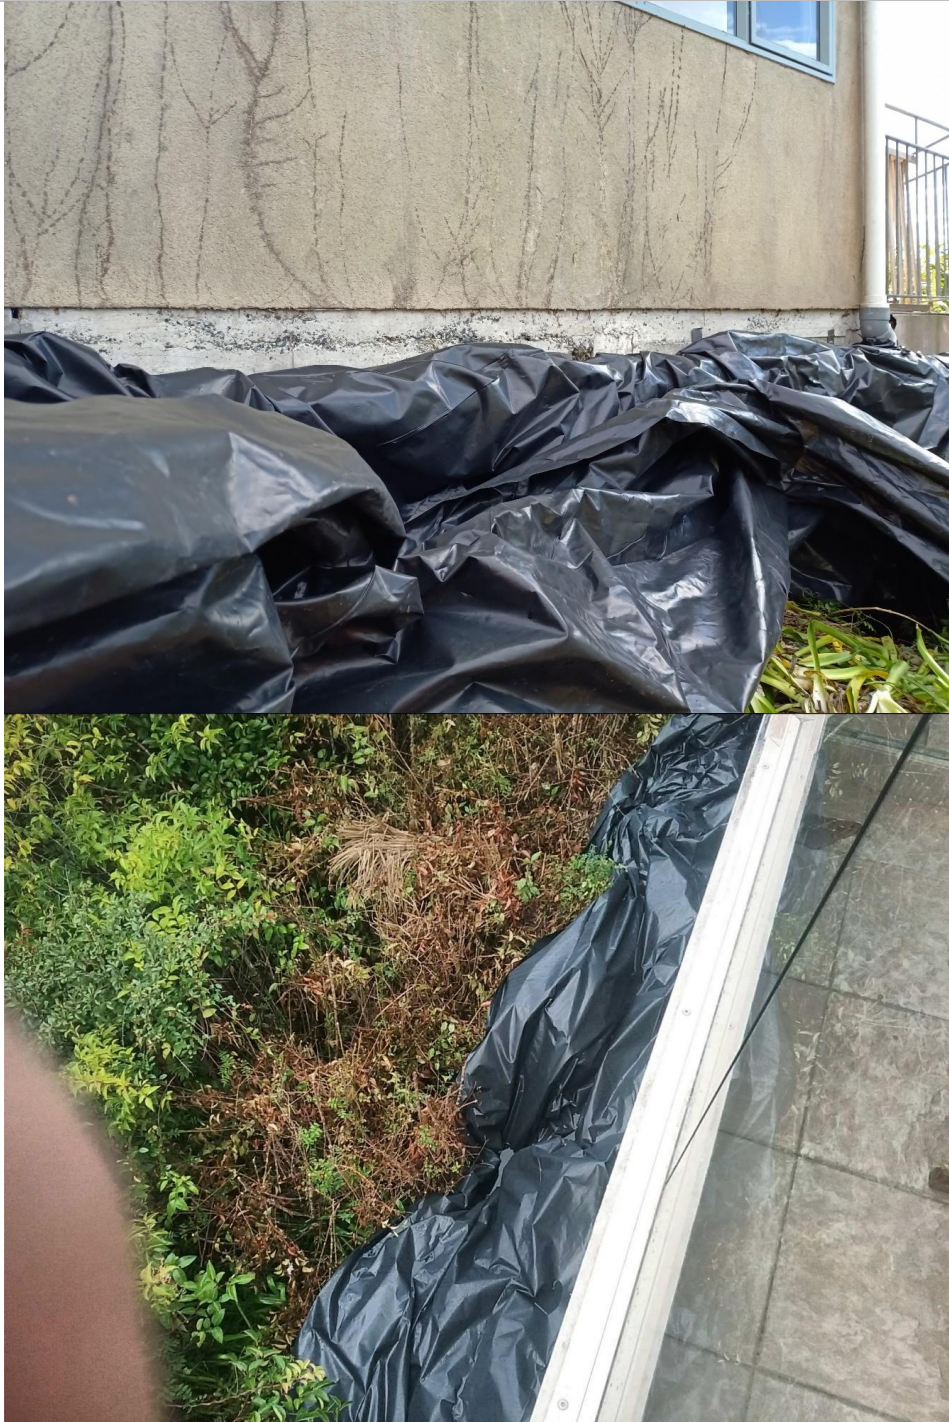
Photo 3: General elevation of slip area showing potential working area.
Photo 4: View of slip area from above.

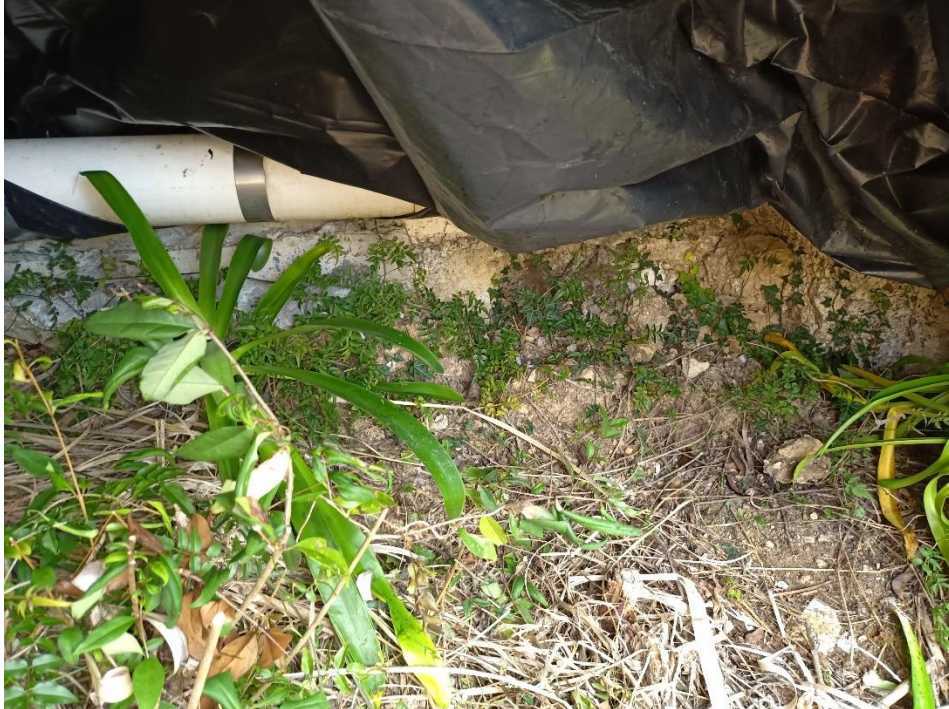
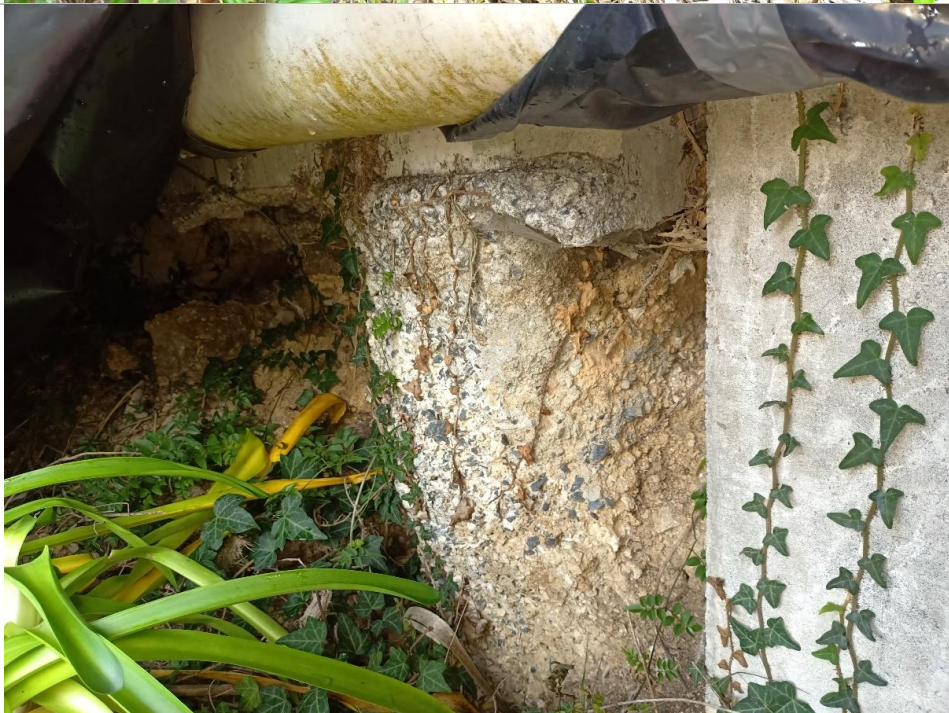
Photo 5: Western end where ground level is at concrete beam level
Photo 6: Exposed pile #1

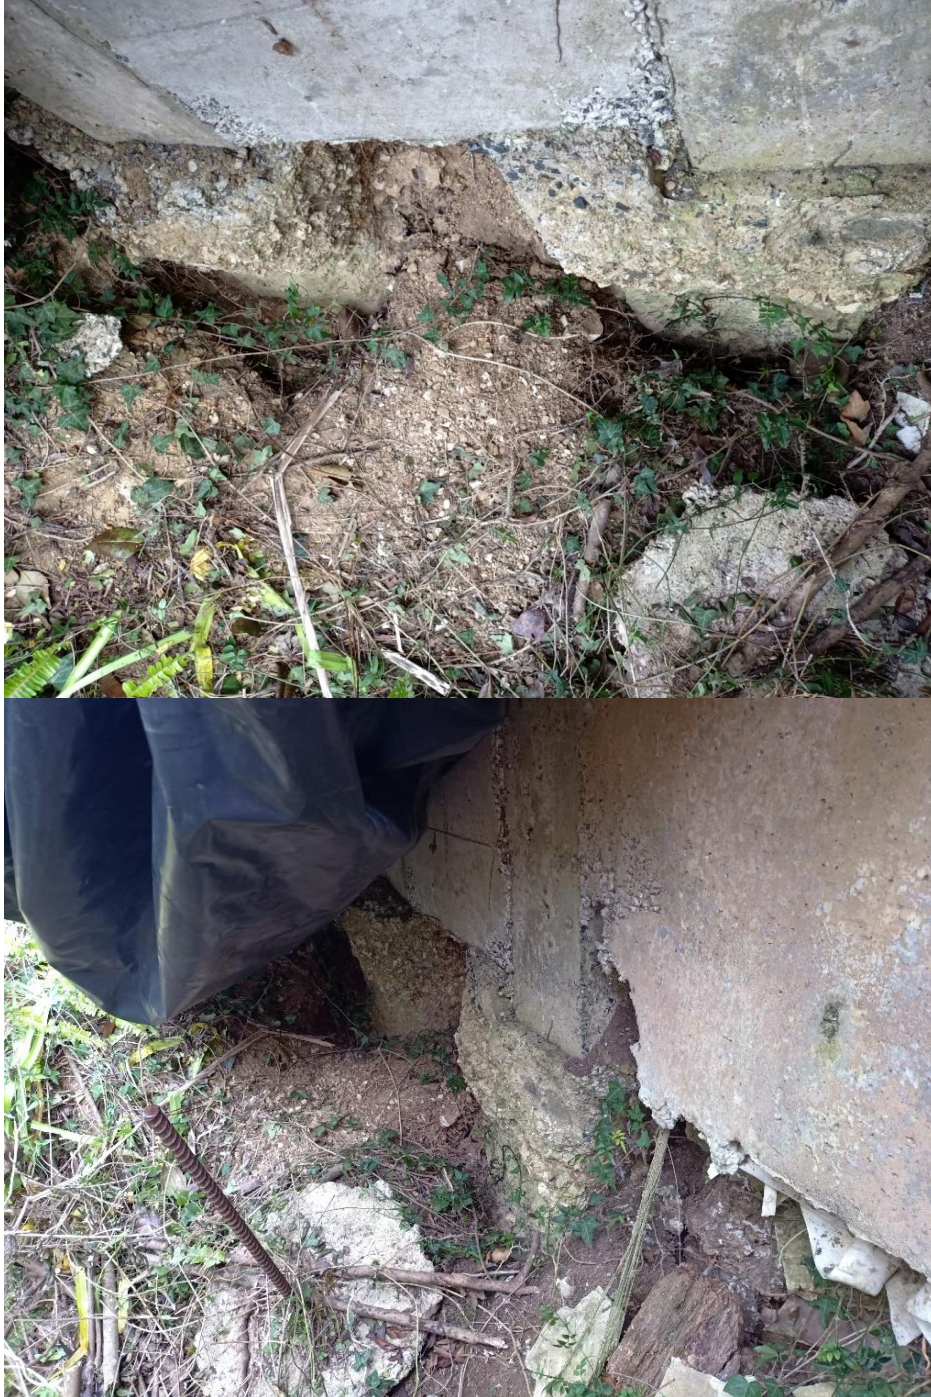
Photo 7: Exposed pile #2 & 3 showing scarp

Photo 8: Exposed pile #2 & 3 showing uncontrolled fill under deck on right. Rebar in foreground is monitoring peg from demolition of neighbouring hotel.

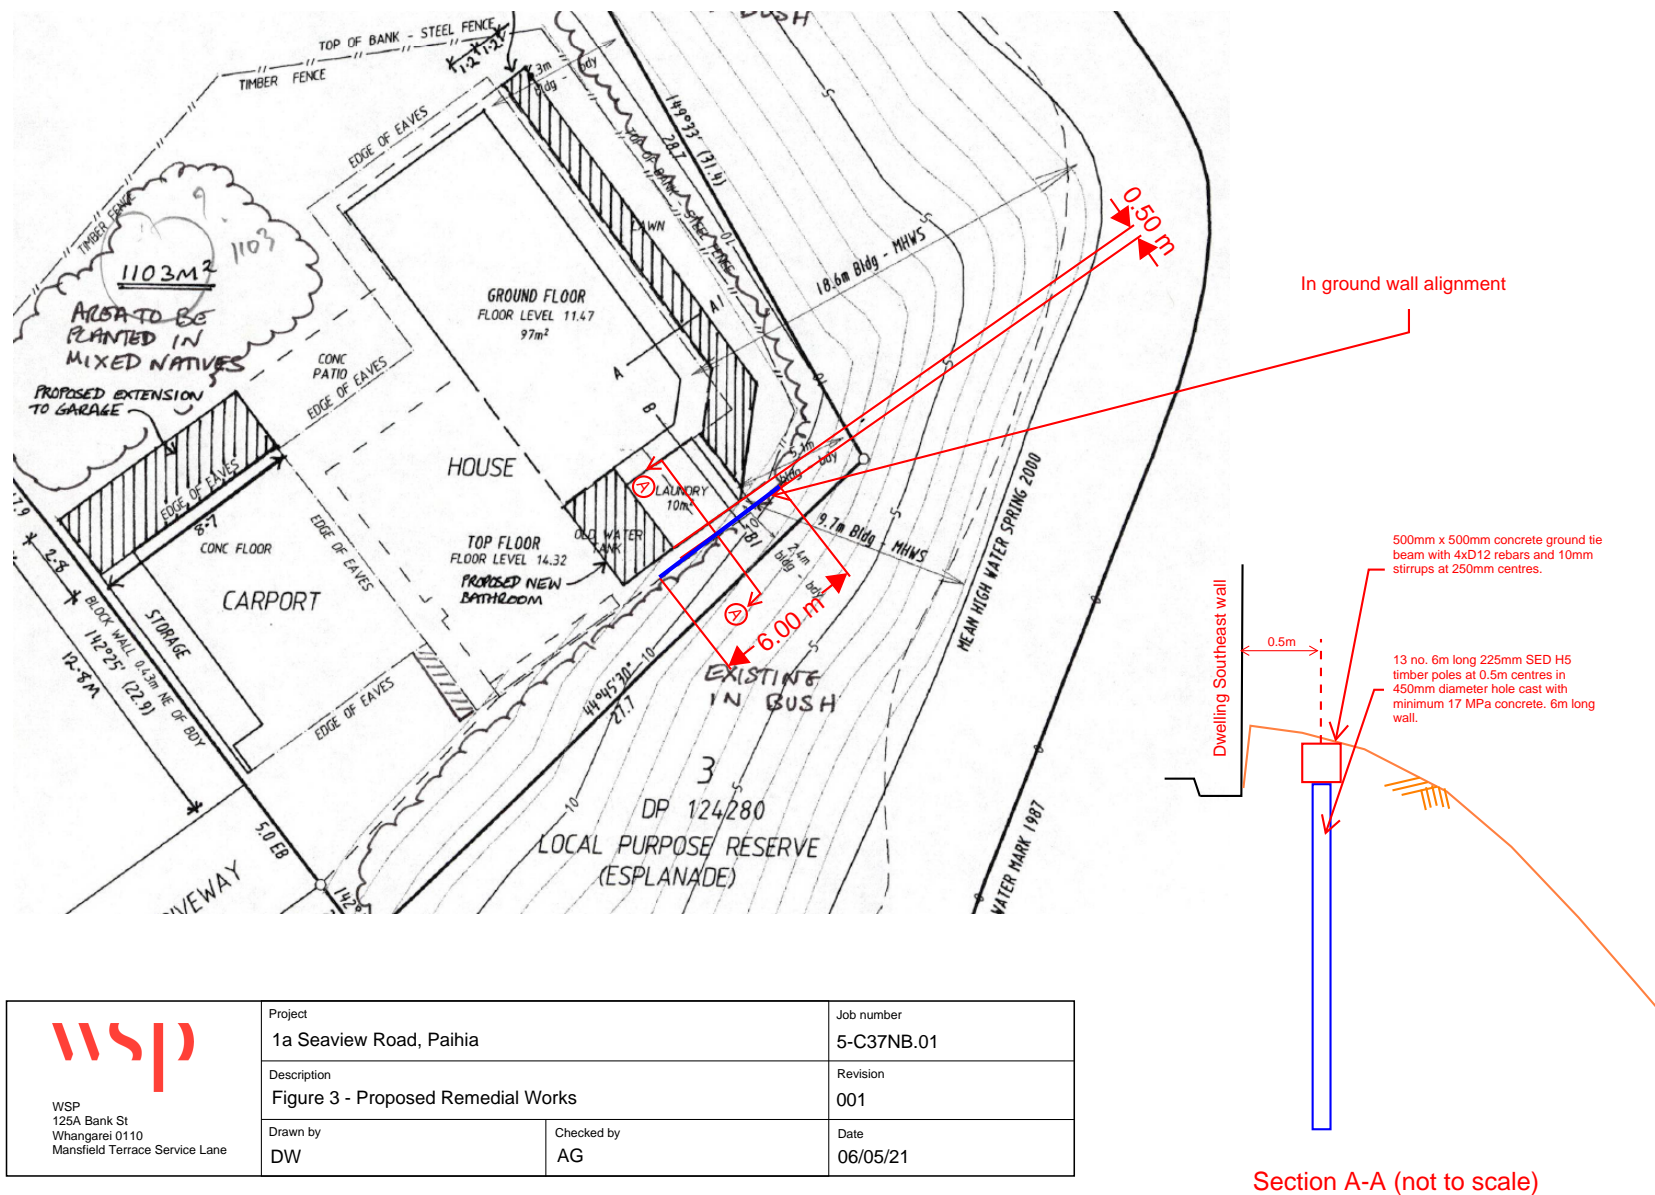
WSP 100 Beaumont St Westhaven Auckland 1010	Project 1a Seaview Road, Paihia		Job number 5-C37NB.01
	Description Figure 2 - Elevation		Revision 001
	Drawn by RP	Checked by AG	Date 06/05/21

Appendix B Figure 1 shows the land damage location and extent for the site. Figure 2 shows the evacuation in elevation.
