1. Refer to Figure No.s 3 to 5 for locations and details of new timber pole retaining walls.
2. These drawings shall be read in conjunction with the NGS report, 1A Seaview Road, Paihia: Landslip remediation, dated March 2022. NGS Ref 0213.
3. Drawings shall be read in conjunction with SCS Drawings SK-SE-000 to -003.
4. All discrepancies to be referred to the Engineer for decision prior to proceeding with works.
5. All works to comply with Constructor's approved Health & Safety Manual and Health and Safety at Work Act 2015.
6. All works to comply with the Far North District Council Engineering Standards & Guidelines 2009.

Project No.	Date	Jane Banfield 1A Seaview Road, Paihia
0213	March 2022	
Figure No.	Revision	Site Plan
2	A

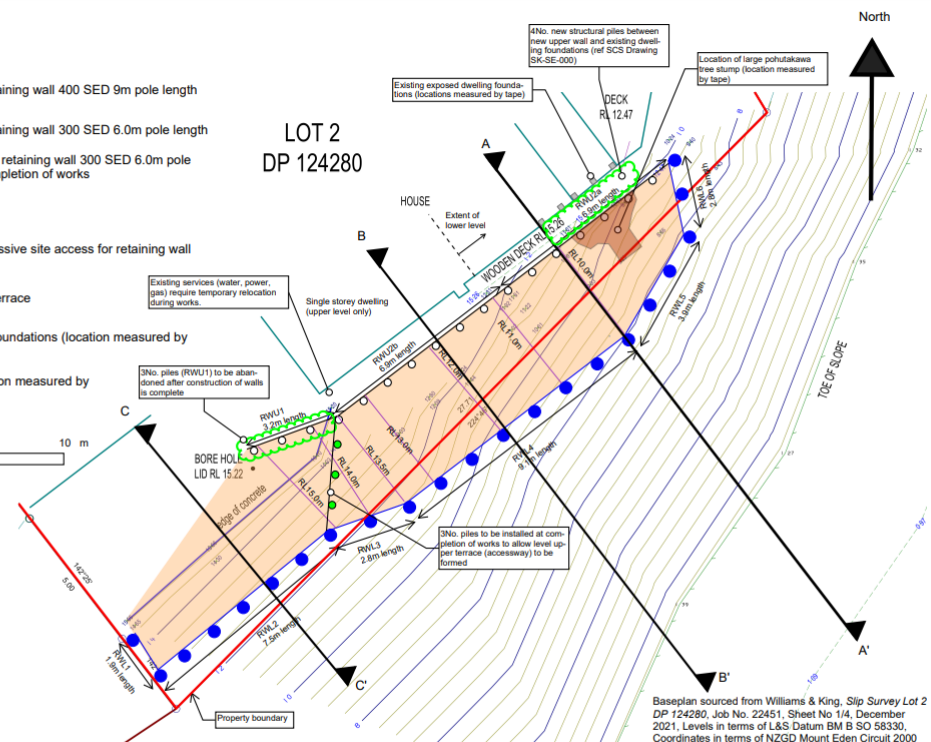
Lower wall: Timber pole retaining wall 400 SED 9m pole length
-

Upper wall: Timber pole retaining wall 300 SED 6.0m pole length
-

Additional wall: Timber pole retaining wall 300 SED 6.0m pole length to be installed at completion of works
-

New terrace to allow progressive site access for retaining wall construction
-

Existing exposed dwelling foundations (location measured by tape rather than survey)
-
