Far North District Council

AGENDA

Infrastructure Network Committee Meeting

Thursday, 23 May 2019

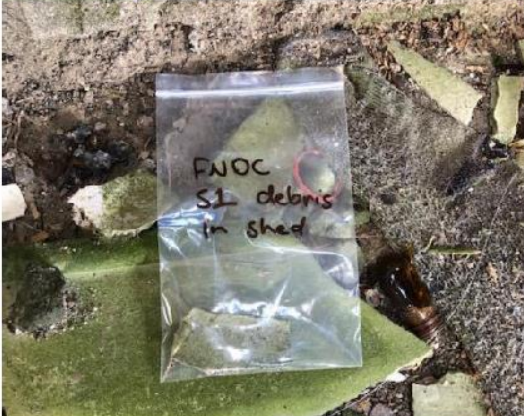
Sample number	Sample 1 - 001	Accessibility	Easy (1)
Quantity	Approximately 350M2	Condition	Poor
Area / Location	Debris in shed	Item / Material	Dust and Debris
Material risk no	6	Analysis	Positive

Surveyor comments	
		<p>A control plan needs to be developed for its removal by a suitably qualified contractor.</p>

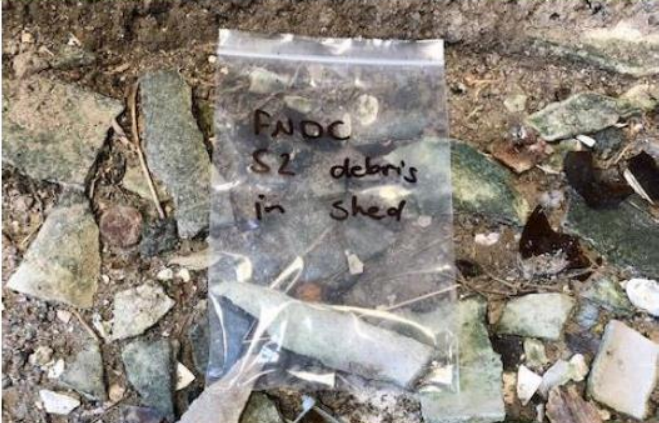
Sample number	Sample 2 - 002	Accessibility	Easy (1)
Quantity	Approximately 350 M2	Condition	Poor
Area / Location	Debris in shed	Item / Material	Dust and debris
Material risk no	6	Analysis	Positive

Surveyor comments	
		<p>A control plan needs to be developed for its removal by a suitably qualified contractor.</p>

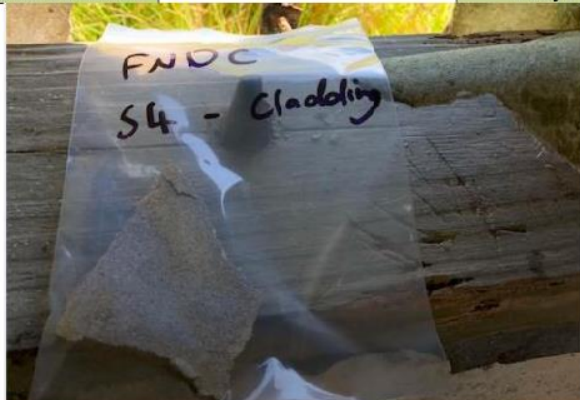
Sample number	Sample 4 - 004	Accessibility	Easy (1)
Quantity	Approximately 120 M2	Condition	Good
Area / Location	Cladding	Item / Material	Cement Sheet
Material risk no	6	Analysis	Positive

Surveyor comments	
		<p>A control plan needs to be developed for its removal by a suitably qualified contractor.</p>

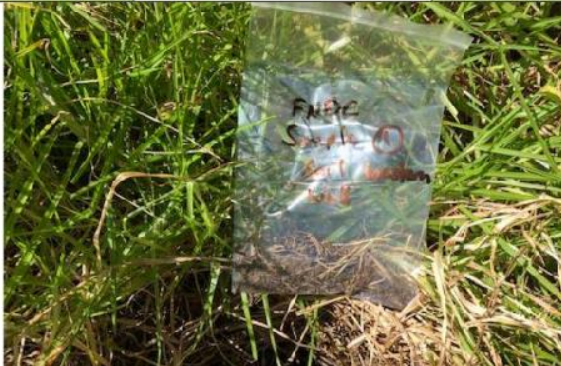
Sample number	Sample 1 - 00S	Accessibility	Easy (1)
Quantity	Approximately M2	Condition	Poor
Area / Location	Western Wall	Item / Material	Soil
Material risk no	0	Analysis	Negative

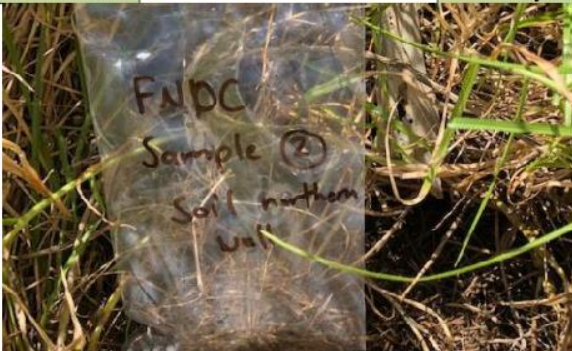
Sample number	Sample 2 - 00S	Accessibility	Easy (1)
Quantity	Approximately M2	Condition	Poor
Area / Location	Northern Wall	Item / Material	Soil
Material risk no	0	Analysis	Negative

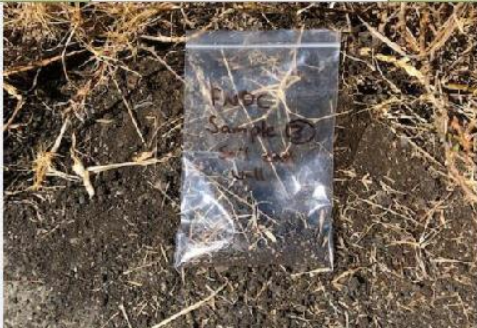
Sample number	Sample 3 – 00S	Accessibility	Easy (1)
Quantity	Approximately M2	Condition	Poor
Area / Location	Eastern wall	Item / Material	Soil
Material risk no	0	Analysis	Negative

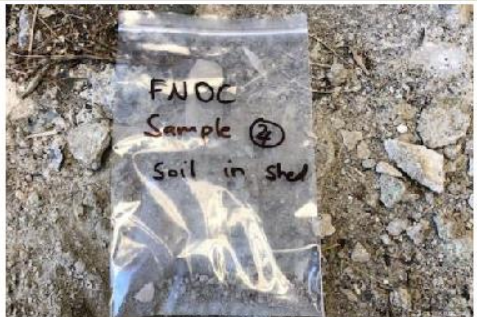
Sample number	Sample 4 – 00S	Accessibility	Easy (1)
Quantity	Approximately M2	Condition	Poor
Area / Location	In Shed	Item / Material	Soil
Material risk no	6	Analysis	Positive

Surveyor comments	A control plan needs to be developed for its removal by a suitably qualified contractor.

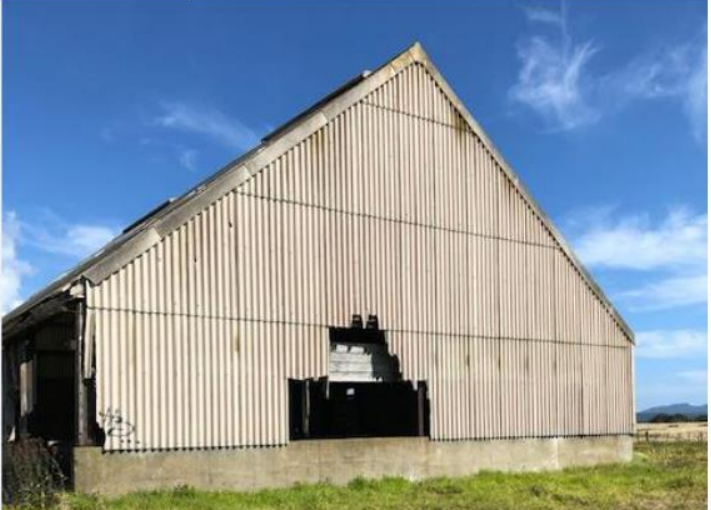
Image number	001
Area / Location	East

<p>Surveyor comments</p> <p>All cement sheet tested positive for Asbestos. A control plan needs to be developed for its removal by a suitably qualified contractor.</p>

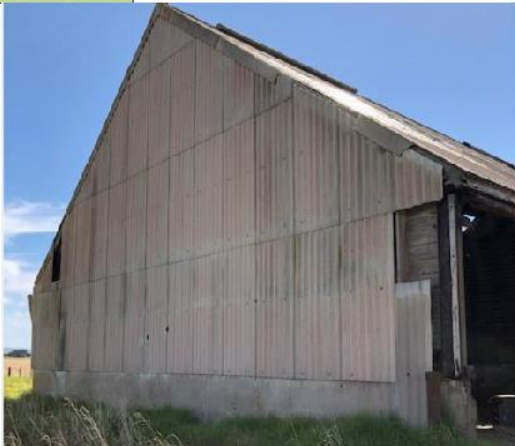
Image number	002
Area / Location	West

<p>Surveyor comments</p> <p>All cement sheet tested positive for Asbestos. A control plan needs to be developed for its removal by a suitably qualified contractor.</p>

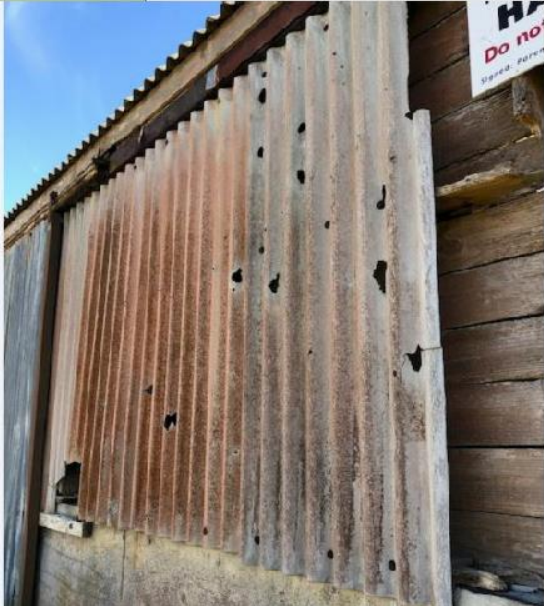
Image number	004
Area / Location	North

<p>Surveyor comments</p> <p>All cement sheet tested positive for Asbestos. This is a typical close up of the cement sheets condition. A control plan needs to be developed for its removal by a suitably qualified contractor.</p>

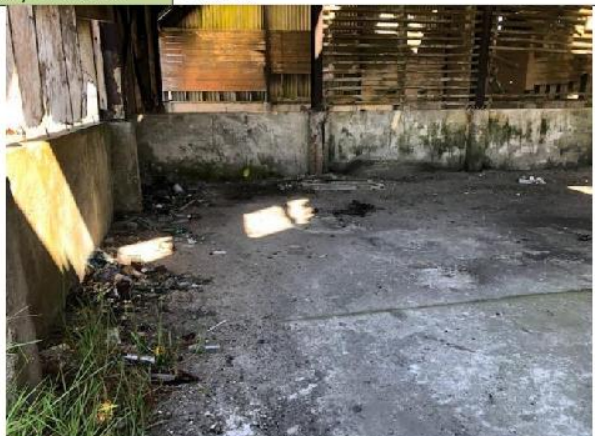
Image number	008	
Area / Location	Interior

Surveyor comments	
	<p>All cement sheet tested positive for Asbestos. A control plan needs to be developed for its removal by a suitably qualified contractor.</p>

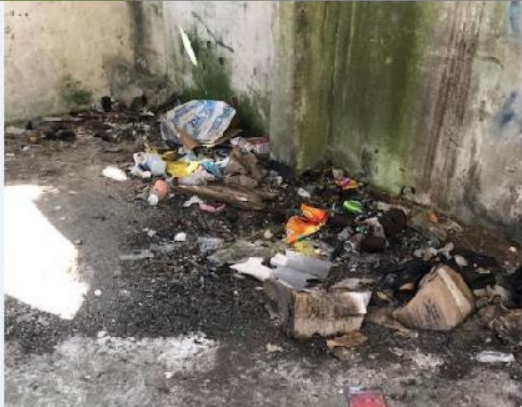
Image number	009
Area / Location	Interior

Surveyor comments
	<p>All cement sheet tested positive for Asbestos.</p> <p>All rubbish is to be treated as contaminated.</p> <p>A control plan needs to be developed for its removal by a suitably qualified contractor.</p>

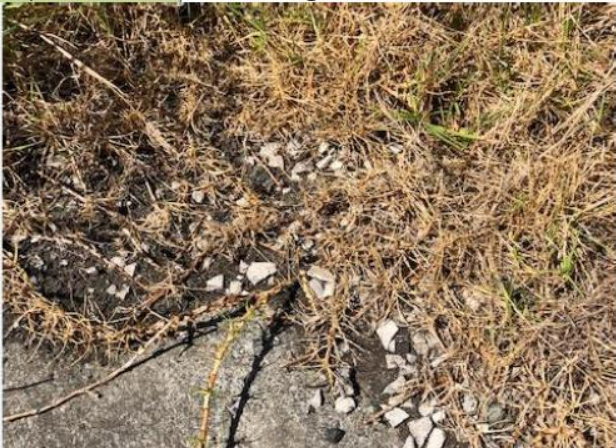
Image number	010
Area / Location	Surrounding area

Surveyor comments
	<p>The soil in the surrounding area is littered with cement sheet.</p> <p>As we have positive lab results for cement sheet, we should Strongly Presume all cement sheet product to contain Asbestos. A control plan needs to be developed for its removal by a suitably qualified contractor.</p>

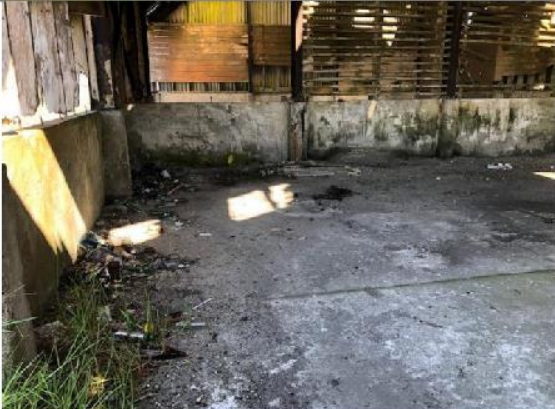
Image number	014
Area / Location	Interior Debris

Surveyor comments
	<p>All cement sheet tested positive for Asbestos.</p> <p>All rubbish is to be treated as contaminated.</p> <p>A control plan needs to be developed for its removal by a suitably qualified contractor.</p>

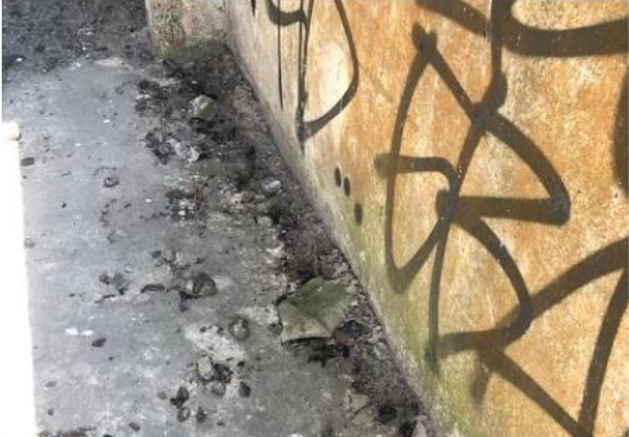
Image number	015
Area / Location	Interior Debris

Surveyor comments
	<p>All cement sheet tested positive for Asbestos.</p> <p>All rubbish is to be treated as contaminated.</p> <p>A control plan needs to be developed for its removal by a suitably qualified contractor.</p>

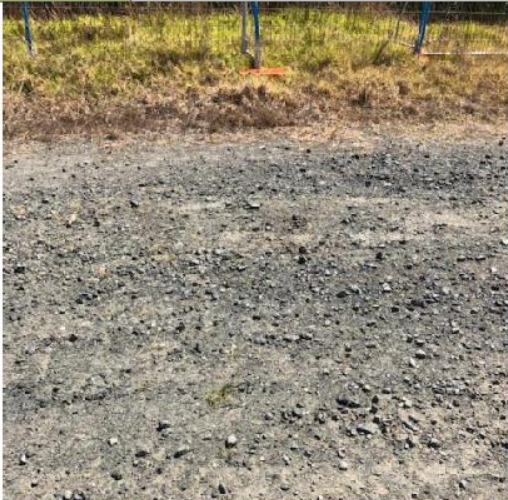
Image number	017		
Area / Location	Surrounding area

<p>Surveyor comments</p> <p>The soil in the surrounding area is littered with cement sheet.</p> <p>As we have positive lab results for cement sheet, we should Strongly Presume all cement sheet product to contain Asbestos. A control plan needs to be developed for its removal by a suitably qualified contractor.</p>

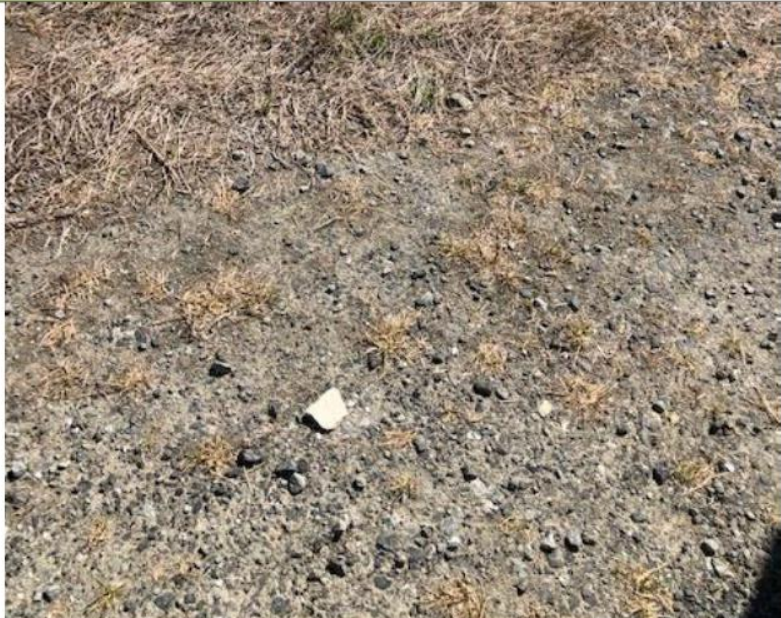
Image number	017	
Area / Location	Surrounding area

Surveyor comments <p>The soil in the surrounding area is littered with cement sheet.</p> <p>As we have positive lab results for cement sheet, we should Strongly Presume all cement sheet product to contain Asbestos. A control plan needs to be developed for its removal by a suitably qualified contractor.</p>

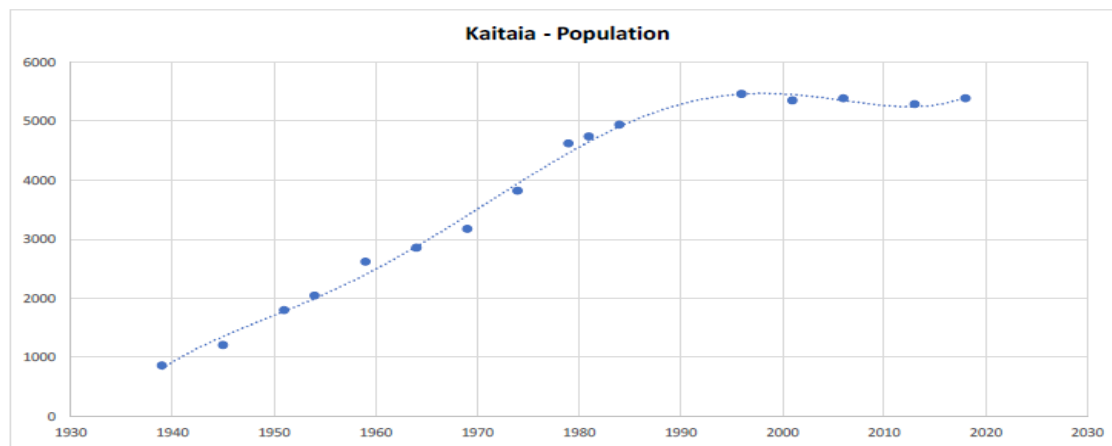
Fig 1; Population Growth

A review of the Kaitaia population shown in Fig 1 shows a steady growth until the mid 1990's with a static population. From this it was concluded that population growth was not a factor in increasing water production.

Since 2010 annual water production has been increasing at around 1.8% p.a. This growth trend is detailed in Fig 2. This growth trend doesn't align with population changes shown in Fig 1.

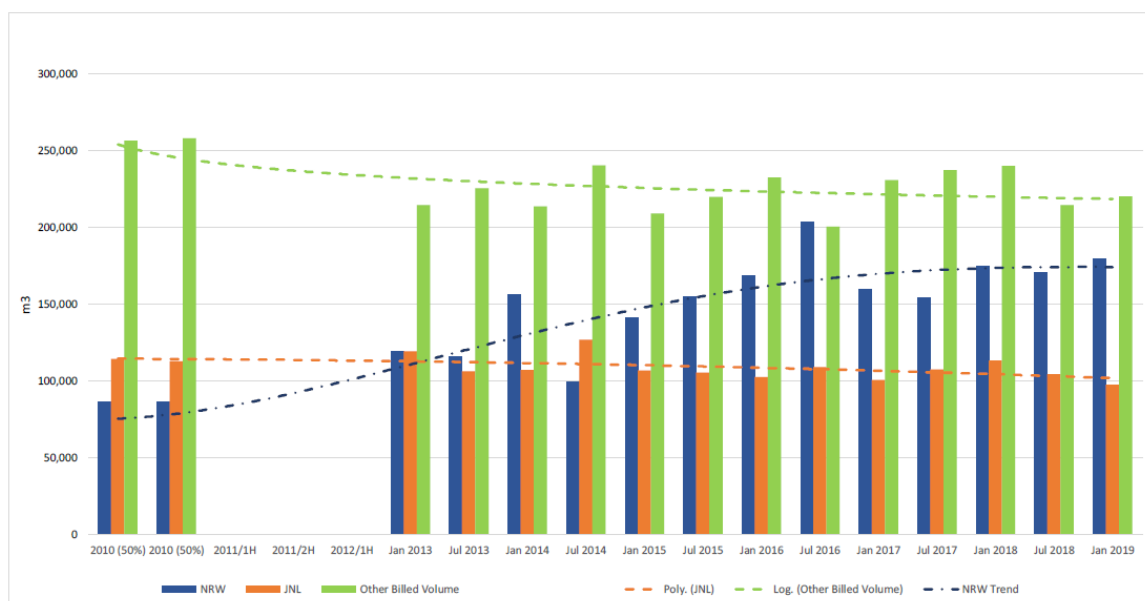
Fig 3; Water Sales and Non-revenue water

For the period 2010 to January 2019, water production water sales to the JNL Kaitaia Mill and other water sales were plotted. This is detailed in Fig. 3. This showed that the general water sales

have been relatively static to slightly decreasing, the JNL water usage slowly decreasing and the volume of non-revenue water progressively increasing.
