Pa Road - Kerikeri Footpath

Road Safety Audit
Post-Construction
September 2021

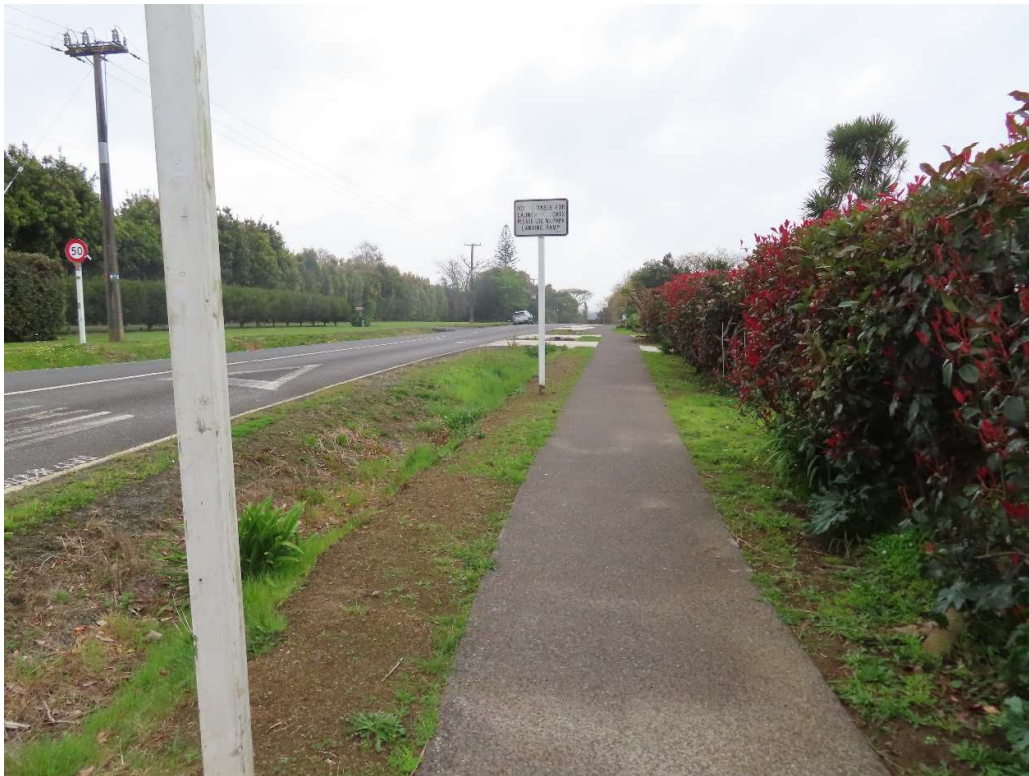
Reference	Issue	Audit recommendation	Comments
2.1	Footpath Location Ch 0 – 110.	1. Relocate the footpath to the east side of Pa Road.	The footpath was relocated to the eastern side of Pa Road, refer to Figure 2 .

Figure 2: The new footpath has been located to the east side of Pa Road.

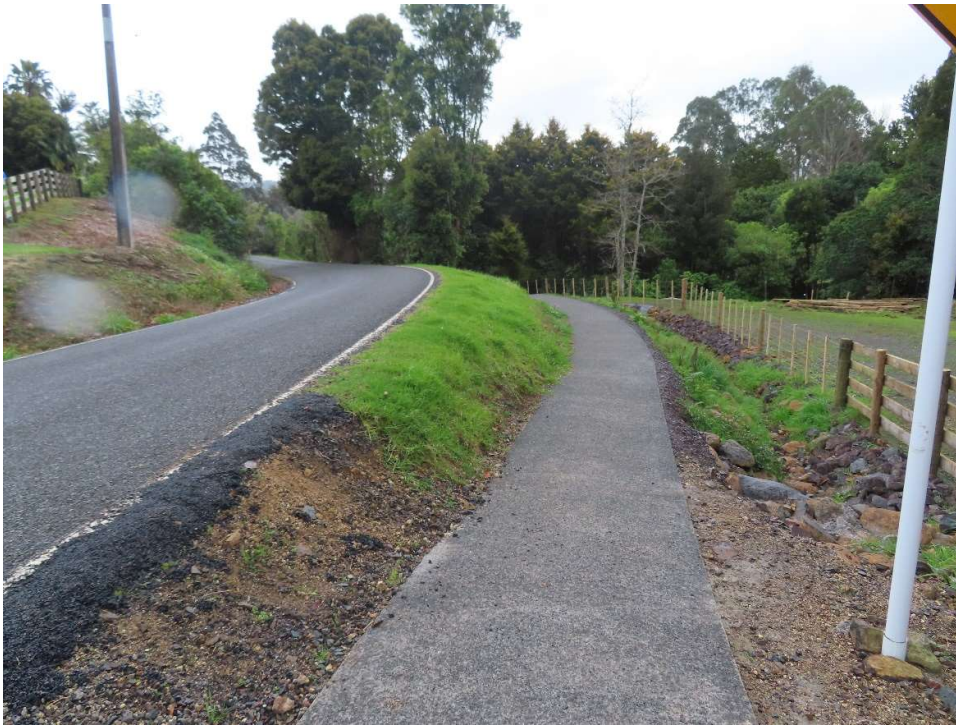
2. Remove fence and relocate to road boundary to enable a suitable setback (berm) to be placed between back of guardrail and proposed footpath.	The client decision agreed with this recommendation and the fence was relocated, refer to Figure 3 .

Figure 3: The relocated fenceline at Ch400.

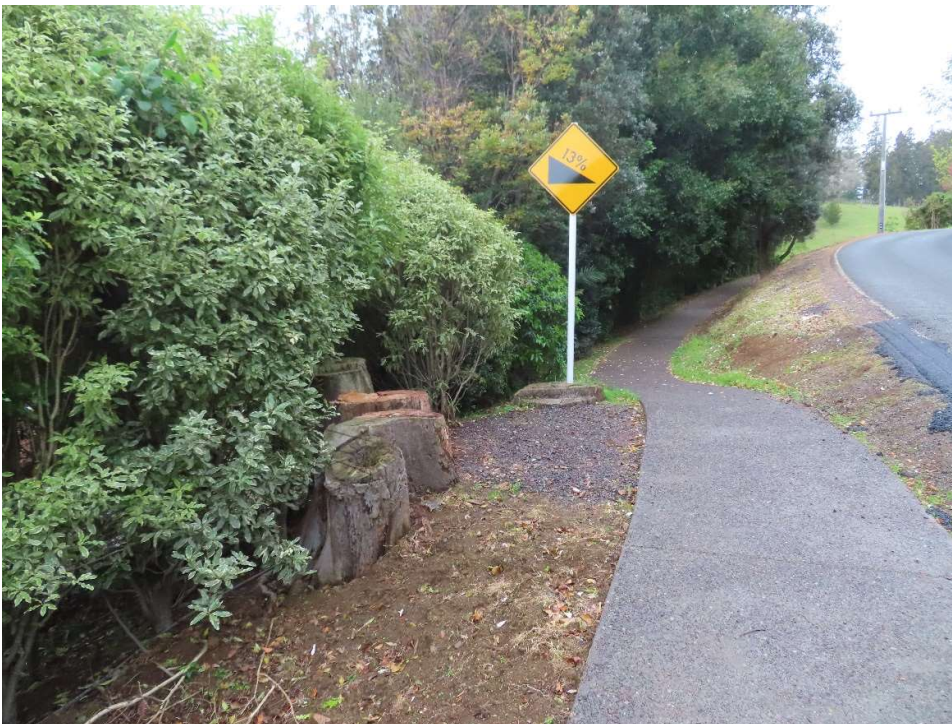
Reference	Issue	Audit recommendation	Comments
2.5	Tree Stumps, Ch 550.	Remove stumps. Straighten the footpath alignment to avoid bringing it closer to the sealed carriageway.	Some of these stumps have been removed and the footpath realigned, refer to Figure 4 .
2.6	Curve, Ch 650 – 700.	Consider pipe culverting approximately 50m of roadside water table to remove short lengths of steep open roadside drain and remove the necessity for a handrail.	This recommendation was not accepted by the client. Refer to Figure 5 for the post-construction situation.
2.7	Culvert adjacent to crossing point, Ch 780.	Consider extending the culverting of the water table to the adjacent driveway.	The client decision was that this recommendation was out of the scope of this project.

Figure 4 : Stumps partially removed and footpath realigned at Ch550.

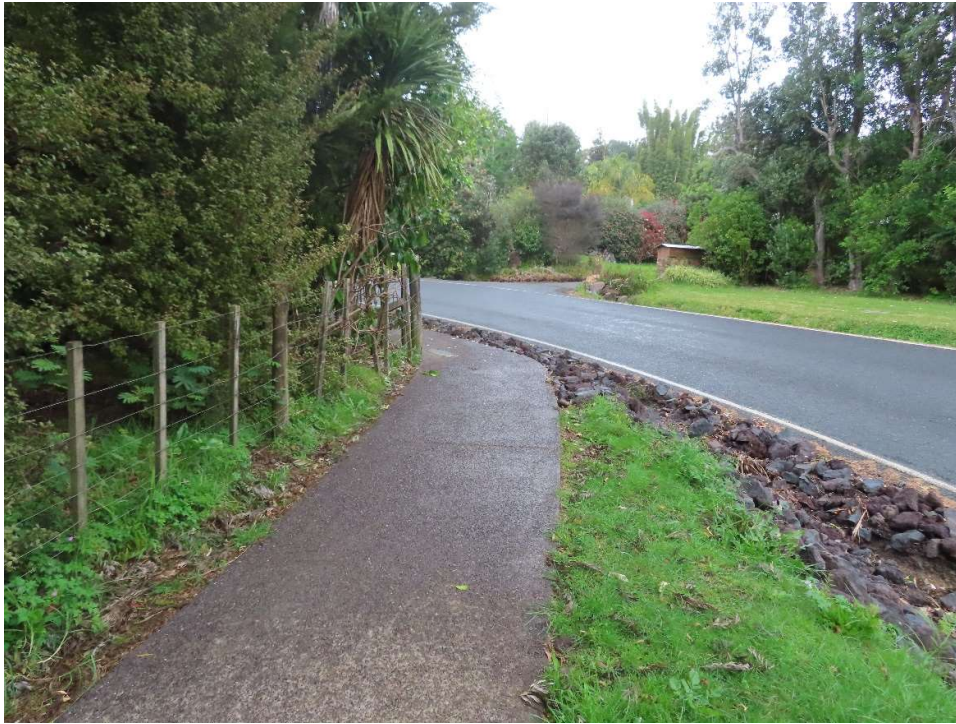
Figure 5 : As-constructed footpath at Ch700.

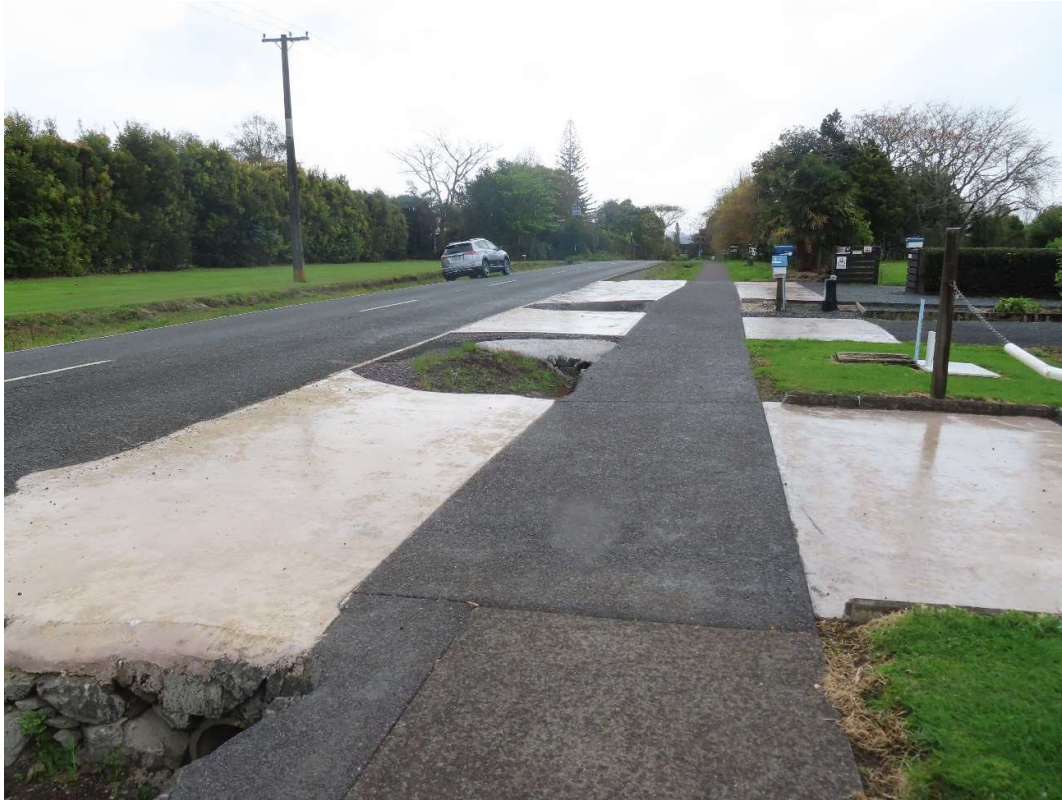
On the eastern side of Pa Road at Ch 140 are three accessways relatively close together. Between the accessways the watertable is open and presents a significant hazard to either errant vehicles, vehicles turning into the accessways or users of the footpath, refer to **Figure 6**. Particularly in case of users of the footpath, if a user were to fall off the edge of the footpath, injury could result.

Figure 6: Hazards between three accessways Ch140.

Overall Rating: Minor

Pipe the watertable in the two short gaps and fill between these 3 accessways.

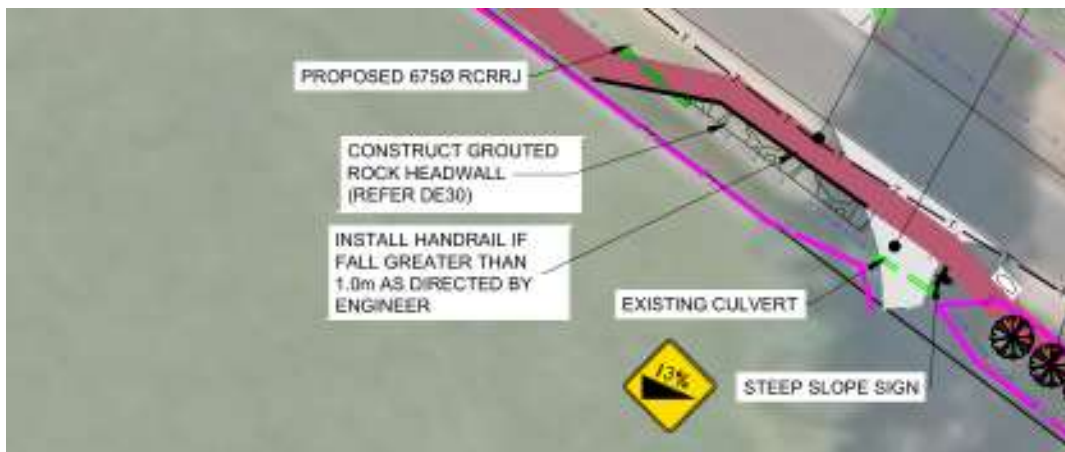
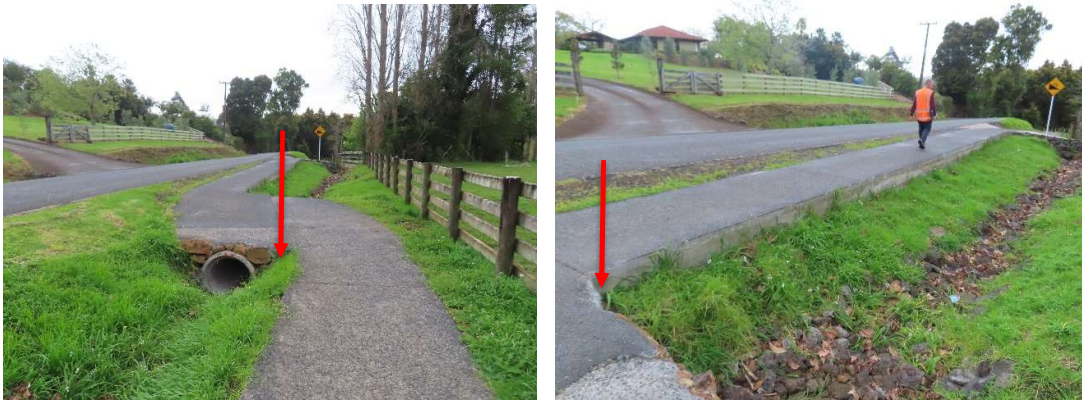
The curvature of the footpath at this location is severe, far more severe than was indicated on the design drawings, refer to **Figure 7**. A footpath user, particularly a wheeled user may drop off the footpath as they pass through this area.

In addition, there is a significant ($\approx 0.5\text{m}$) drop immediately off the edge of the footpath. Should a user wander off the edge of the footpath, they will fall into a rubble lined watertable, possibly resulting in injury. Typically, level safety zones are provided at the edges of paths to mitigate this risk. A width of 0.5 is considered appropriate for the environment.

The design drawings indicated a handrail was to be installed in this area 'if fall greater than 1m as directed by the engineer'.

Figure 7 : Watertable Ch 360; extract of design drawing (upper) and as constructed footpath (lower) showing the location of steep drops at the edge of the footpath.

1. Reconstruct this area to provide an alignment closer to that indicated on the design drawings and provide a level safety zone within 0.5m of the footpath edge.

2. Provide handrails at locations where users may fall off the side of the footpath and injure themselves.

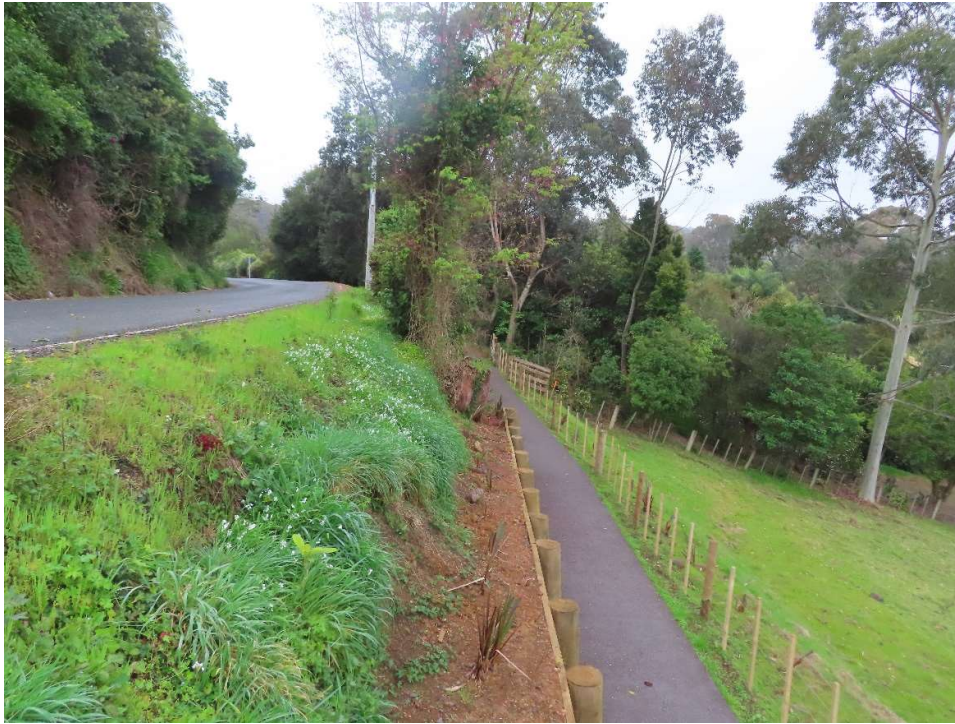
This curve, particularly with the footpath below the road on the outside of the curve, has been the subject of a petition from footpath users concerned that they are vulnerable should a vehicle lose control on this curve.

The latter of the two was accepted and implemented (refer to **Figures 8 and 9**), the designer's response to the former stated *'the probability of an errant vehicle occurring is infrequent, this combined with the very unlikely chance of a pedestrian being on the path at the same point gives a minor risk rating using the Table 1 assessment matrix'*

There is, however, a residual risk that such an incident could occur, albeit very infrequently. This risk could be further reduced by providing appropriate delineation on this curve.

Figure 8 : Footpath at curve at Ch400.

Provide appropriate delineation on this curve.

Designer's recommendation: Install reflective roadside edge markers NZTA M14 by Sreka Industries or similar approved. Spacing as per Guidelines for Rural Road Marking and Delineation RTS 5.

Horizontal spacing of posts on outside of LH curve shall be 50 m.

Posts shall be placed vertically so that the top of the post is 900 mm above the adjacent edge of the

traffic lane. Posts not further than 3 m from the side of the adjacent traffic lane. Where no shoulders exist a lateral clearance of at least 1.2 m to the adjacent traffic lane shall be provided where practicable.

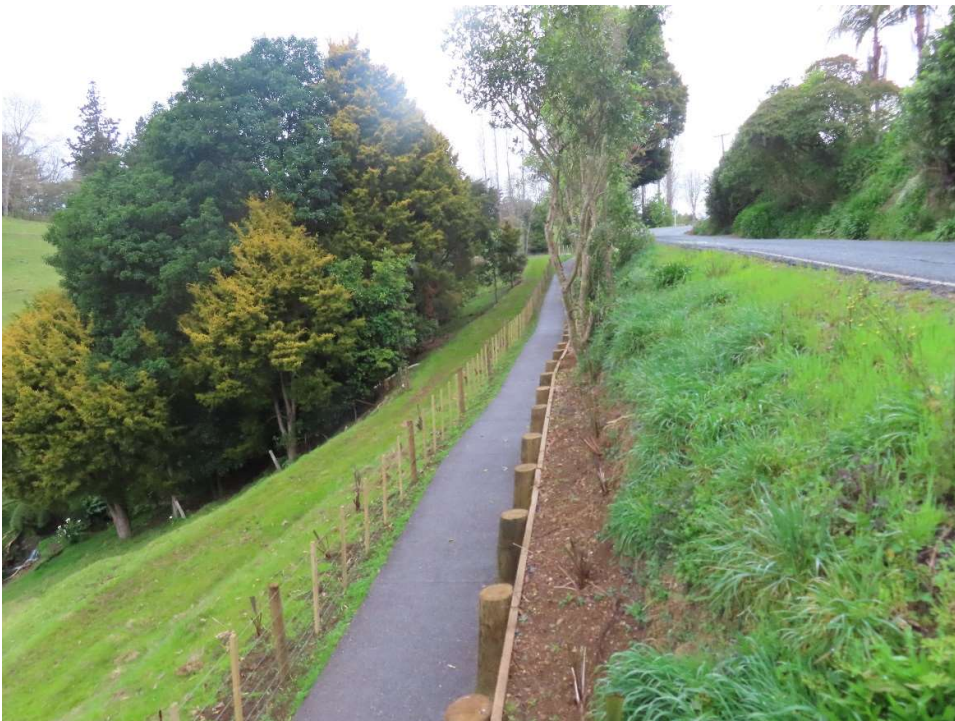
Figure 9 : Footpath at curve at Ch400.

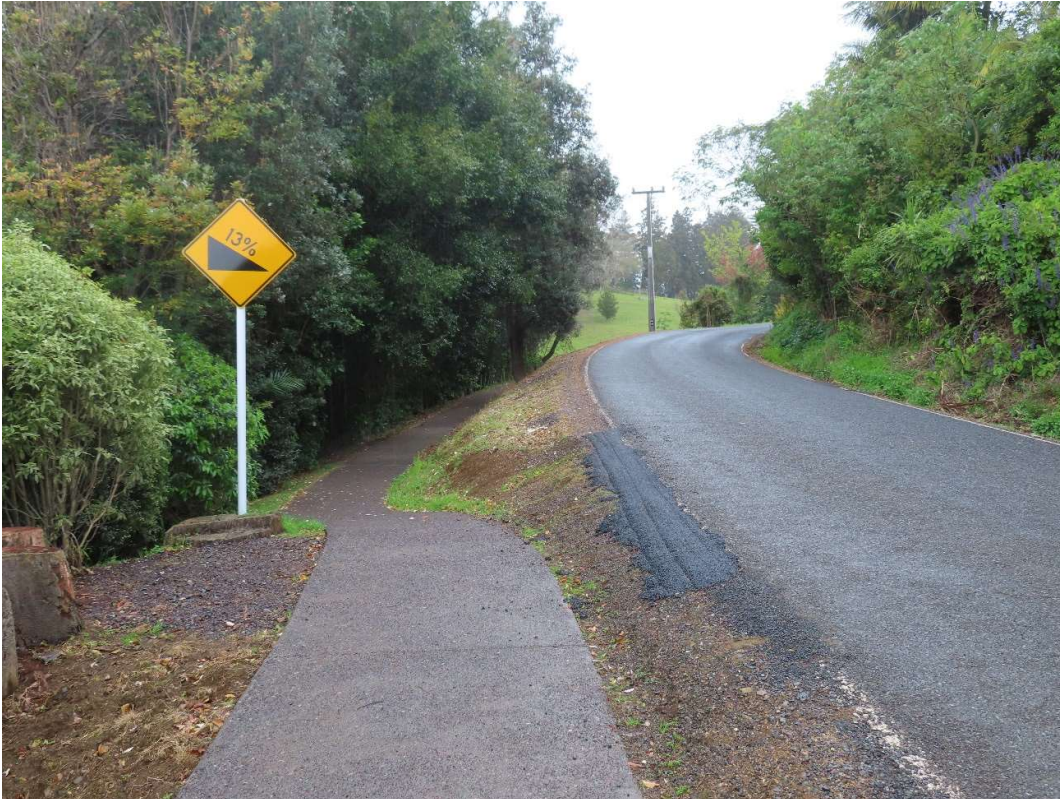
This sign has been erected to warn footpath users of a 13% downhill gradient, the gradient is relatively short. However, the sign erected is a full-size road sign and to approaching drivers it looks like it relates to road users (refer to **Figure 10**). This is potentially confusing as the road immediately following the road sign ascends a gradient. Given that the sign is potentially confusing to road users and the downhill gradient on the footpath is relatively short it should be removed.

Figure 10 : Downhill gradient sign Ch 550.

Remove this sign.

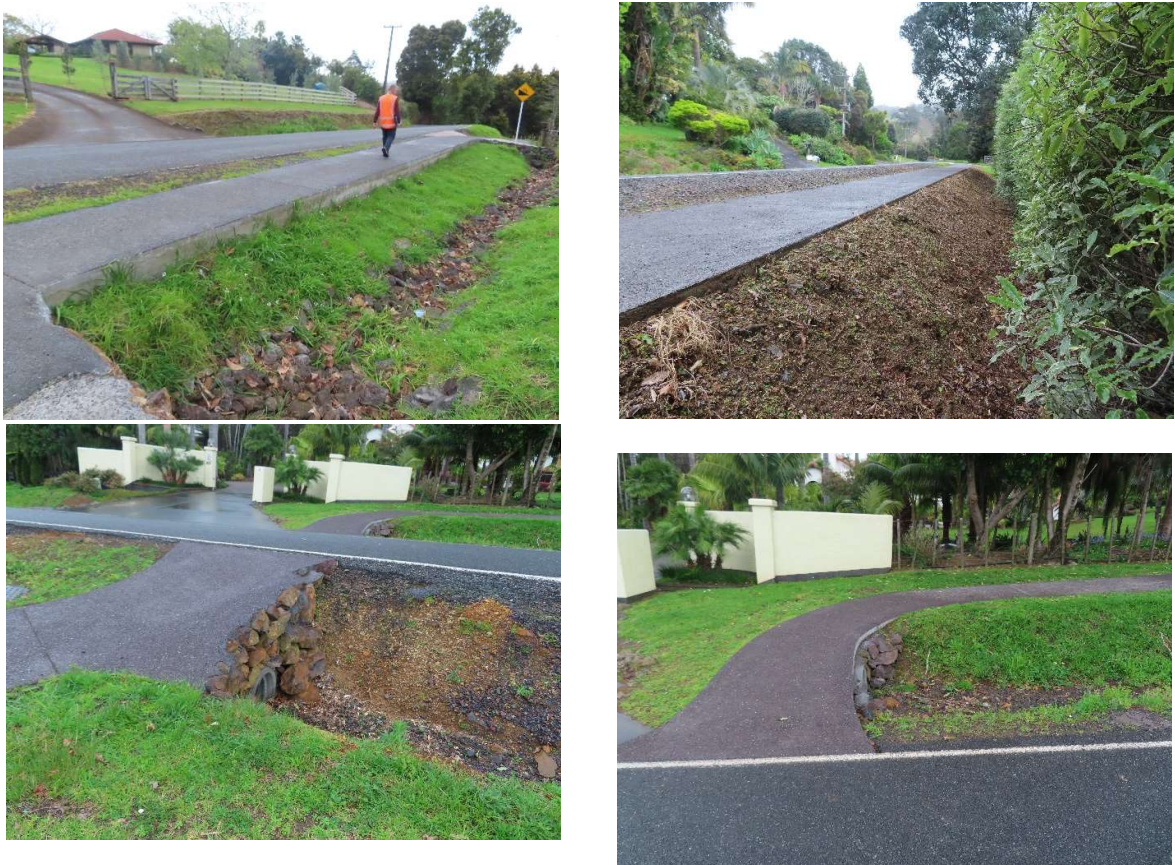
Throughout the project there are examples of there being step drops ($\approx 0.5 - 1.0\text{m}$ in height) immediately off the side of the footpath. In these circumstances should a user slip or accidentally wander off the footpath this could possibly result in falling and injury. **Figure 11** indicates examples of these steep drops.

Typically, level safety zones are provided at the edges of paths to mitigate this risk. A width of 0.5 is considered appropriate for the environment.

Figure 11 : Examples of steep drop offs off the edge of the footpath.

Provide a level safety zone within 0.5m of the footpath edge.
