Subject: Freese Park, Omapere – Erosion issues

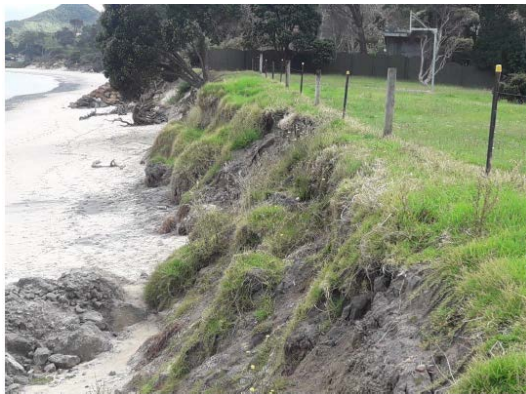
December 2018

Since the photo taken in December 2018, the Freese Park foreshore has continued to deteriorate rapidly.

This coastal erosion has affected several Council assets including a picnic table, rubbish bin and what appeared to be old pipe work etc.

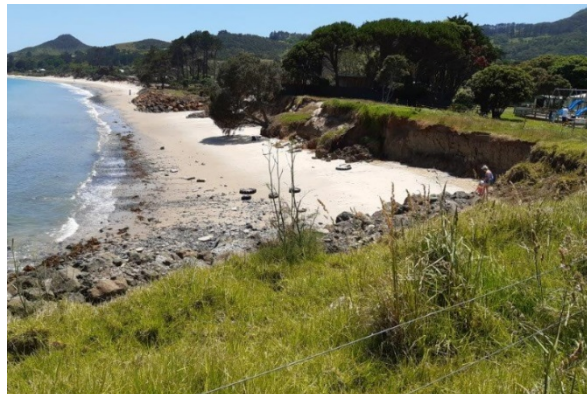
December 2019

However, the speed of this deterioration is now putting not only putting council assets at risk e.g.: playground and public toilet facilities but also neighbouring property asset's e.g.: fencing.

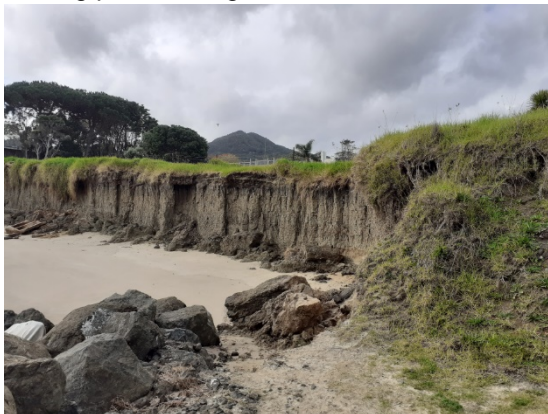
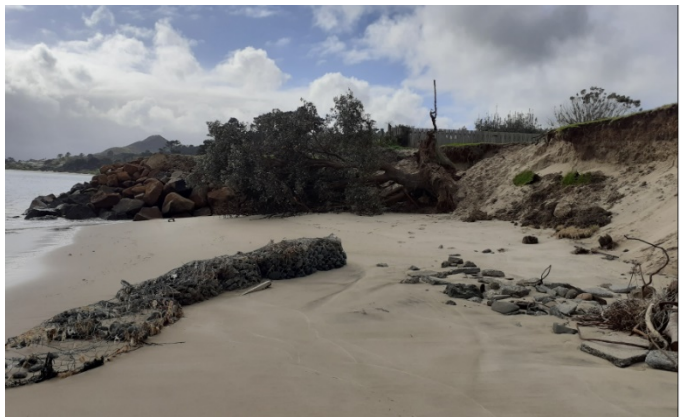
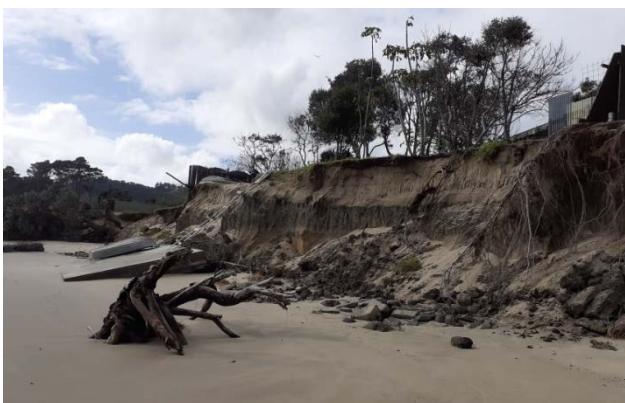
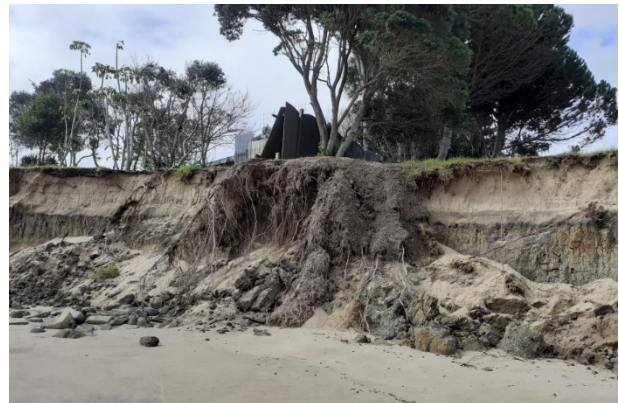
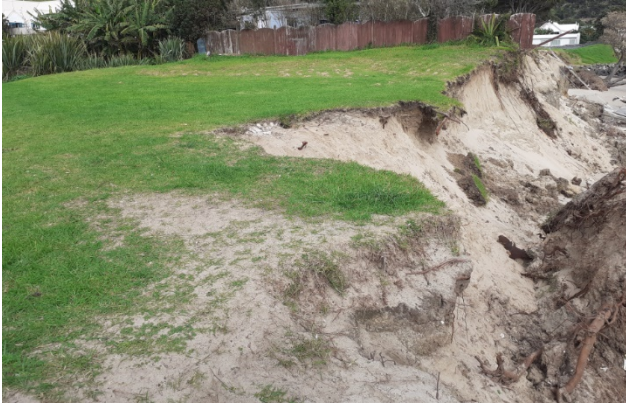
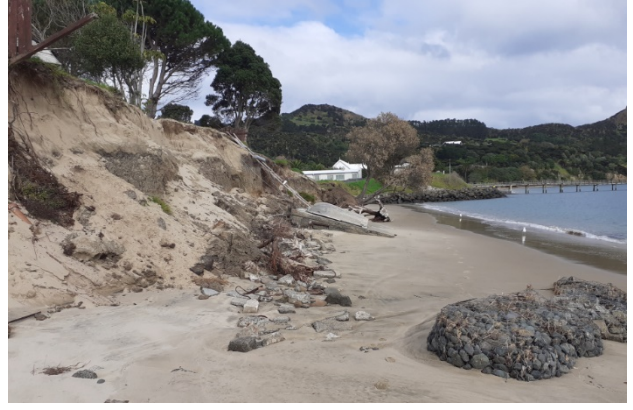
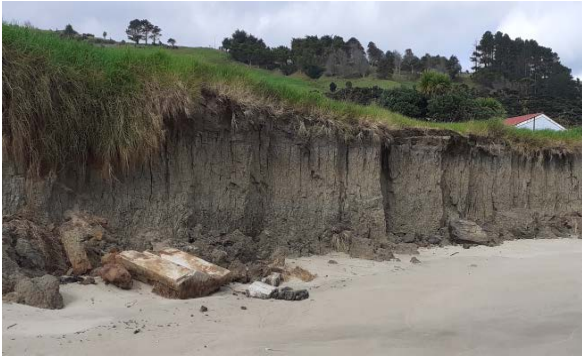
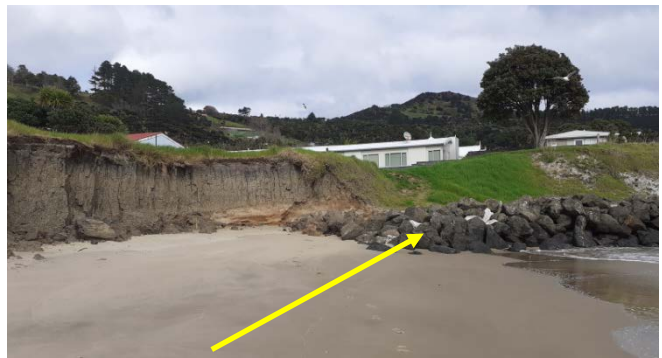
The following photo collage was taken 23 June 2020:

It is believed that works carried out to the west of Freese Park a few years ago has only escalated and channeled the damage being done along this foreshore area.
