PROPOSED RECLAMATION RANGITANE LOOP ROAD

For Far North Holdings Limited

Ecological Assessment

June 2021

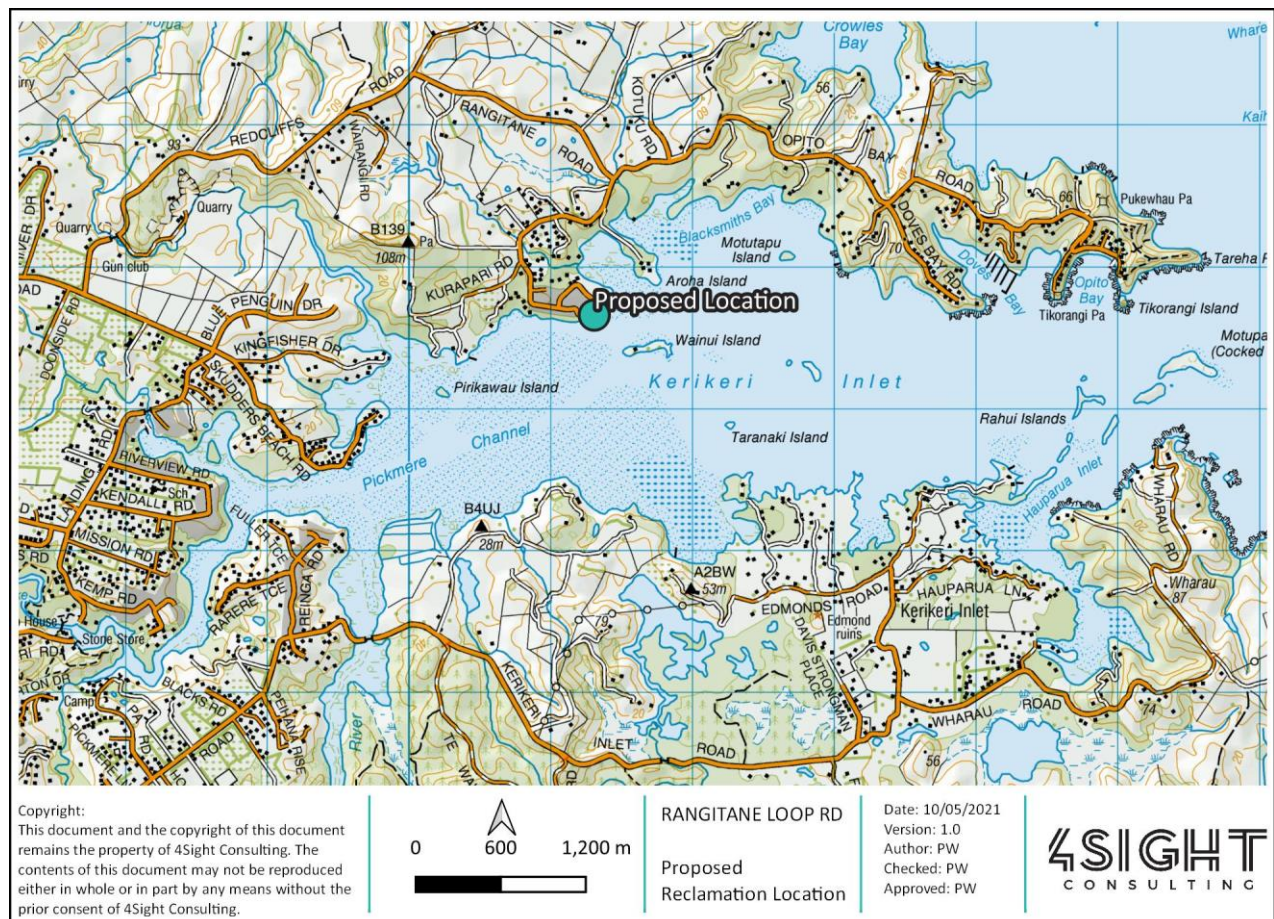
Figure 1: Location of proposed reclamation adjacent to Rangitane Loop Road, Kerikeri.

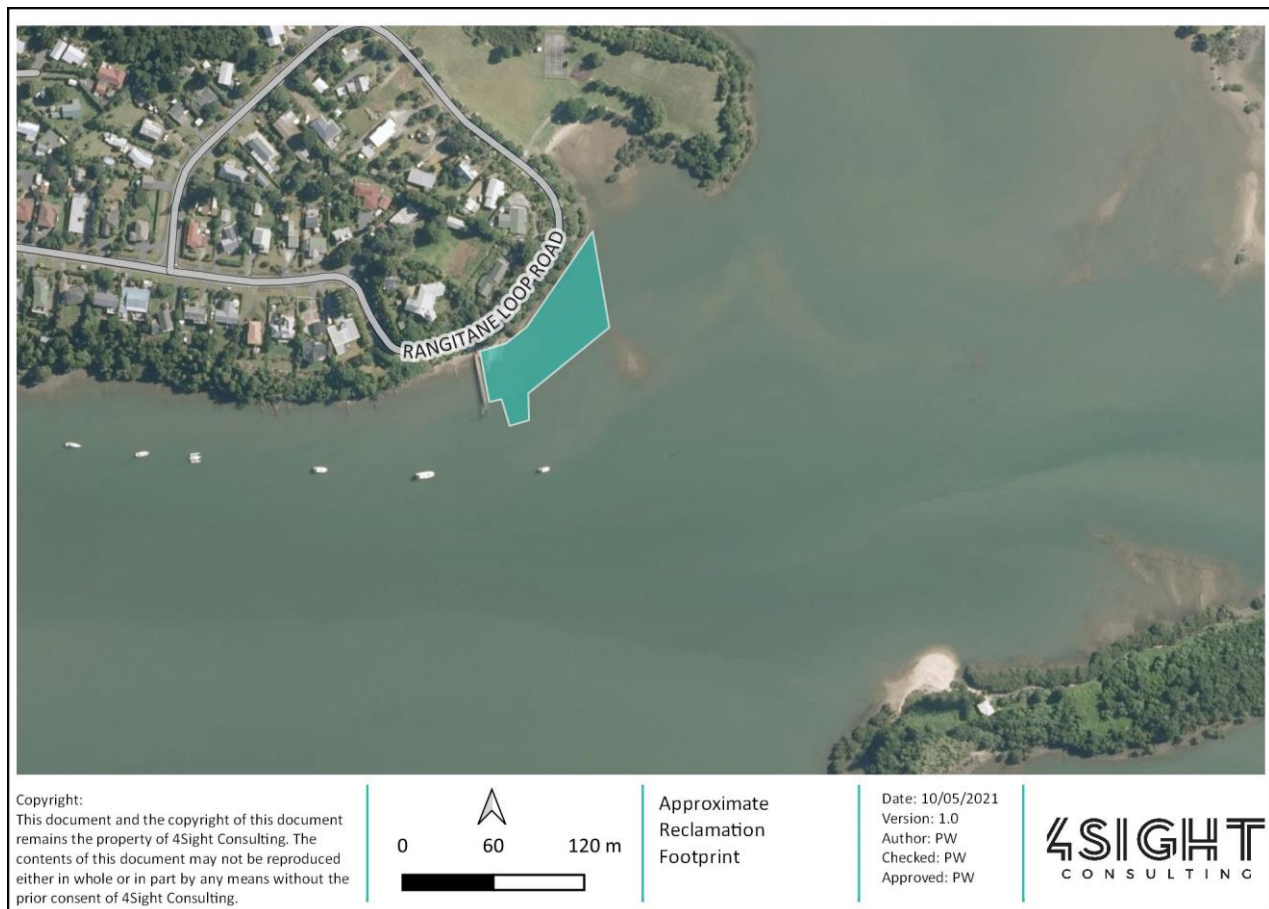
Figure 2: Approximate location of proposed reclamation (teal area), adjacent to Rangitane Loop Road, Kerikeri.

4Sight Consulting was commissioned by Far North Holdings Limited (FNHL) to provide an ecological assessment of a proposed reclamation and development at Rangitane Loop Road, Kerikeri. The proposal includes a reclamation within the coastal marine area (CMA) and installing a new public boat ramp, pontoon and carparking facility. The proposed reclamation site is shown in Figure 1 and Figure 2 with proposed reclamation concepts in Appendix A.

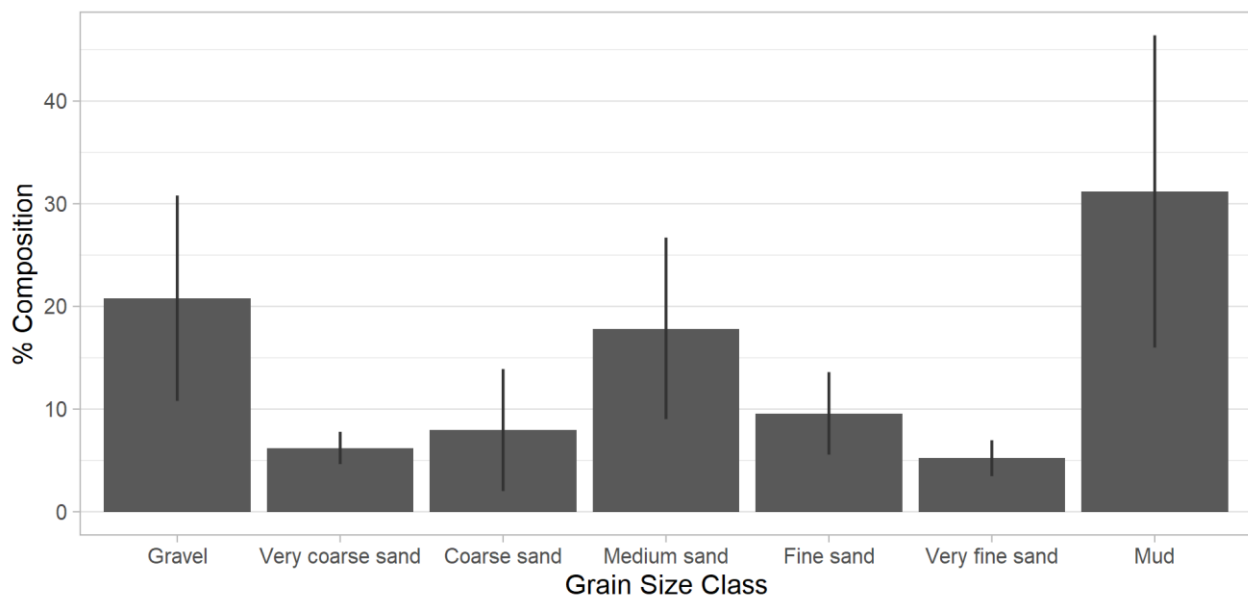
Figure 3: Summary of sediment grain size. Error bars show the 95% confidence interval of the mean (n = 5).

Grain size analysis was undertaken for the five sediment samples. Seven grain size profiles were determined and shown in Figure 3 and Table 2. On average the sediment consisted of just under a third (31.2%) of the fraction <63µm, 20% of the fraction >= 2mm and 17.8% of the fraction < 500 µm, >= 250 µm. All other grain sizes consisted of less than 10%.

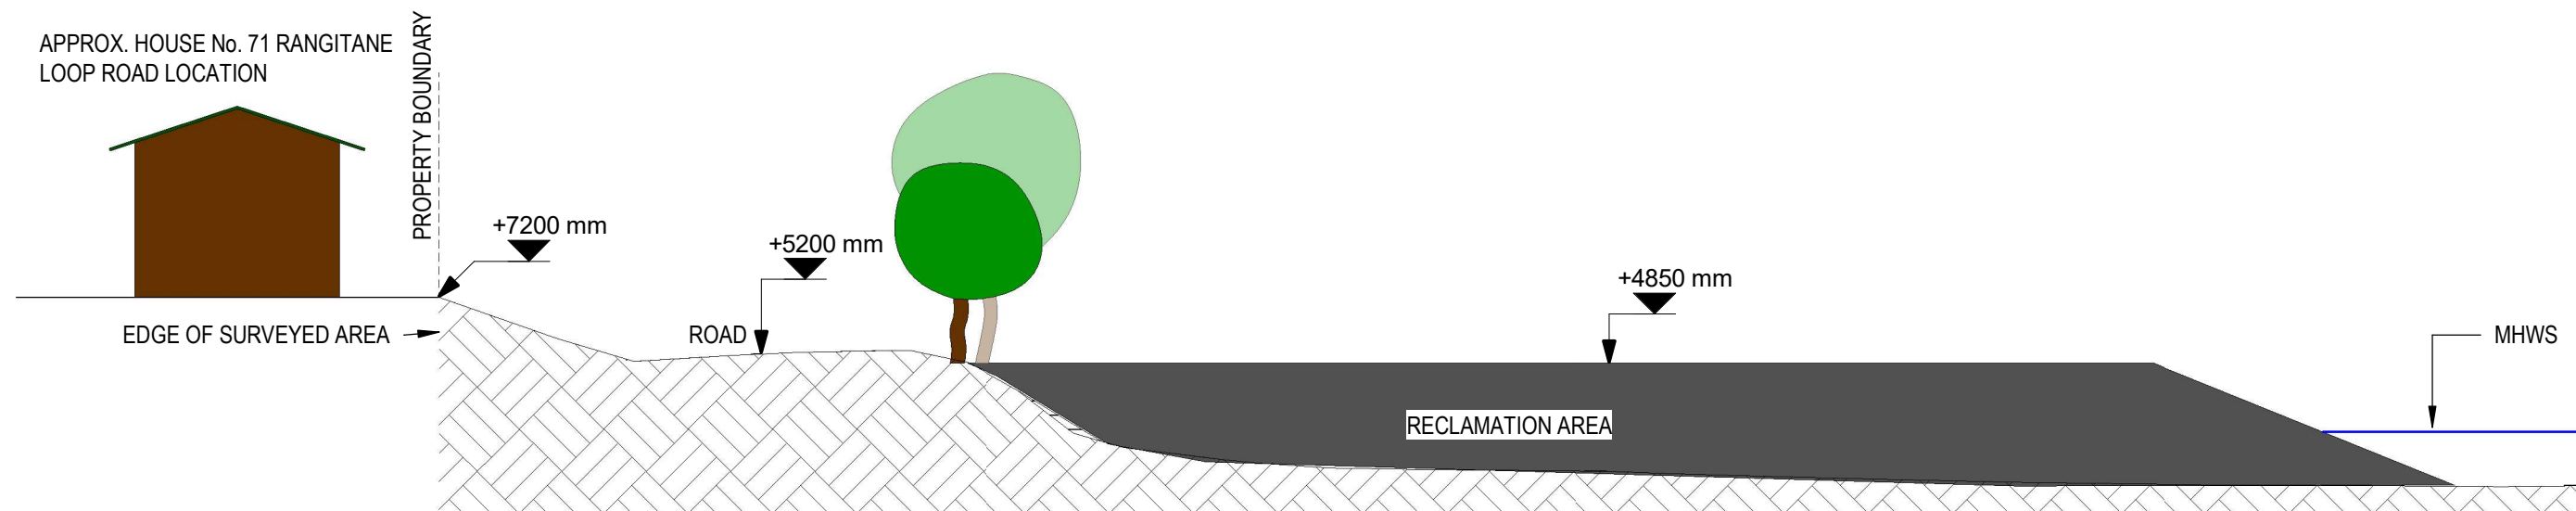
RECLAMATION SECTION
1 : 250

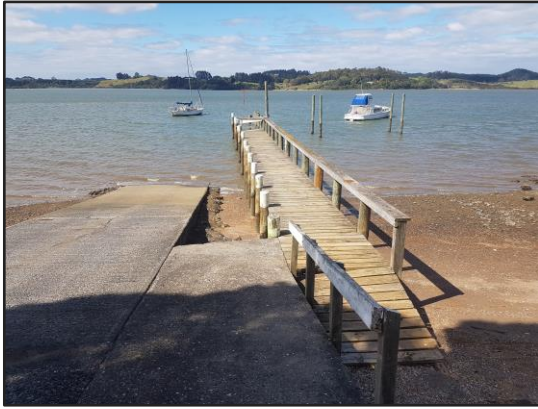
Photo 1: Existing single lane boat ramp and a timber jetty that is partially demolished at end, looking southeast to Kerikeri Inlet.

The site is located on Rangitane Loop Road in Kerikeri and faces southeast into the Kerikeri Inlet. The existing site has a tidally limited single lane boat ramp accessed directly off the road, and a timber jetty that is partially demolished.

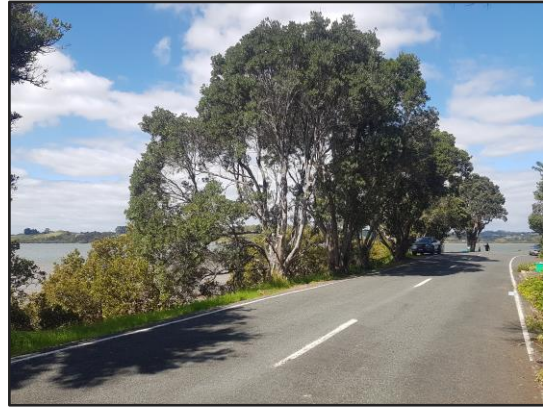
Photo 2: Landward area (road berm) above the foreshore, showing Pohutukawa and mangrove on foreshore.

The landward area (road berm) above the foreshore was inspected on 8 March 2021 (Photos 2 – 3). Planting is proposed in this area in addition to retaining the existing trees.

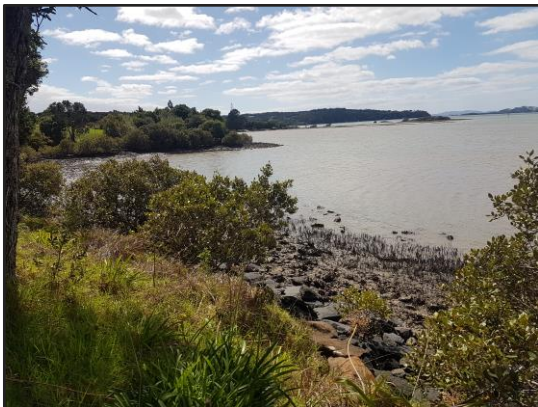
Photo 3: Landward area (road berm) above the foreshore.

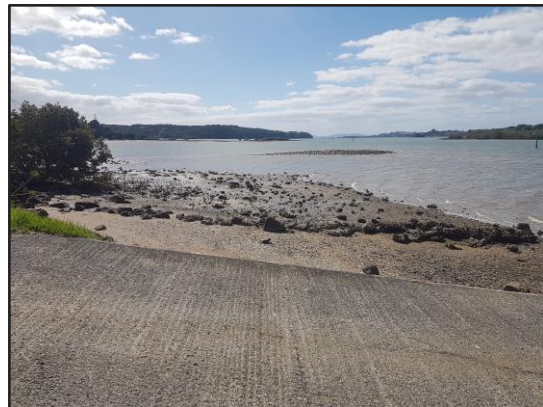
Photo 4: Low tide area.

The intertidal area was inspected at low tide on 8 March 2021 (See photos 4 – 6). The site includes a rocky area (rock retaining wall) beneath the road berm and beach of grainy muddy clay with the presence of rocks and predominantly Pacific oysters (*Crassostrea gigas*). A small rocky shoal is visible at low tide near the northern end of the site (Photo 4).

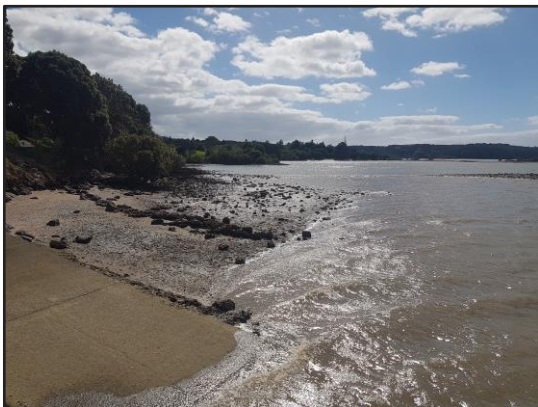
Photo 5: Low tide area.

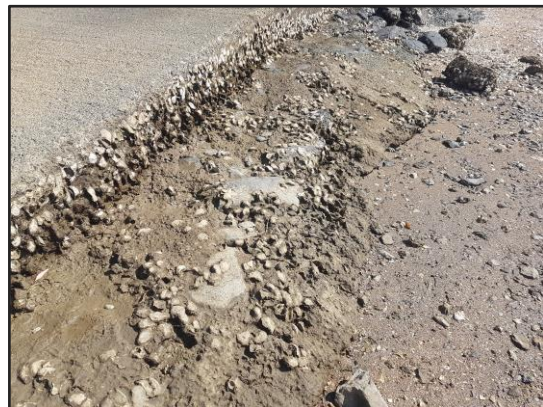
Photo 6: Presence of oysters.

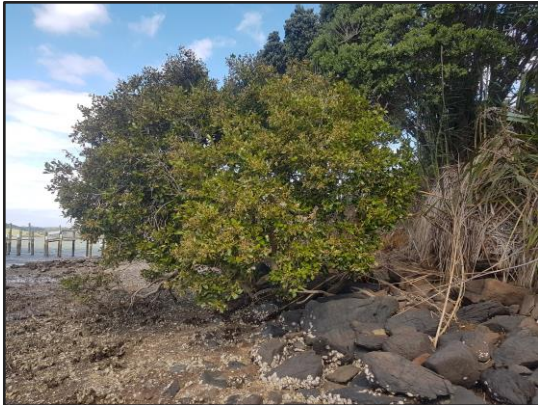
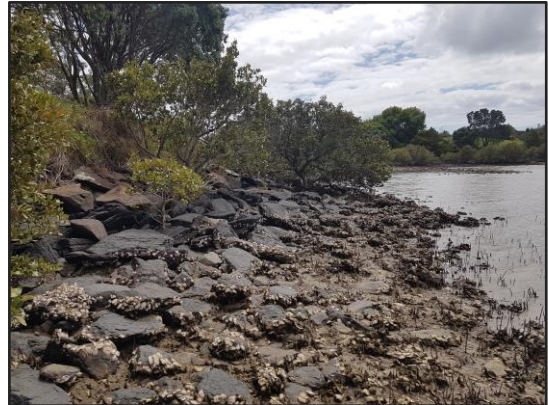
Photo 7: Foreshore showing mangrove, oysters and rock retaining area.

Photo 8: Foreshore showing mangrove, oysters and rock retaining area.

There are approximately seven shrubby three-metre-high mangroves along with pneumatophores on the lower shore and within the rock retaining wall (Photos 7 – 8). The reclamation and/or works area will potentially involve the removal of these mangroves.

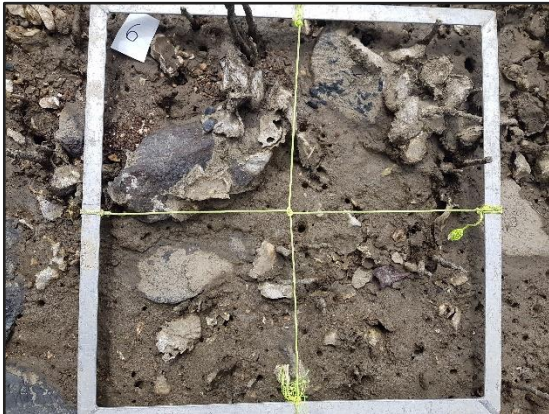
Photo 9: Quadrat sample 6.

Six intertidal sites were surveyed at low tide using a 0.25 m² (0.5 × 0.5 metre) quadrat, recording biota abundance as number or percent substrate cover as appropriate (Photos 9). To assess relative abundance of crabs, mud holes were counted in the quadrat locations. Intertidal sampling locations are shown in Figure 5, page 11.

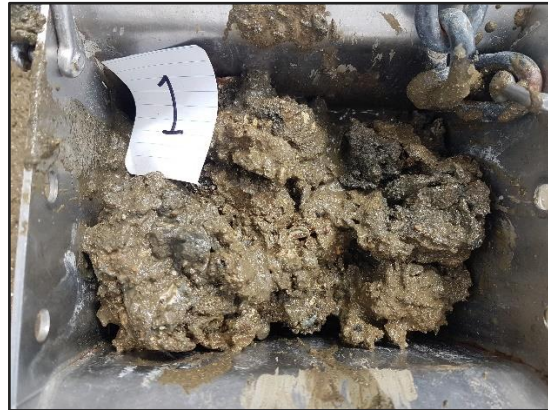
Photo 10: Biota sample 1.

Sediment was collected on 8 March 2021 (Photo 10).

Samples were generally fine dark grey muddy sand with a light brown surface layer and most had organic debris and shell hash present. A typical seabed sample is shown in Photo 10.
