Approved by Far North Distirct Council at an ordinary meeting dated 28<sup>th</sup> May 2023.

Author Organisational Solutions Ltd Local Government Planning and Resource Management	Shawn Baker	11 May 2023
Reviewer NorthLand transportation alliance	Elizabeth Stacey	12 May 2023

The Kerikeri Bay of Islands Interim Speed Management Plan has been produced under the transitional provisions of the Rule as it will come into force prior to the 2024 - 2027 RLTP.

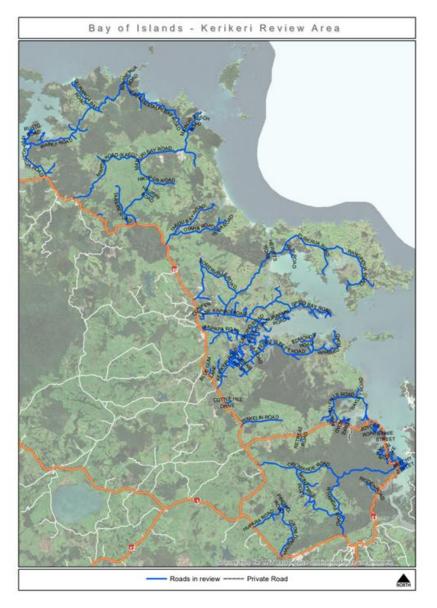
This Interim Speed Management Plan includes all roads to the east of State Highway 10 and extends from State Highway 11 in the south (Kawakawa – Opua) through to the Whangaroa Harbour in the north. and includes:

- Kerikeri urban area
- Opua
- Paihia
- Waitangi
- Haruru Falls
- Whangaroa

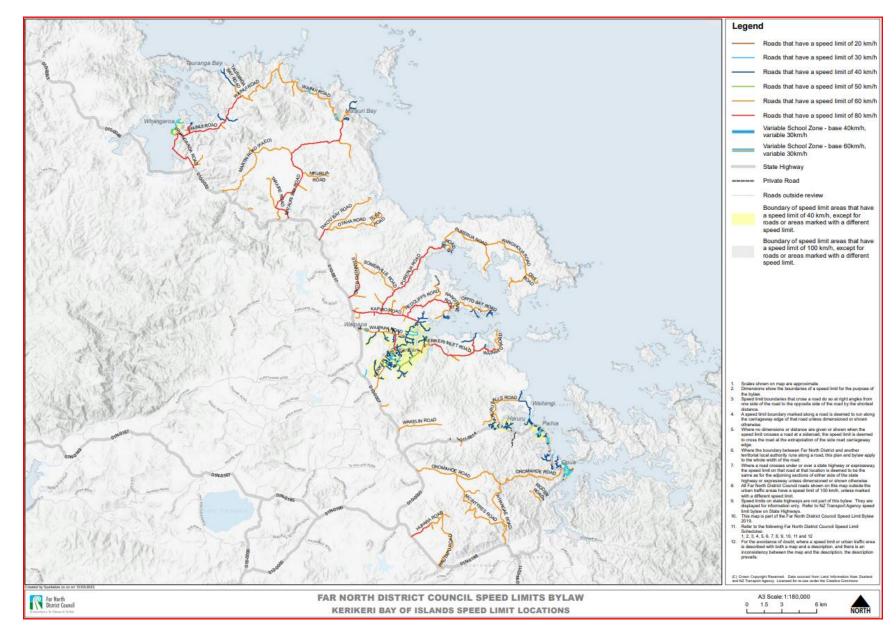
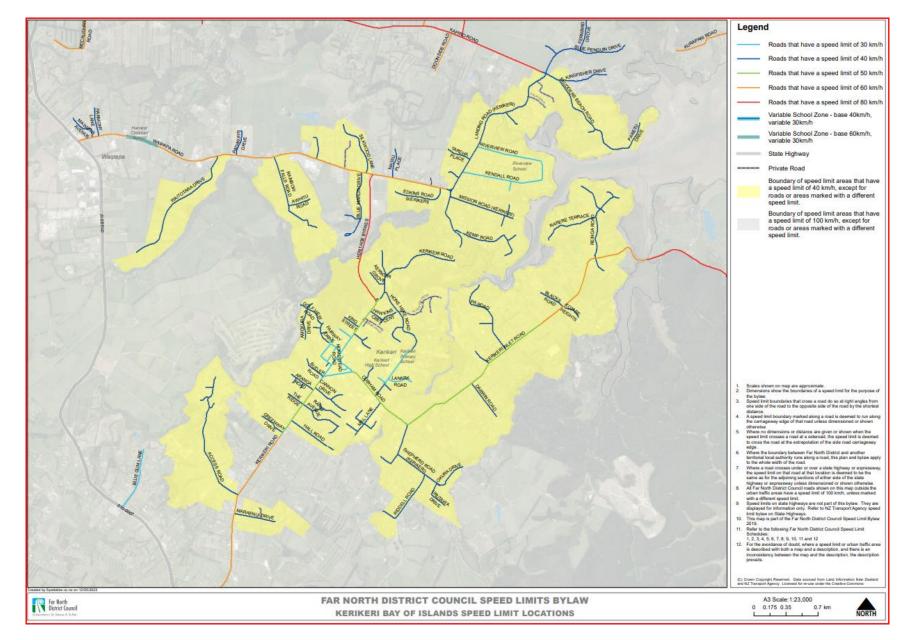
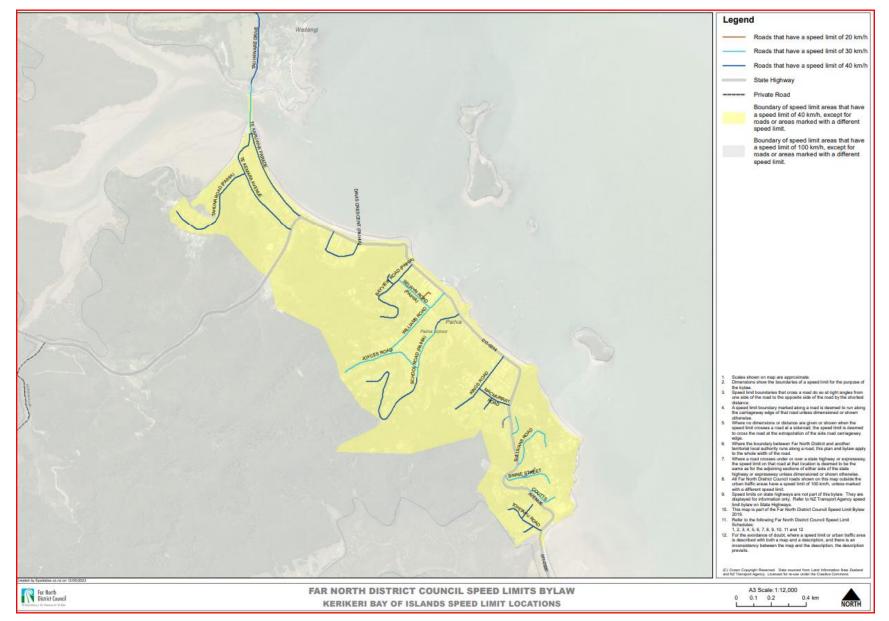
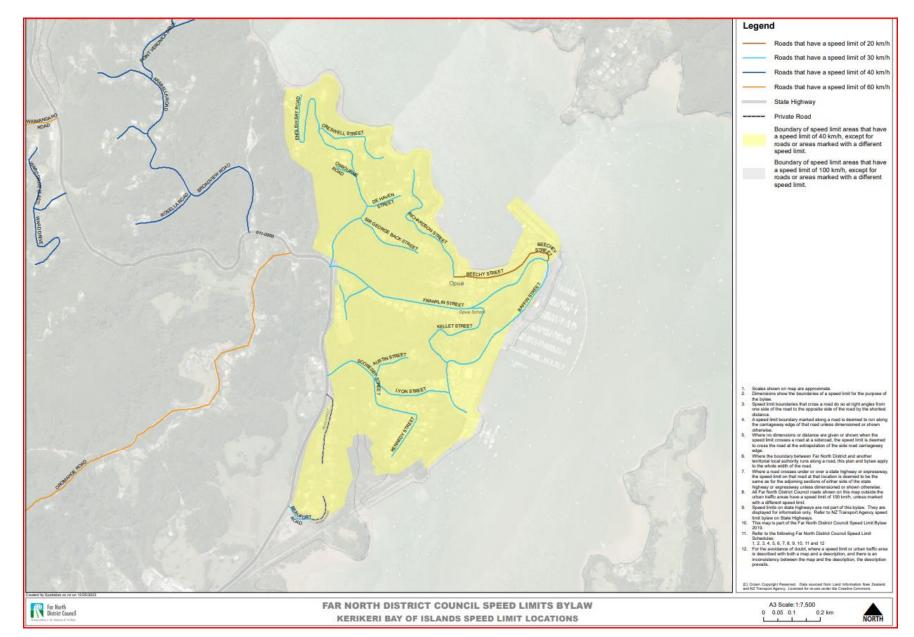
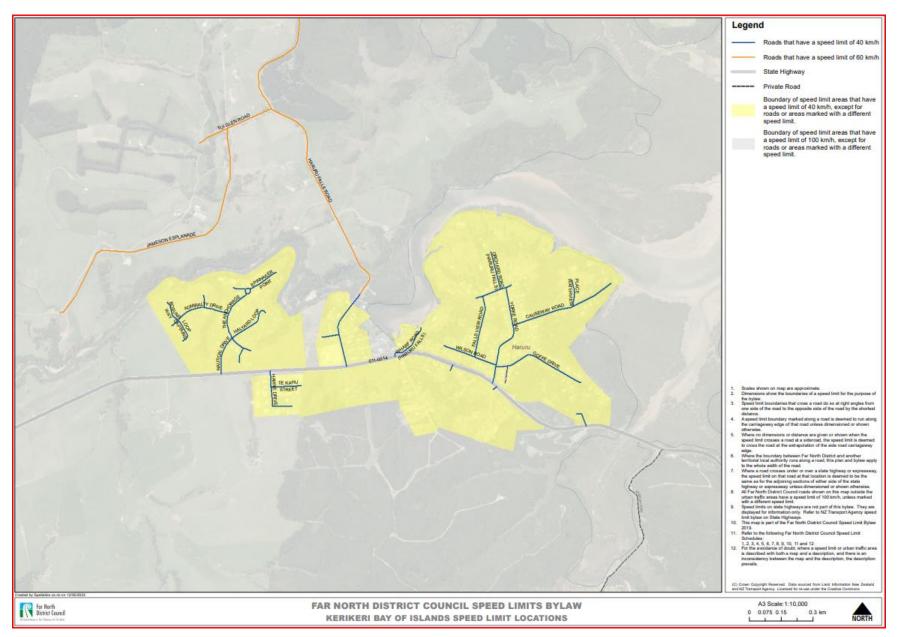
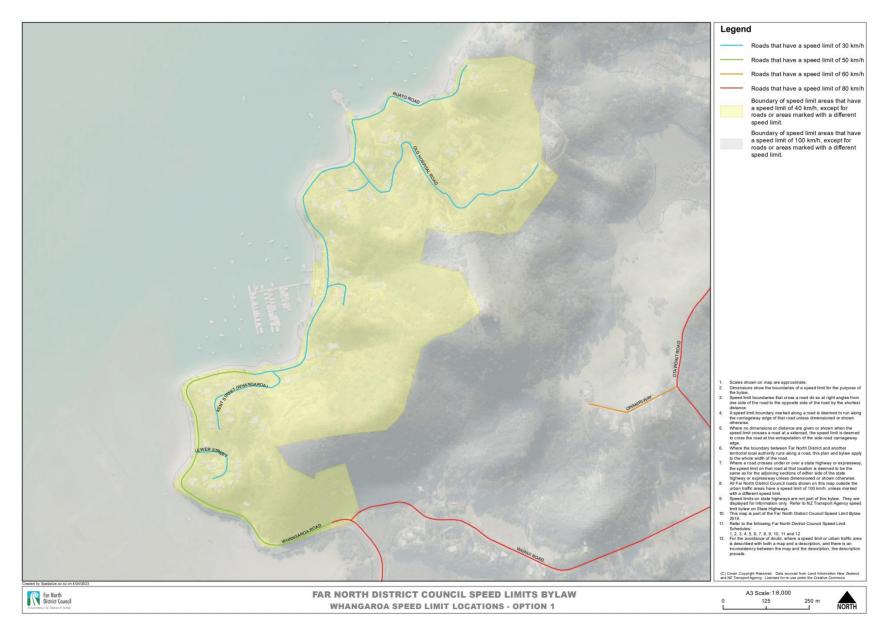
The following maps set out the speed limits described in Section 5. It should be noted that the maps contained in this Interim Speed Management Plan are supported with detailed GIS information and identified Reference Points (RP) identifying the actual speed limit transitions. Maps with RP's identified are utilised for the purposes of detailed design and implementation. RP's are not included in the maps in this Interim Speed Management Plan due to the need for clarity at the published scale. Not all road names are identified in the following maps due to the need for clarity at the published scale.
