FAR NORTH DISTRICT COUNCIL
CONTRACT 7/18/101

Road Maintenance and Renewals Contract

MONTHLY REPORT – NOVEMBER
2023

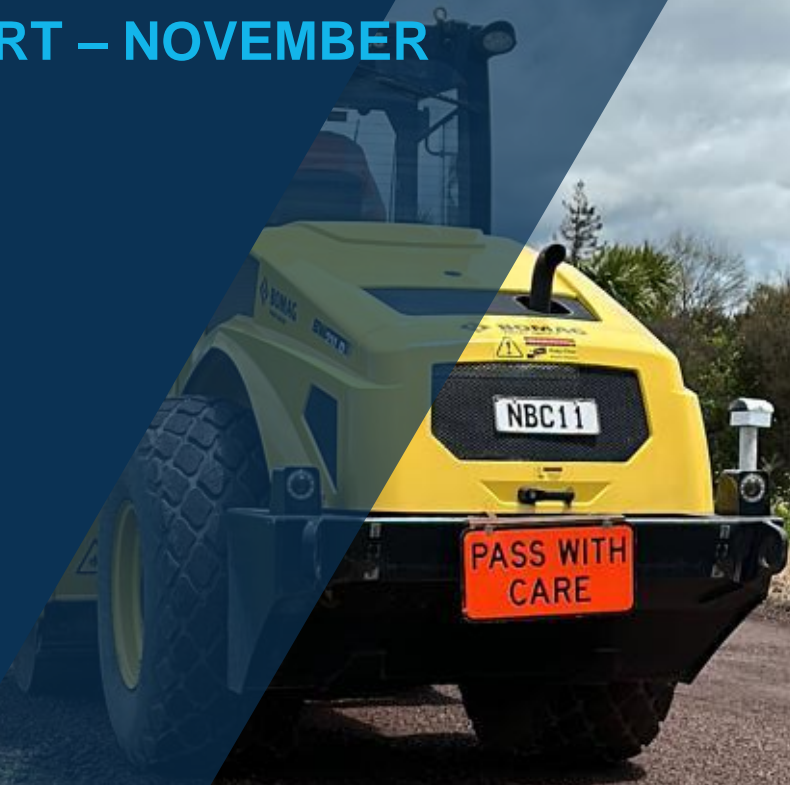
*Preseal Repairs – Putts on
the roller*

We are about 50% of the way through our pre seal repair programme and have all but completed everything except Russell. This year a large proportion of our works are in Russell. We are making a start on the critical Russell sites early December in a bid to make them safe for the Christmas period. We will carry on with the remainder of the programme in January.

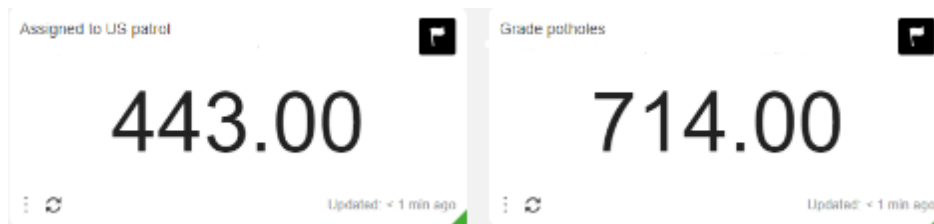
Routine Response Time Band checks

Monitoring for potholes per road & those cleared by patrol crew vs. grading.

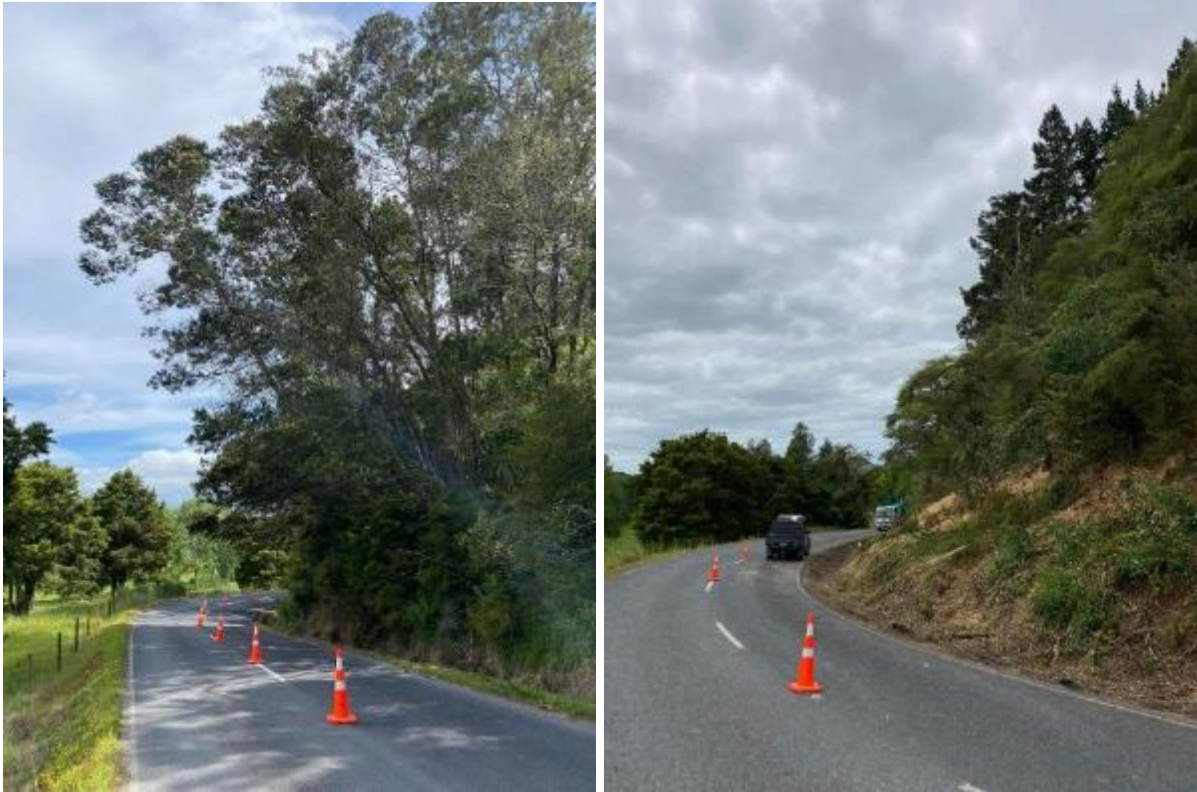
Before/after Pokapu Rd

The main emergency works in November were trees from the weather event late October. We also had a slip on Waitotemarama Gorge Rd and Oromahoe Rd.

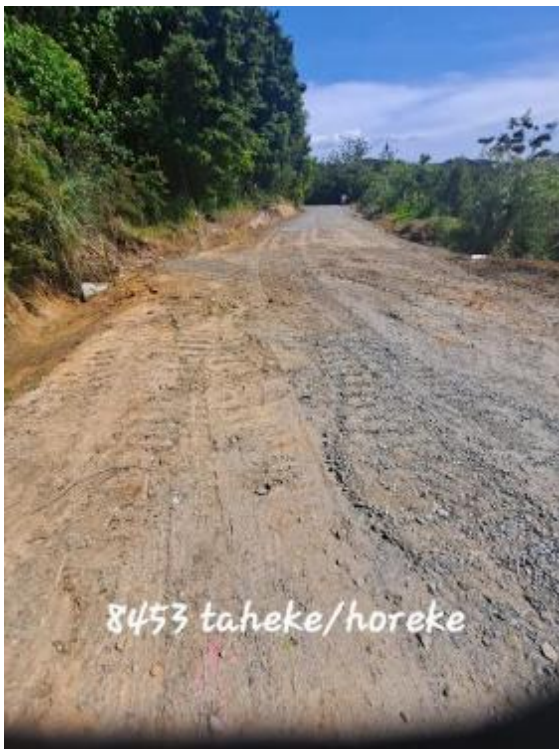
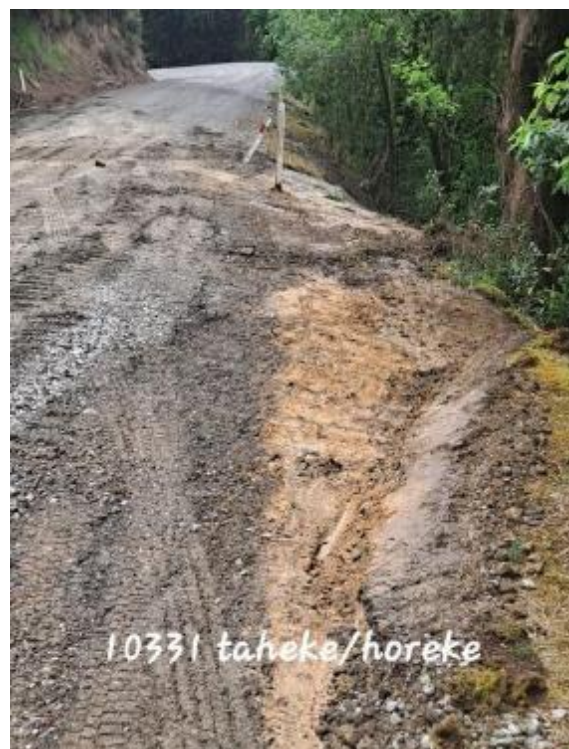
Taheke Horeke Rd culver renewals

- 251m of heavy water tabling (Storm recovery package & scheduled work).
- 137m of water table reconstruct/scouring. (Storm recovery package & scheduled work).
- 46.5m of Culvert pipes replaced/new. (Renewals Programme).
- 3 Culverts flushed.

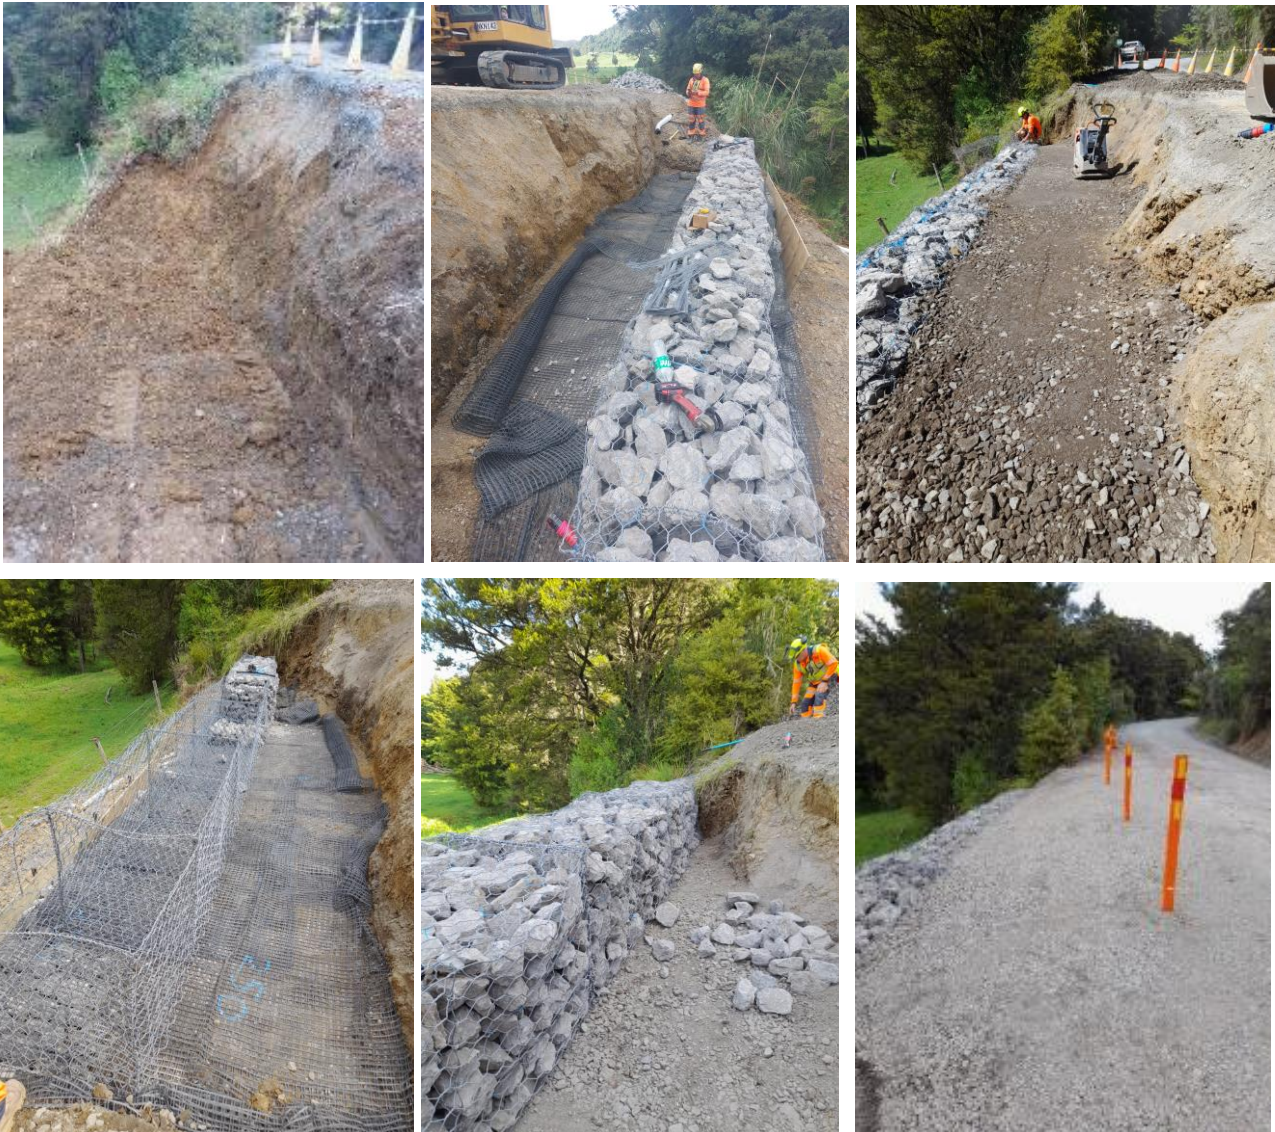
Pipiwai Rd Under slips

We carried on with phase 2 works, but we mainly worked on tidying up lots of the smaller remaining storm damage. Our subcontractor DCL carried and completed a gabion retaining wall on Pipiwai Rd.

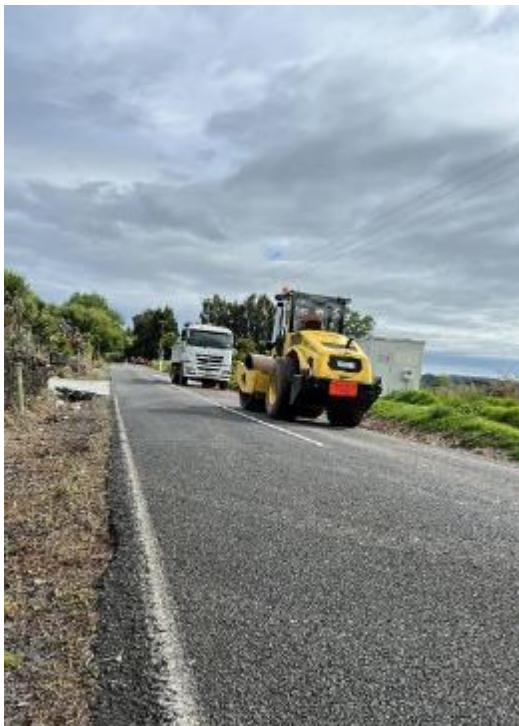
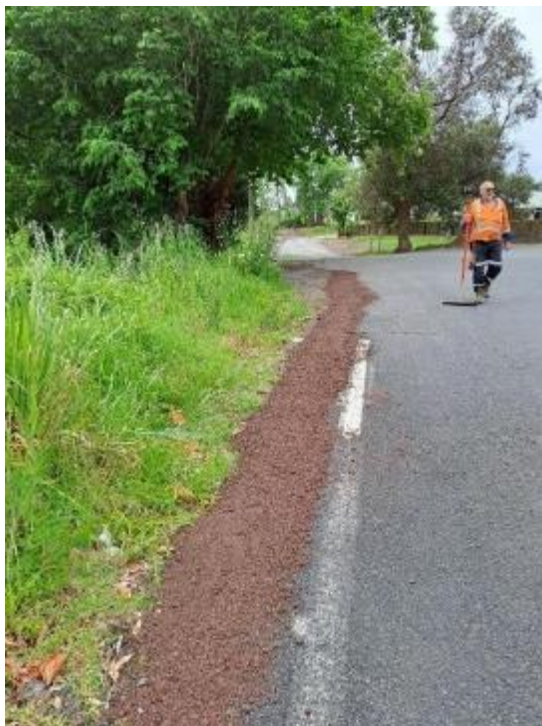
Preseal Repairs Keri inlet Rd / Waiomio Rd

- 615.7km of spraying.
- 592.9 m2 of Digouts and 1,050.6m2 of stabilised patches.
- Edge breaks/Shoulder repairs
- Kerb and Channel sweeping round started the week of the half marathon and started with sweeping of marathon route.
- Rubbish Run involving litter collection of the half marathon route.
- Wet roll and grades began late November, making a start on Whangae Rd

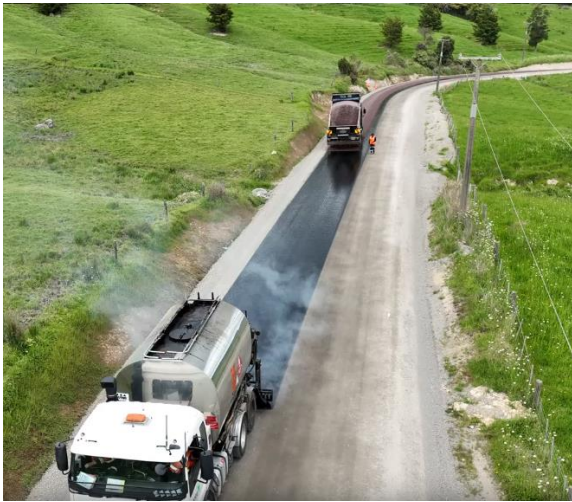
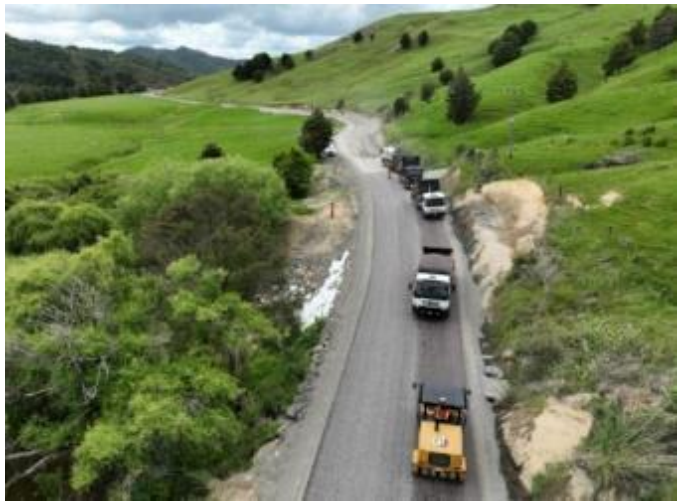
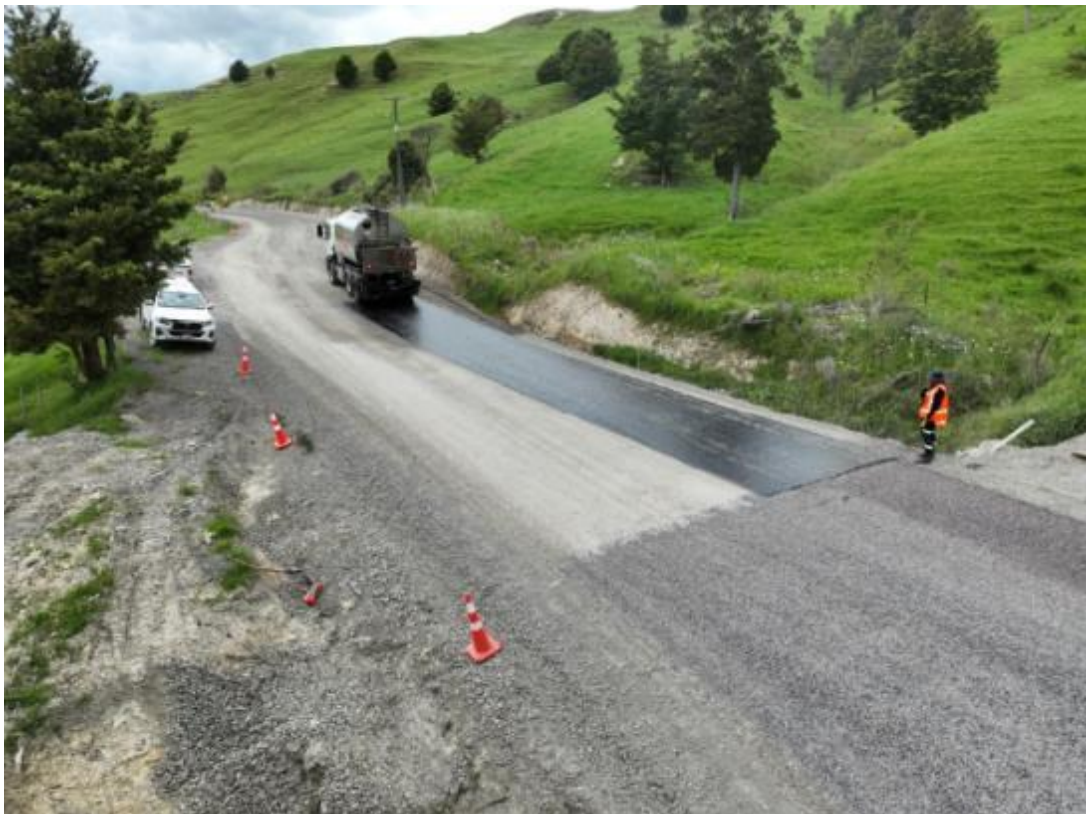
1. **Ngapipito Rd 1850-3000m** – Sealed on the 9th of November. Line marking has been booked next week once sweeping has been completed. Sealing drone footage link below:

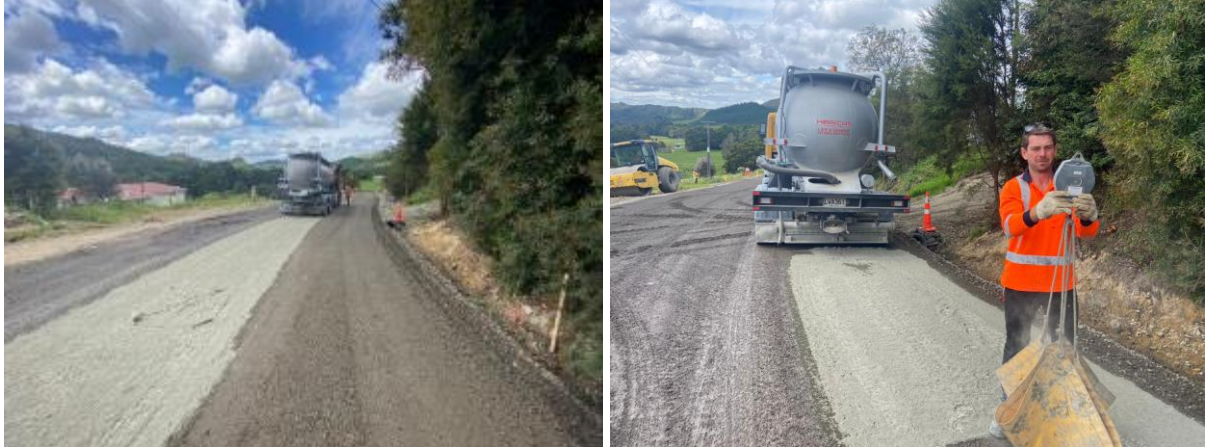
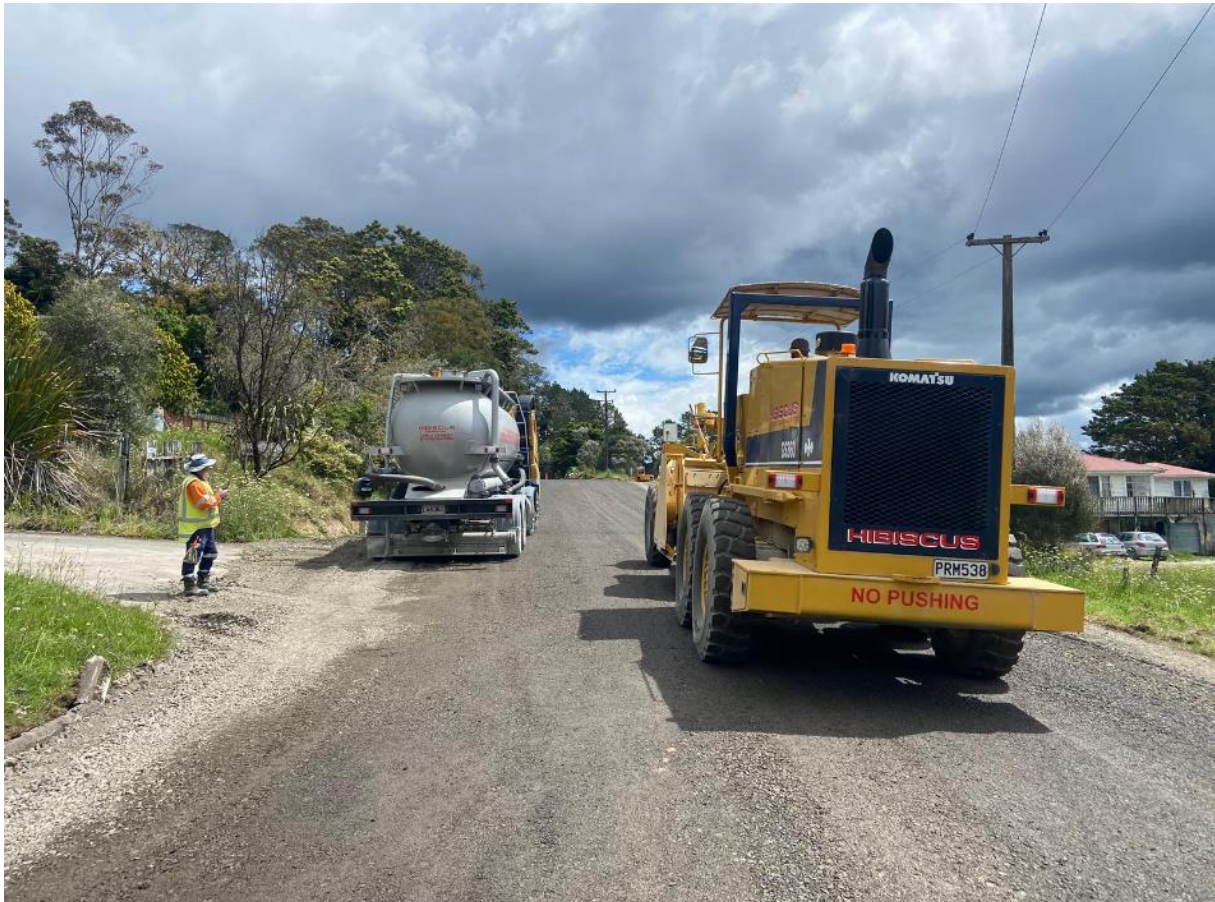
2. Orakau Rd 14822-15050 –

The construction team moved onto Orakau rehab after Ngapipito road. This was a 220 m long rehab section with minor drainage works and 200mm overlay. Site was stabilised on the 22nd of November and sealing has been booked in for the 29th of November.

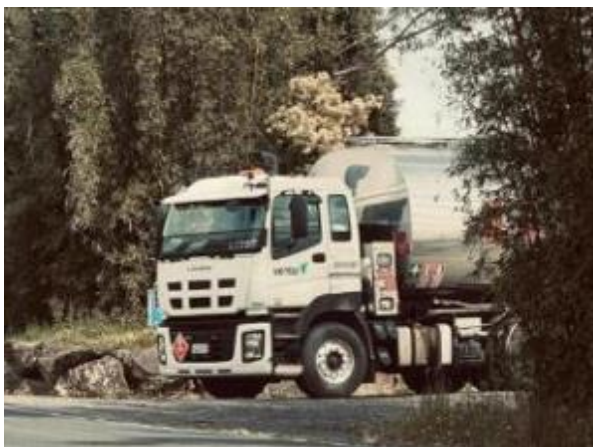
FNDC Reseals 2023/2024

In November we have completed 15 kms of the reseal programme. This included three second coat seal sites totally 5kms on Ruapekepeka Rd, and various sites within, in both Kerikeri and Russell. Reseals also began on Wiroa Rd, and you may have noticed that we left out the sites east of the Wiroa Rd/Waimate North Rd intersection (in front of the airport) We did this to avoid the Fulton Hogan State Highway detour trafficking our sites. These remaining Wiroa Rd sites will be completed once the detour has been disestablished.

- Reseals Length Remaining
- Length Resealed to date (Sept - Nov)

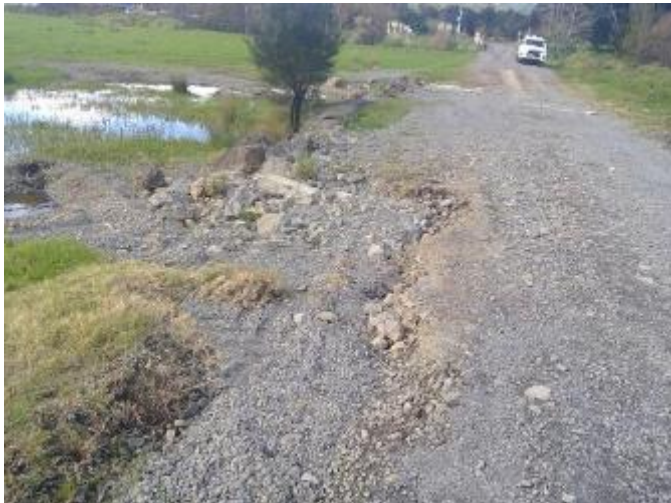
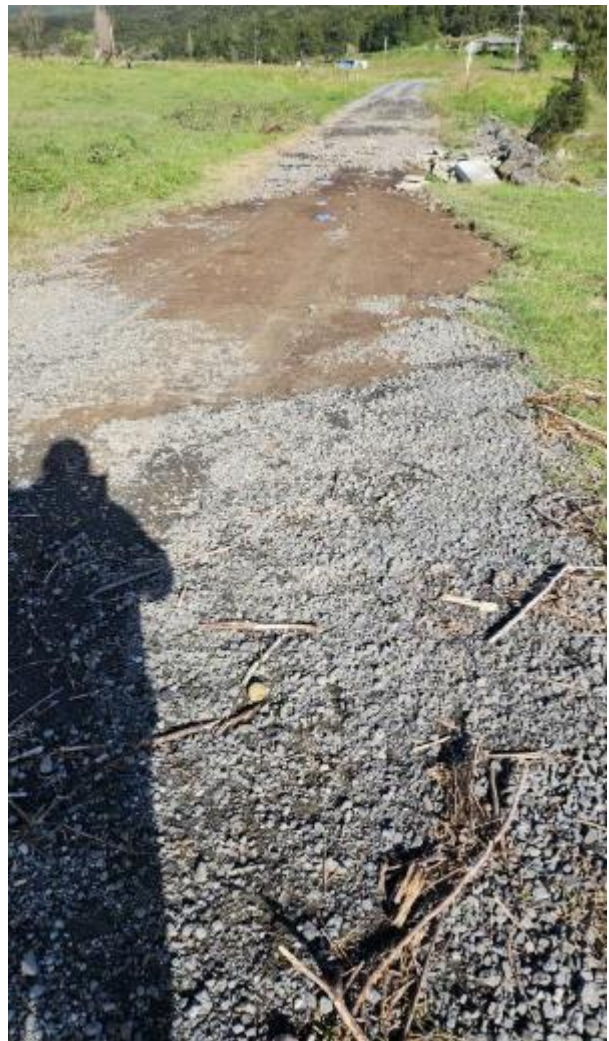
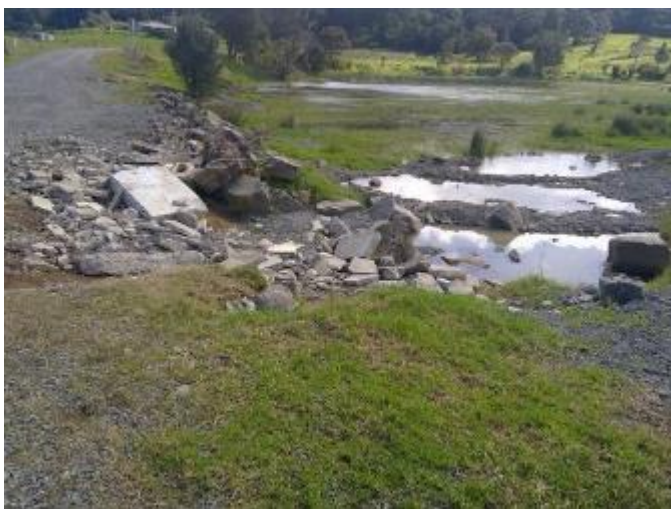
Before

After investing a lot of time and money in addressing the ongoing challenges on Otatara Marae Rd, both our team and the residents got tired of the persistent road damage. The area, prone to flooding, had an additional historical complication – a road positioned right through its centre.

In response to this issue, a collaborative brainstorming effort led to the installation of a concrete ford just this month. The results have been overwhelmingly positive; residents are delighted, our team is satisfied, and the overall road network is now more resilient against future weather events.

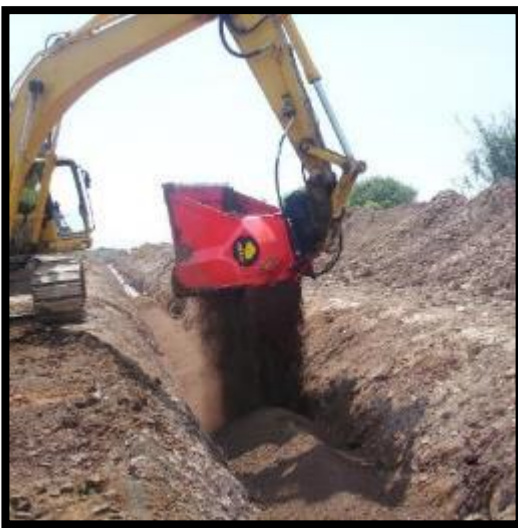
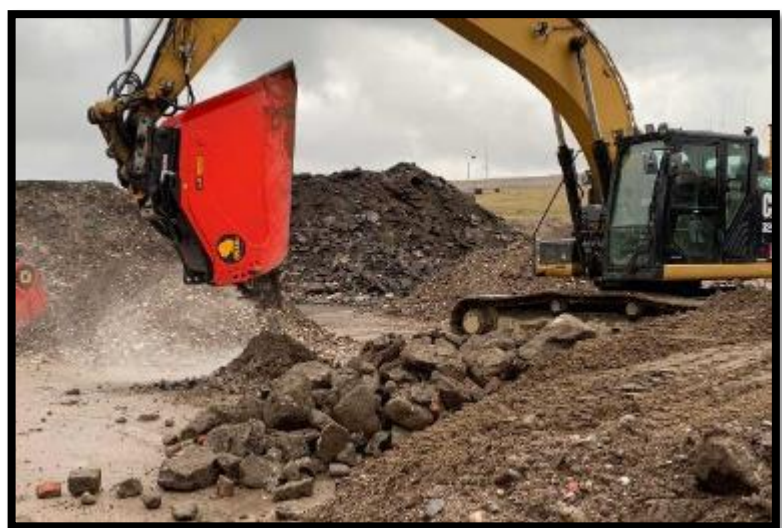
One of our plant hire friends (ACE Rental) came along and spoke about the various attachments they hold throughout the North Island for their excavators. We are currently exploring options around these for better sustainability. Below are two examples of hitch attachments – Screening material excavated to place back in place (reducing emissions by carting less from site and reusing resources). Right hand side is a crushing bucket. Taking concrete and crushing while on site. We are unable to utilise this with our concrete team just yet as we operator with a small excavator, the crushing bucket works very well on the machines over 20tn. But watch this space the future. Imagine damaged concrete being reused right where it was removed as basecourse for fresh new concrete.

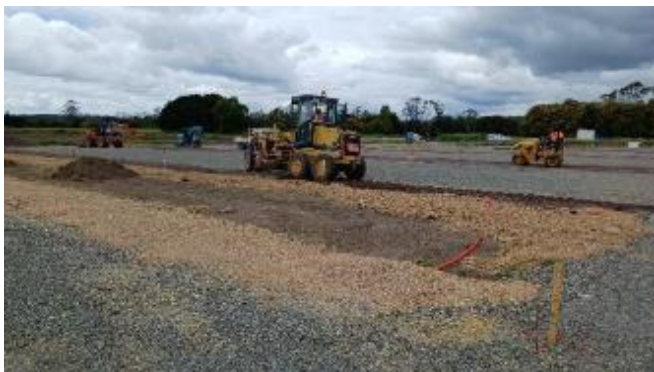
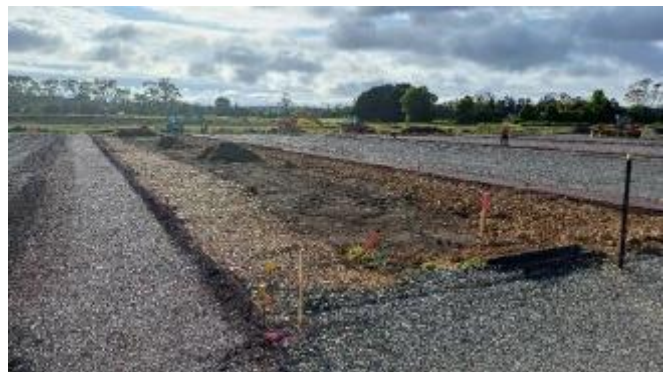
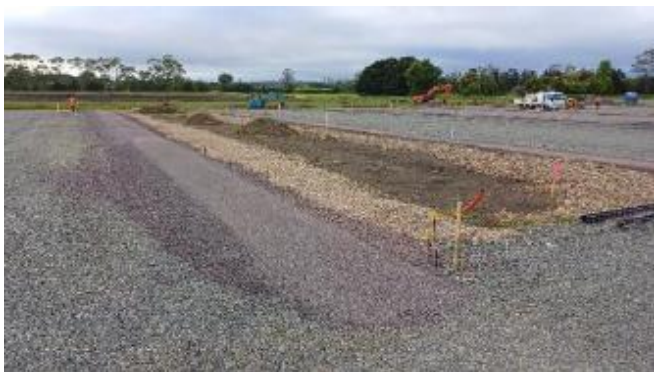
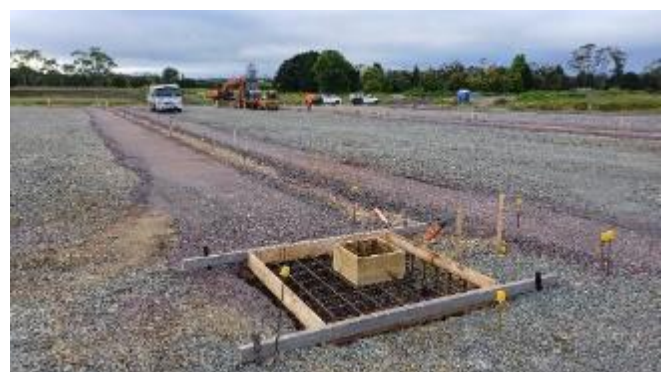
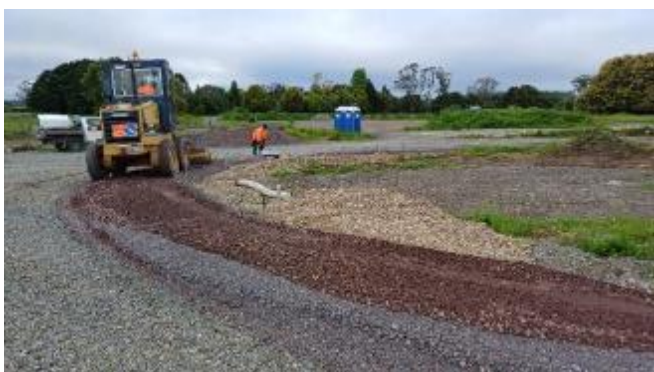
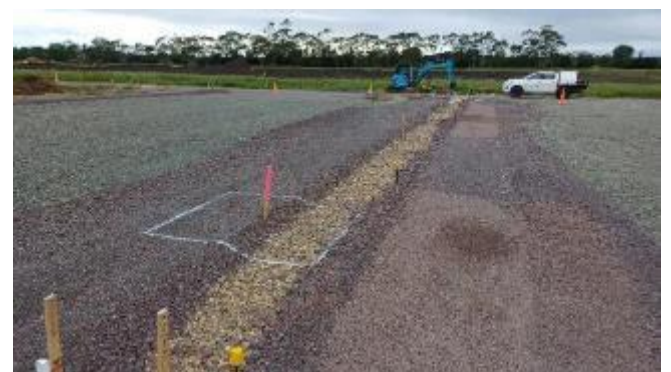
Waipapa Sports Complex

Work has started at Waipapa for the Sports Complex site with preparation for the kerb and light foundations underway. There are some long sections and tricky areas to get around but there is real good progress happening. Kerb installation and concrete for the light foundations will be ready to pour in the next few days. Boxing and pouring of the footpaths, installation of pram crossings and ramps, and draw pits to follow.

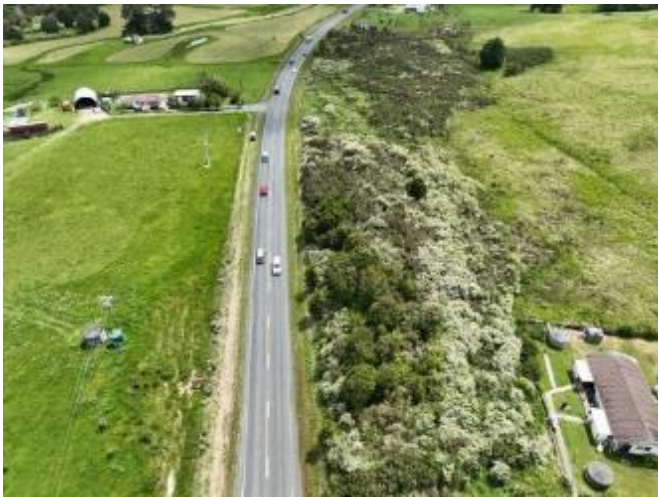
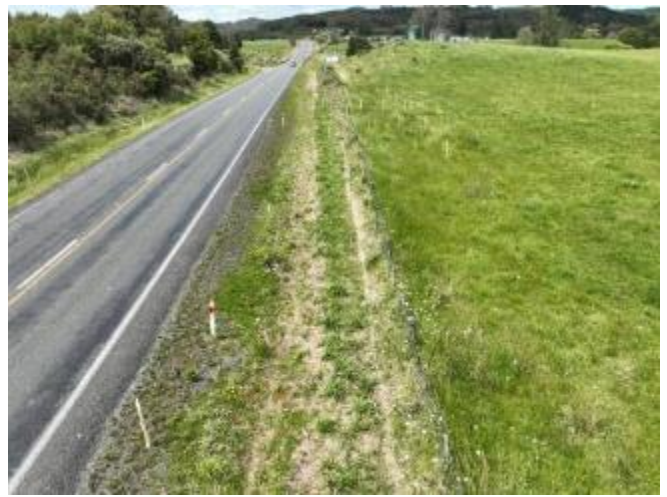
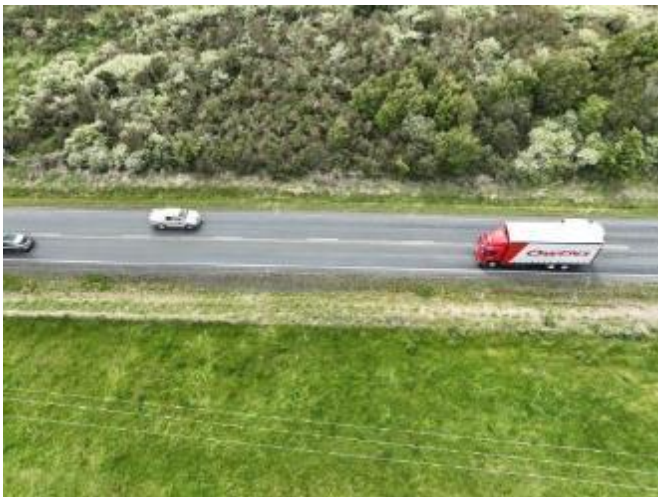
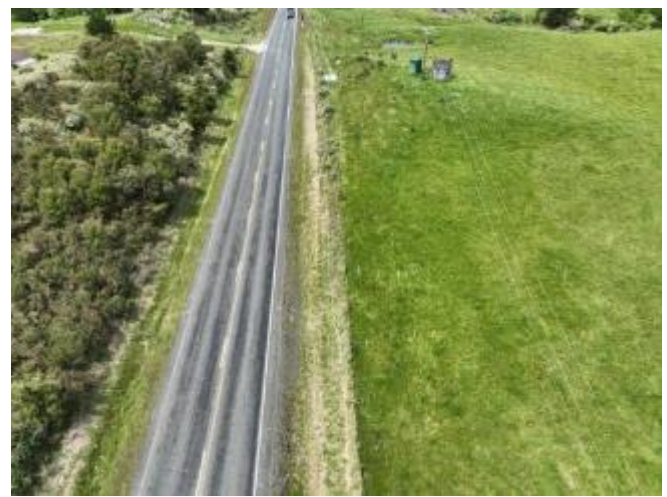
Cherrington Project

Work is nearing completion in Waiomio where a new Papakainga is being situated. Work has involved road widening on the SHW as well as the entranceway into the Papakainga. Watertables have been improved with some vegetation cleared to tidy the area and help with sight visibility. Below are a few photos of the initial set up.
