02 August 2023

Far North District Council  
C/o – Andy Finch

**RE: GEOTECHNICAL WALKOVER APPAISAL FOR COASTAL SLIPPAGE BELOW 7 RICHARDSON STREET, OPUA  
(TE ARAROA TRAIL)**

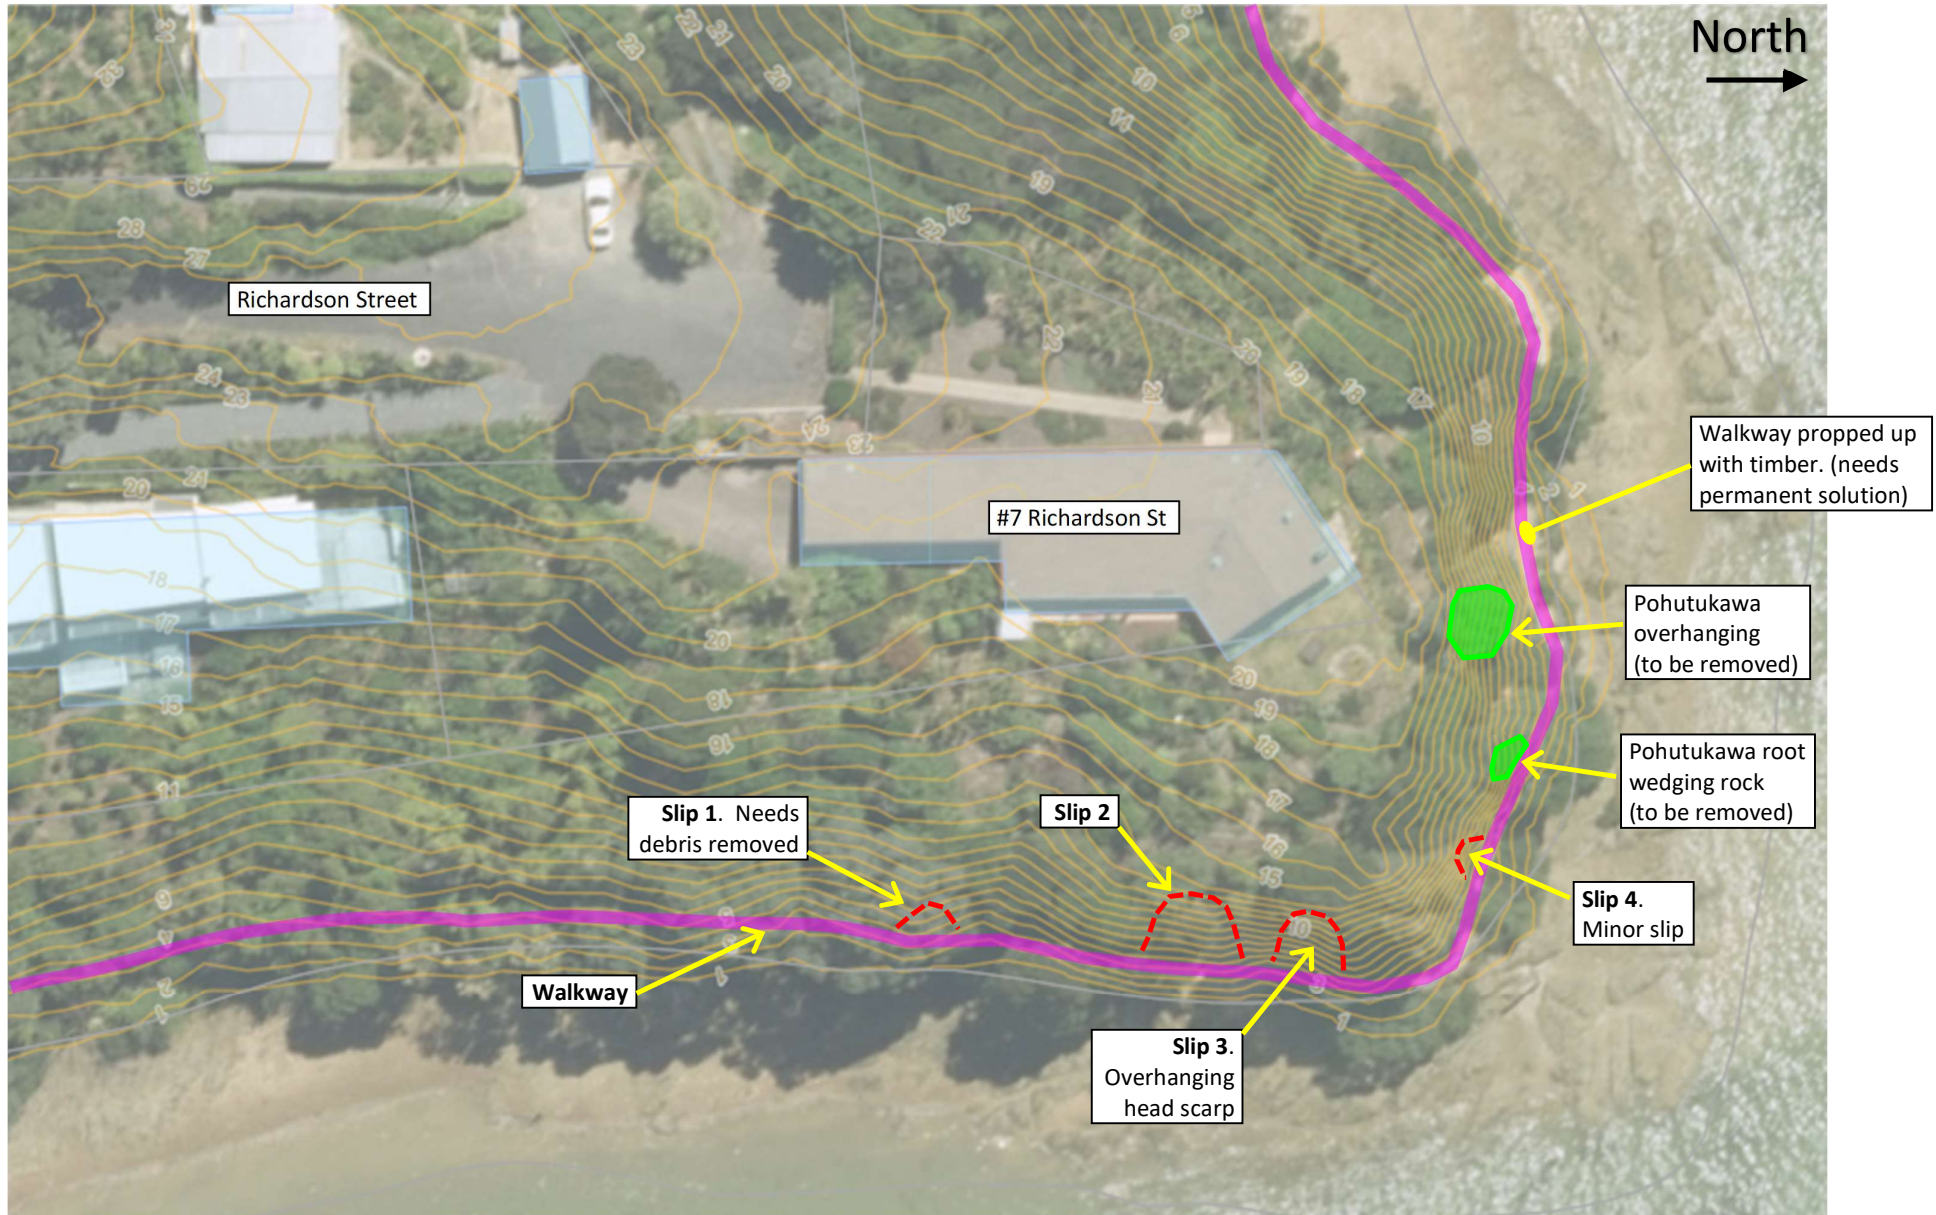
- There are 3 main slips along the eastern side and 1 minor slip along the northern side (refer to attached mark-up plan)
- The first slip (numbered slip 1 on the attached plan) is a small slump, approx. 2.0 m wide with the bulk of the slip material remaining in place, including large block of rock.

- The second slip (slip 2) is approx. 5.0 m wide. The slip material has completely evacuated and exposed the weathered rock surface. The slipped material appears to have comprised a 500 mm thick layer of soil and vegetation. This slip has left a near vertical lip at the headscarp with several trees overhanging.

- The third slip (slip 3), approx. 3.0 to 4.0 m wide, has mostly evacuated with a small amount of debris at the toe. This slip has regressed further than Slip 1 (approx. 1.5 m into cliff) and the slipped material is mostly weathered rock. This slip has also left an overhanging lip at the headscarp with several trees above.

- The minor slip on the northern face (slip 4) has left an overhanging lip at the headscarp with vegetation above.
- On the northern face there is an area where Pohutukawa tree roots are wedging a large block of rock and the tree is overhanging the walkway. The cliff is vertical in this area.

- Another mature Pohutukawa tree on the northern cliff has been undermined (by cliff erosion) and is overhanging the edge of the cliff.
- There are numerous visual signs of historic shallow seated soil movement within the landscaped area on the eastern side of 7 Richardson Street, above the coastal cliff (i.e. terracing, cracks, over-turned landscape walls) however, these are older features and unrelated to the recent slippage along the cliffs.

The above mention features are outlined on the attached mark-up plan.

- Removal of any trees that are overhanging the walkway, have been undermined by erosion, or are situated above the recent head scarps.
- Descaling / removal of any loose rocks and slip debris.
- Re-grading of the vertical and overhanging lips below the head scarps to the typical cliff slopes.
- Removal of the rock and Pohutukawa tree root wedging on the northern cliff face.
- Removal of the undermined Pohutukawa tree (and any loose soil/rock) on the northern cliff face.
