### Unsealed Roding Network Audit

Prepared for Far North District Council

August 2019

Ref L21634a

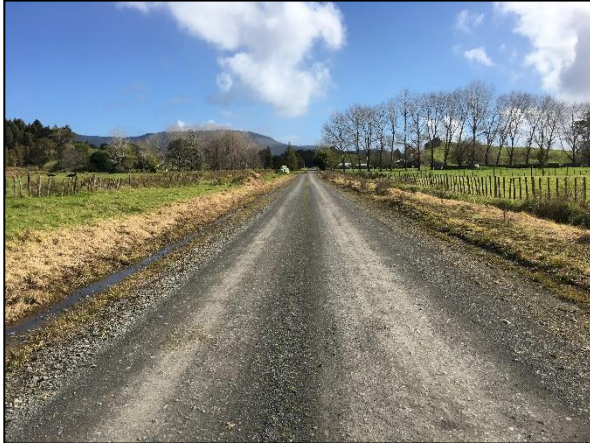
This office visited and performed an assessment of Wharepunga Road on Wednesday 17<sup>th</sup> July 2019. The carriageway was observed to be in satisfactory condition with no evidence of any recent maintenance.

Figure 7.3.1 – Typically Hard Packed Smooth Surface

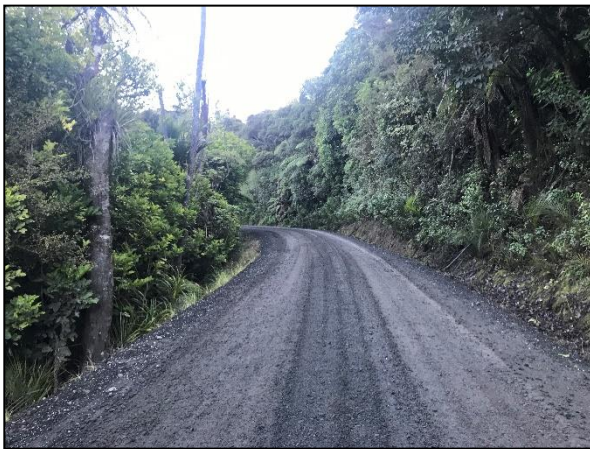
Figure 7.4.1 – Constrained Carriageway – Recent Metal

Assessment of the Paponga Road carriageway identified no significant widespread defects or fundamental issues aside from sections of the carriageway that are highly constrained by the steep topography of the area. Recent embankment work was noted, likely to clear loose overslip debris. Fresh attrition metal was also noted throughout the site, however had not been adequately compacted and was very loose. Pavement thickness was typically sufficient elsewhere through the site. Only one shear failure was noted, however this was likely as a result of poor drainage and weakening of the subgrade in an isolated section. No other significant potholing, corrugating or rutting was noted.

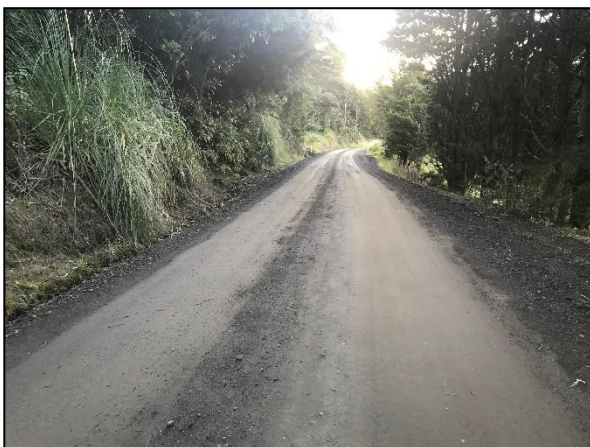
Figure 7.4.3 – Smooth Hardpacked Surface in Areas

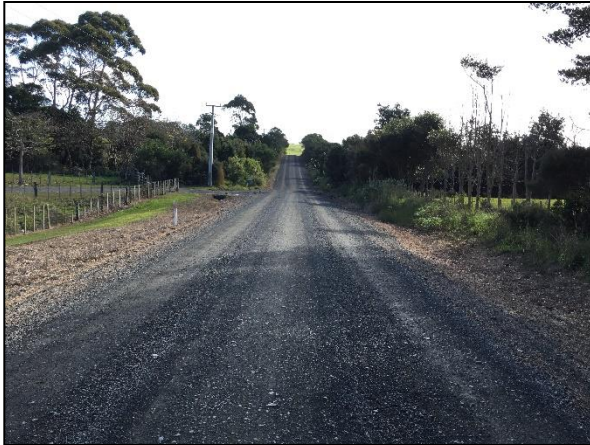
This office visited and performed an assessment of Henderson Bay Road on Thursday 18<sup>th</sup> July 2019. The carriageway was observed to be in typically good condition, with no evidence of recent maintenance and only one isolated subgrade failure.

**Figure 7.5.1 – Wide, Smooth Carriageway Profile**

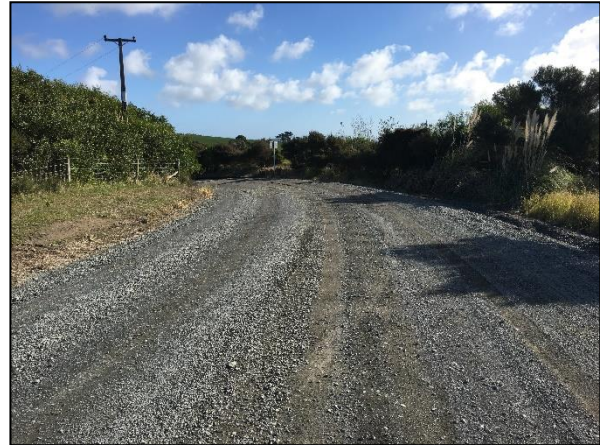
**Figure 7.5.2 – Appropriate Superelevation**

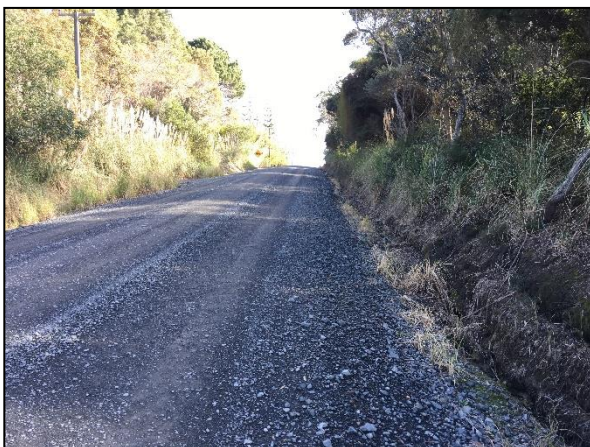
Henderson Bay Road was generally observed to be in good condition with the only defect being an isolated shear failure located at the brow of a rise. At the location of the shear failure the carriageway has been cut through the ridgeline to ease the vertical curve and it is likely that the weaker underlying subsoils have been exposed in this location. Aside from the shear failure, roadside drainage, pavement thickness and carriageway profile were satisfactory throughout the site, with adequate water tables, no other notable surface failures and crossfall and super-elevation typically within specification.

**Figure 7.5.3 – Defined Drainage & Crossfall**

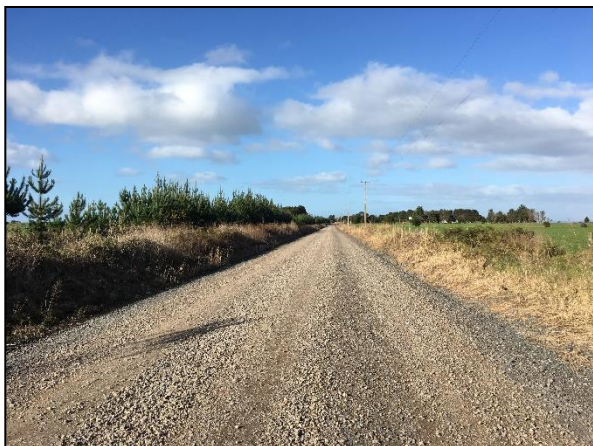
This office visited and performed an assessment of Puketotara Road on Wednesday 17<sup>th</sup> July 2019. The carriageway was observed to be in good condition, with no evidence of recent maintenance.

Figure 7.6.1 – Wide, Smooth Carriageway Profile

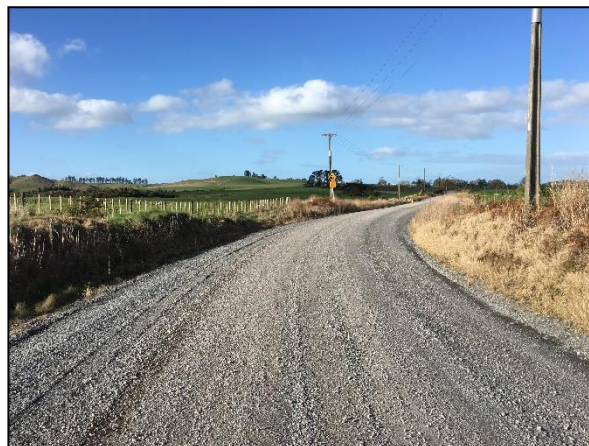
Figure 7.6.2 – Appropriate Superelevation

Puketotara Road was generally observed to be in good condition, within only isolated ponding of surface water within section of the site with limited fall, aside from this ponding no other notable defects were noted. Carriageway profile was good, super-elevation and crossfalls were appropriate and generally appeared to direct stormwater away from the trafficable pavement. Pavement condition was good, albeit the running course was relatively loose and 'boney'. This is a direct result of using a rounded conglomerate aggregate which although provides a smoother ride, is typically very loose and reduces traction.
