Preliminary Present Value End of Life (PVEOL) Analysis			
Network area:	Highway:	RP:	BSN:	Structure name:	Owner:	Far North District Council	
Northland	Kahikatoa Rd	1607		Kahikatoa Road Culvert No. M35	RCA:	Far North District Council	
General Structure Data				PVEOL Questions:	Yes/No	Brief explanation of restrictions	
Year constructed:	Unknown			Is the bridge over 80 year old	No		
One Network Road Classification (ONRC):	Access (low volume)			Is there significant maintenance required in the next 3 years	Yes		
Vehicles per day:	<50			Is the bridge inspected in accordance with NZTA-S6	Yes		
% heavy vehicles:	10.0%			Is the bridge on special inspections	Yes		
Number of Spans	2			Has a live load assessment been carried out based on the known condition	No		
Total Length of Bridge	3.1m			Are there any brittle and/or vulnerable details on the bridge	Yes		
Road width between Kerbs/rails	4m (soffit 6m)			Are there live load or speed restrictions across the bridge	No

Preliminary Present Value End of Life (PVEOL) Analysis			
Network area:	Highway:	RP:	BSN:	Structure name:	Owner:		
Northland	Kahikatoa Rd	1607		Kahikatoa Road Culvert No. M35	RCA:	Far North District Council	
Other general photos

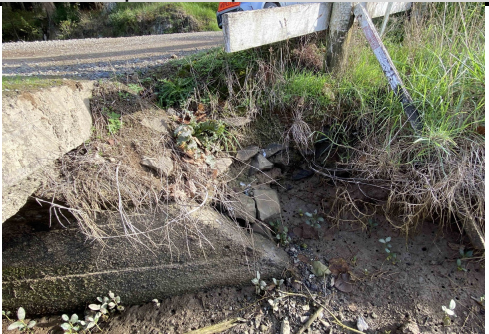
Current Condition		Briefly explain the current defects			Representative photo of condition		
Parapets / Barriers / Surfacing		N/A
