Hihi Wastewater Treatment Plant

CAPITAL WORKS BUSINESS CASE

Project Code:	WWP0655	Project ID (Finance):	551302
Objective ref:	A3068094	Objective version #:	1

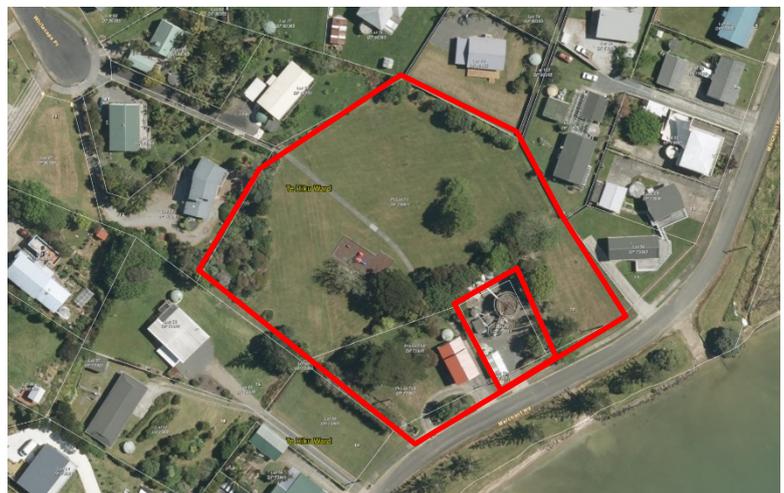
Figure 2) WWTP shown inside recreational reserve

The Hihi Wastewater treatment plant (WWTP), built around 1975, is located alongside the Hihi Marchant Road Reserve which sits within the boundary of residential properties. The wetland marshes are located off Hihi Road, approximately 800m away from the plant. The plant undertakes both primary and secondary treatment processes, then effluent is pumped from the plant to wetland marshes for tertiary treatment. It is then discharged by gravity to Hihi stream, a minor watercourse that runs through the settlement of Hihi before reaching the coast at Hihi beach. This WWTP employs an extended aeration, activated sludge process. The plant consists of two aerations

tanks that operate in series, followed by a sedimentation tank, which collects the clarified wastewater in an effluent storage tank and from here it is pumped through a rising main to a series of wetland cells.

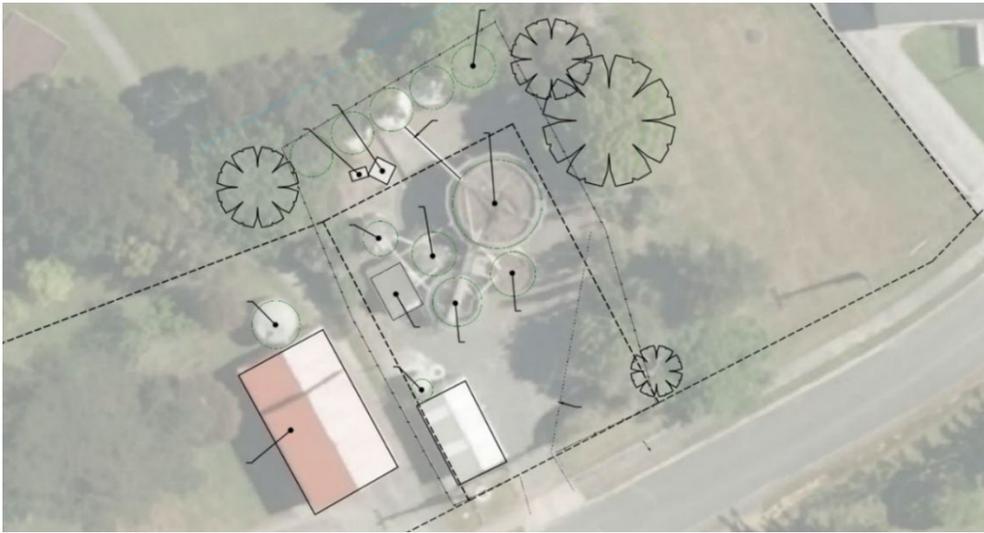
Figure 3) Hihi WWTP, Marchant Road – Site boundary and existing asset layout.

- Five stormwater storage tanks installed at the rear of the plant extends outside of the lawful designated area, which does not meet planning requirements.

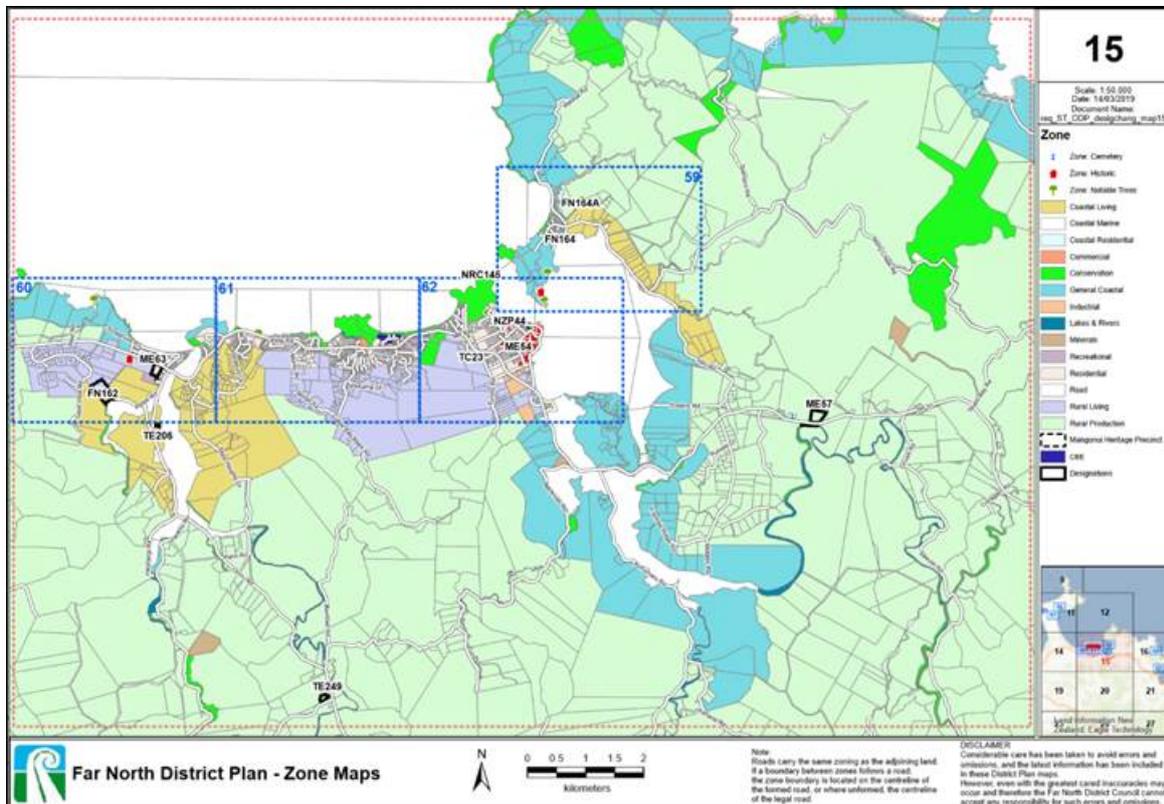
Figure 4) FNDC Zoning and Designations – refer FN164 and FN164A

1. Existing Site (Lot 78 DP 73991)
 - District Plan – Underlying zone Coastal Residential with a Designation (FN164) for the purpose of Hihi Sewage Treatment and Disposal – applying to Lot 78 DP 73991 and SO 69378 Blk IV Mangonui SD.
2. Neighbouring Site (Part Lot 71 DP73991)
 - District Plan – Recreation reserve land zoned recreational activities subject to the Reserves Act.
3. Wetland Site (Part Lot 1 37697 and Part Lot 2 DP 88975)
 - District Plan – Rural Production Zone with designation FN164A. The designation was approved on 1 May 2008 – Consent number RC 2061079. This decision was issued by the Environment Court, it has specific conditions that apply to the site.
4. Far North District Council's Engineering standards and Guidelines 2004 (3rd revision July 2007).

Note: Figure 4 shows the Far North District Zoning (referred to in the previous numbered points) for Hihi WWTP designations.
