Name: John Vujcich

Far North Councillor

Date: 16/05/2023

Extensive
Roading
problems and
flooding

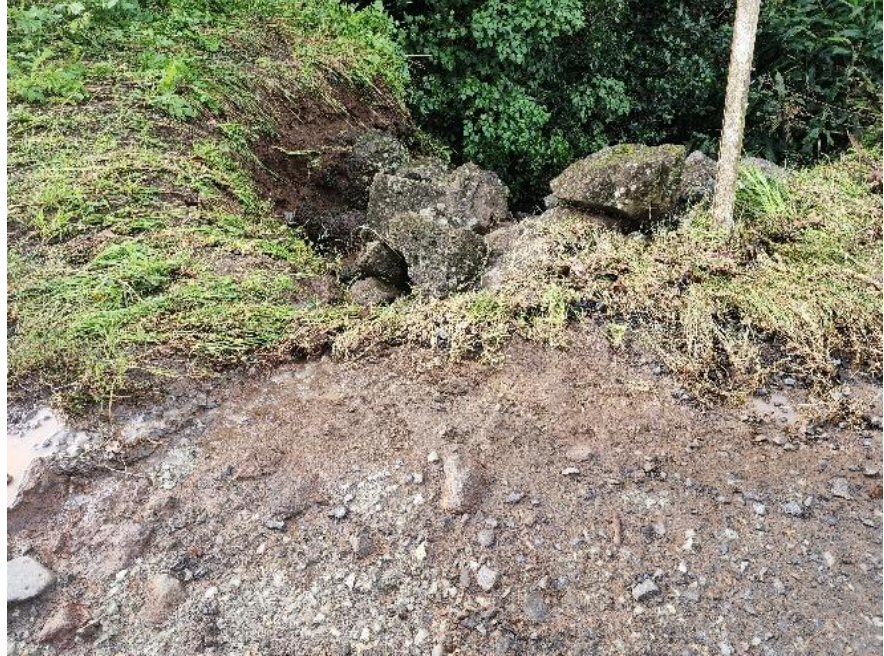
Have received numerous complaints of flooding and roads failing and visited a number of local roads. Most of these roads show poorly maintained water tables and culverts that are blocked or too small to cope with the water volumes. Below is an example on Waitāheke Road, south of Kaikohe, of badly eroded road and erosion around the culvert.

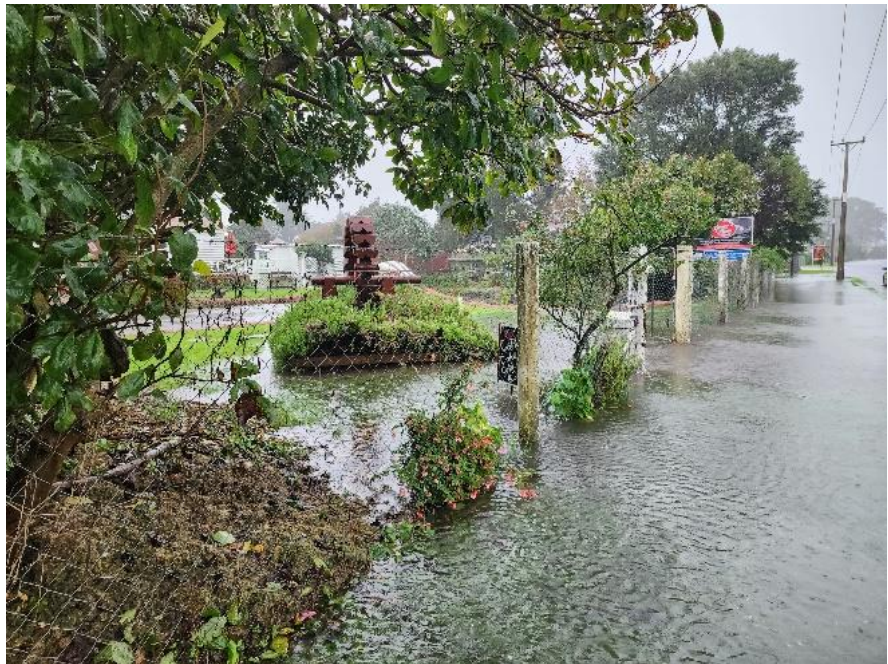
Flooding on Recreation Road, Kaikohe. The area floods regularly; the storm water funding allocated needs to be spent urgently as this storm water problem also causes a traffic hazard on the heavy traffic bypass when it floods.

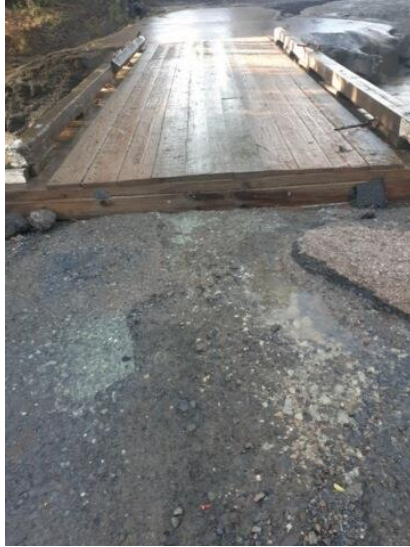
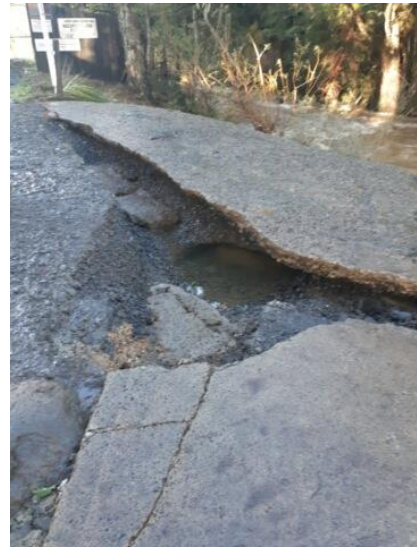
Cumber Road

Cumber Road, Kaikohe, is used by Council vehicles discharging at the Kaikohe sewerage plant, by local farmers and residents as well as contractors at the old DSIR site. The road is slumping and needs water tables cleaned. The biggest issue is the bridge that floods 3 to 4 times a year with the last flood seriously eroding both ends. Immediate attention is needed and a better fix is urgent.
